Project Name Ft. Pickett
Project Location Blacksstone, VA
Project Number TO124
Purchase Order No. _____

LABORATORY ANALYSIS REPORT

Asbestos Identification by EPA Method 600/R-93/116

PO NO.:
PROJECT NAME: Fort Pickett
PROJECT NO.: Building TO124
JOB LOCATION: Blackstone, VA

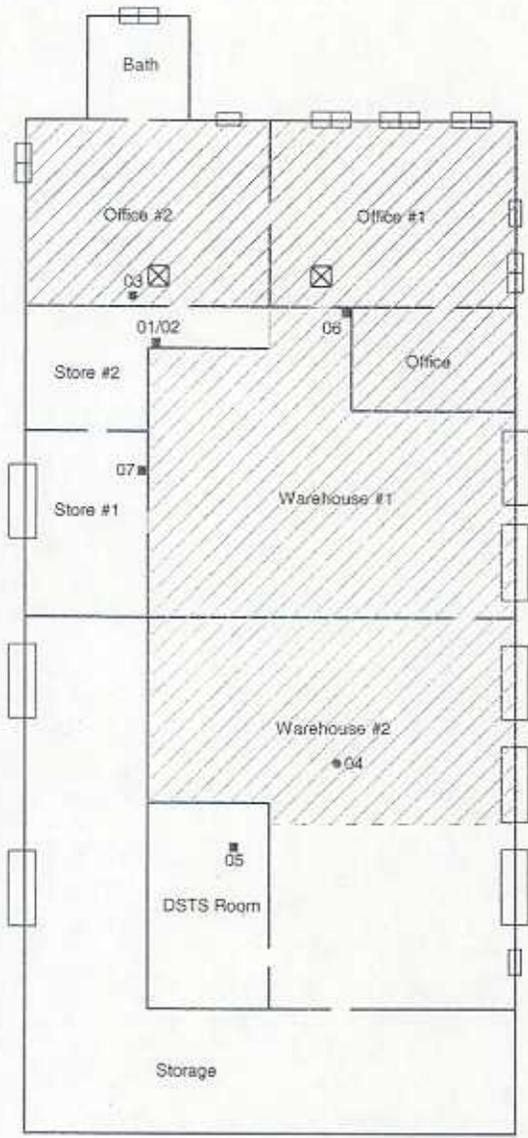
Project: Fort Pickett
Building T0124
Warehouse
Sample Locations

- 1.0 Drawing Not To Scale
- 0 All Roof Materials Are Assumed Positive
- 3.0 Window Glaze Is Assumed Positive

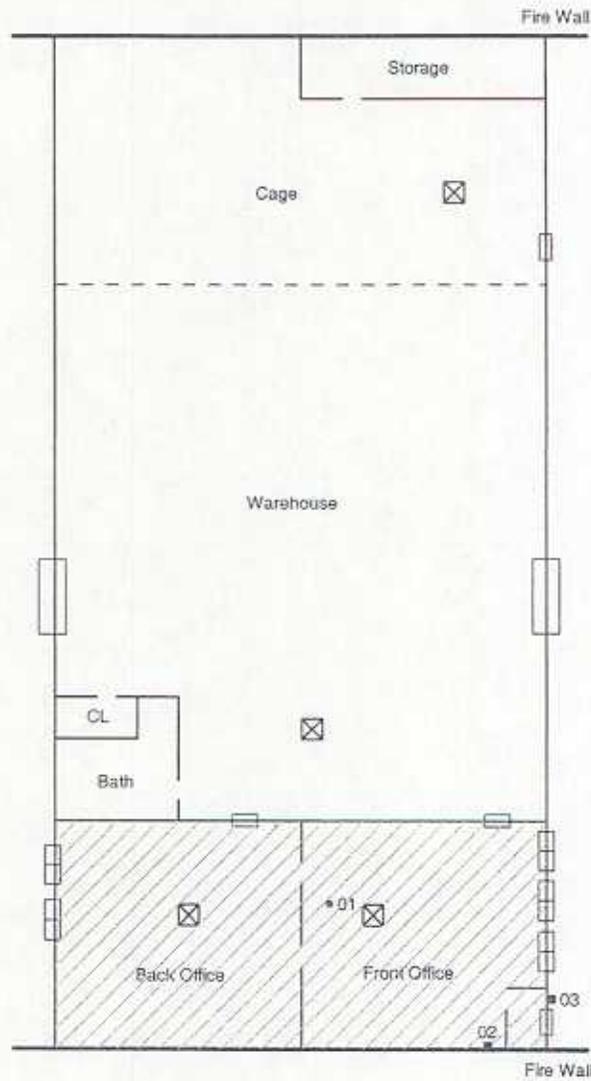
Project: Fort Pickett
 Building T0125
 Warehouse
 Sample Locations

- 1.0 Drawing Not To Scale
- 2.0 All Roof Materials Are Assumed Positive
- 3.0 Window Glaze Is Assumed Positive

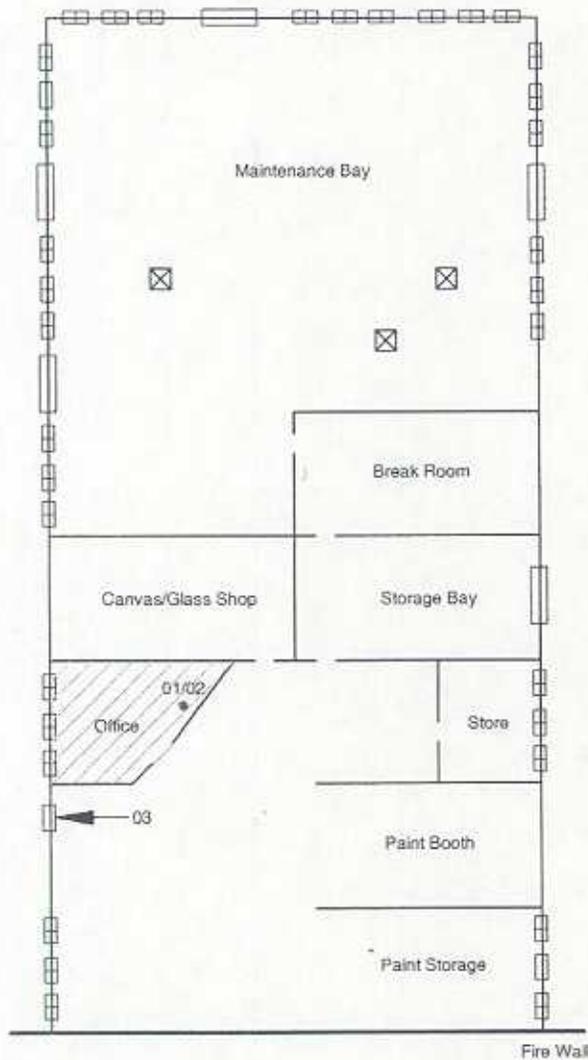
Project: Fort Pickett
 Building T0127
 Warehouse
 Sample Locations

- 1.0 Drawing Not To Scale
- 0 All Roof Materials Are Assumed Positive
- 3.0 Window Glaze Is Assumed Positive

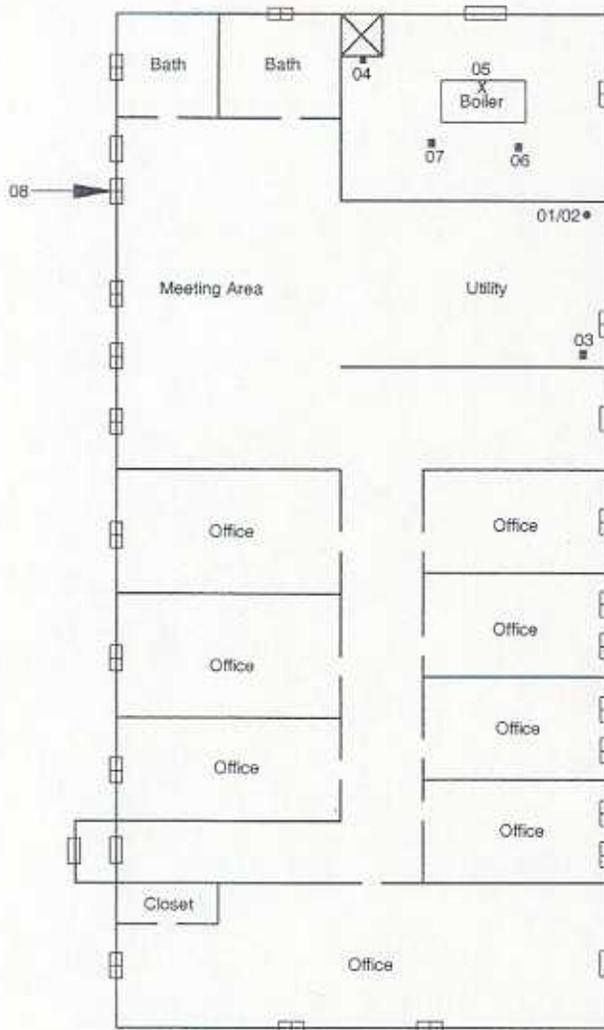
Project: Fort Pickett
 Building T0130
 Administrative
 Sample Locations

- 1.0 Drawing Not To Scale
- 2.0 All Roof Materials Are Assumed Positive
- 3.0 Window Glaze Is Assumed Positive

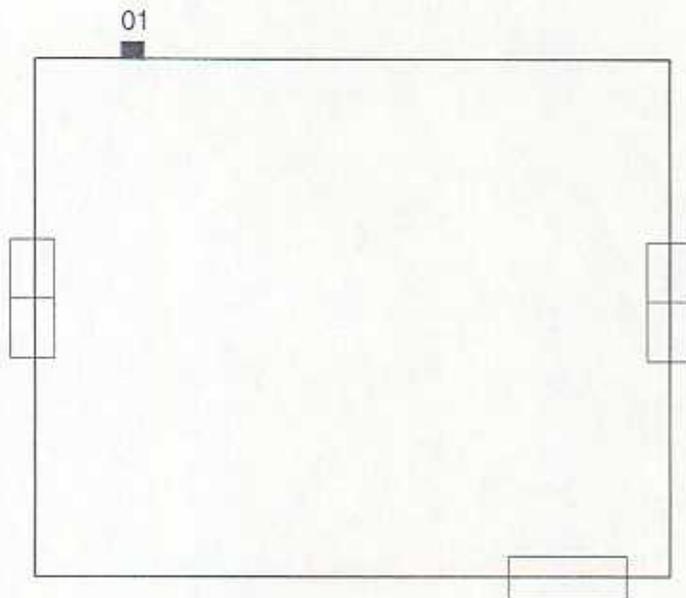
Project: Fort Pickett
Building T0132
General Storage
Sample Locations

) Window Glaze Is Assumed Positive

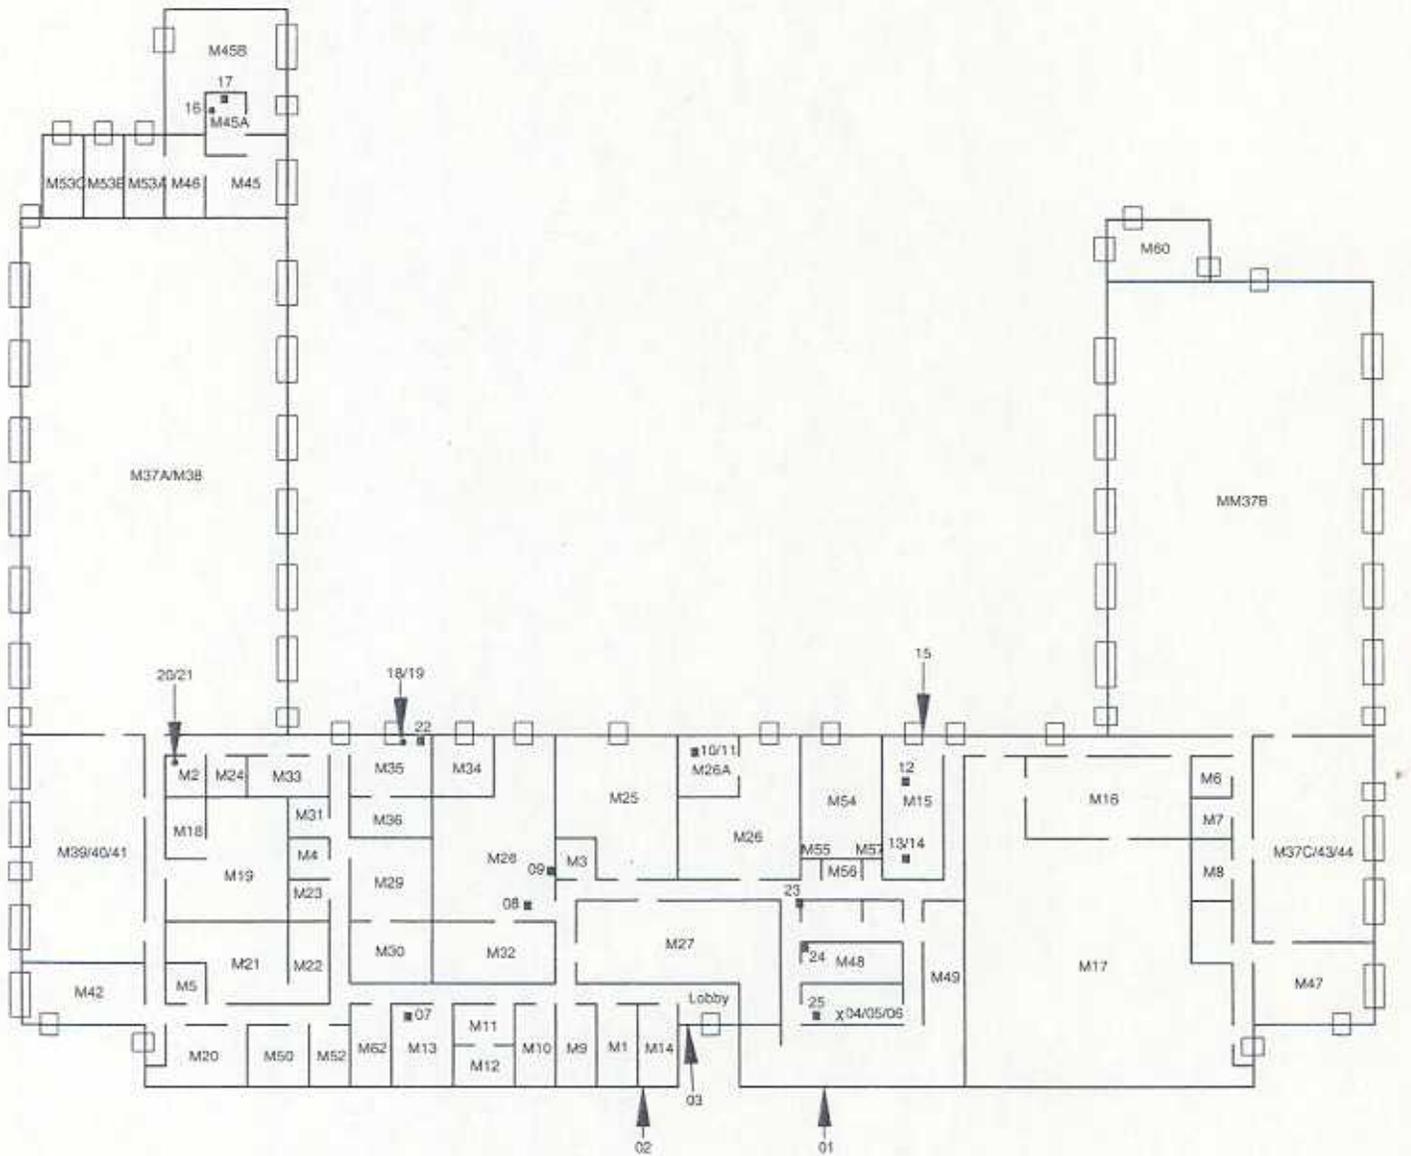
- 1.0 Drawing Not To Scale
- 2.0 All Roof Materials Are Assumed Positive

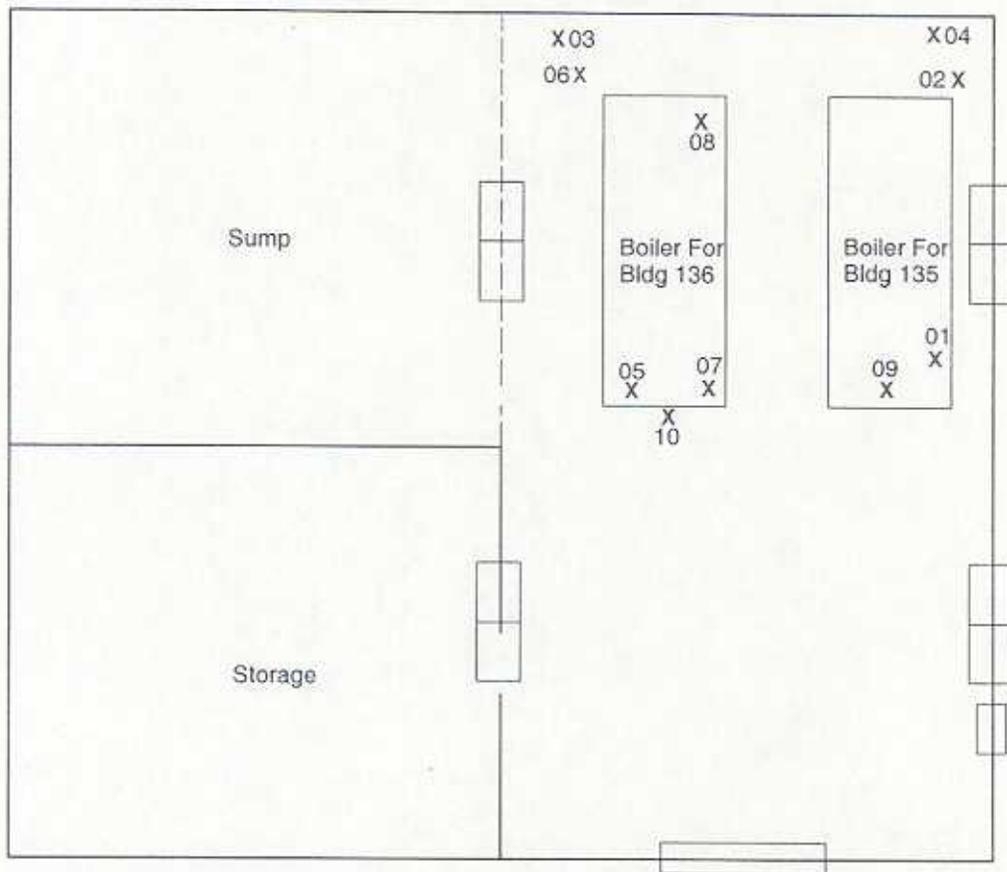
1.0 Drawing Not To Scale
 1 Window Glaze Is Assumed Positive

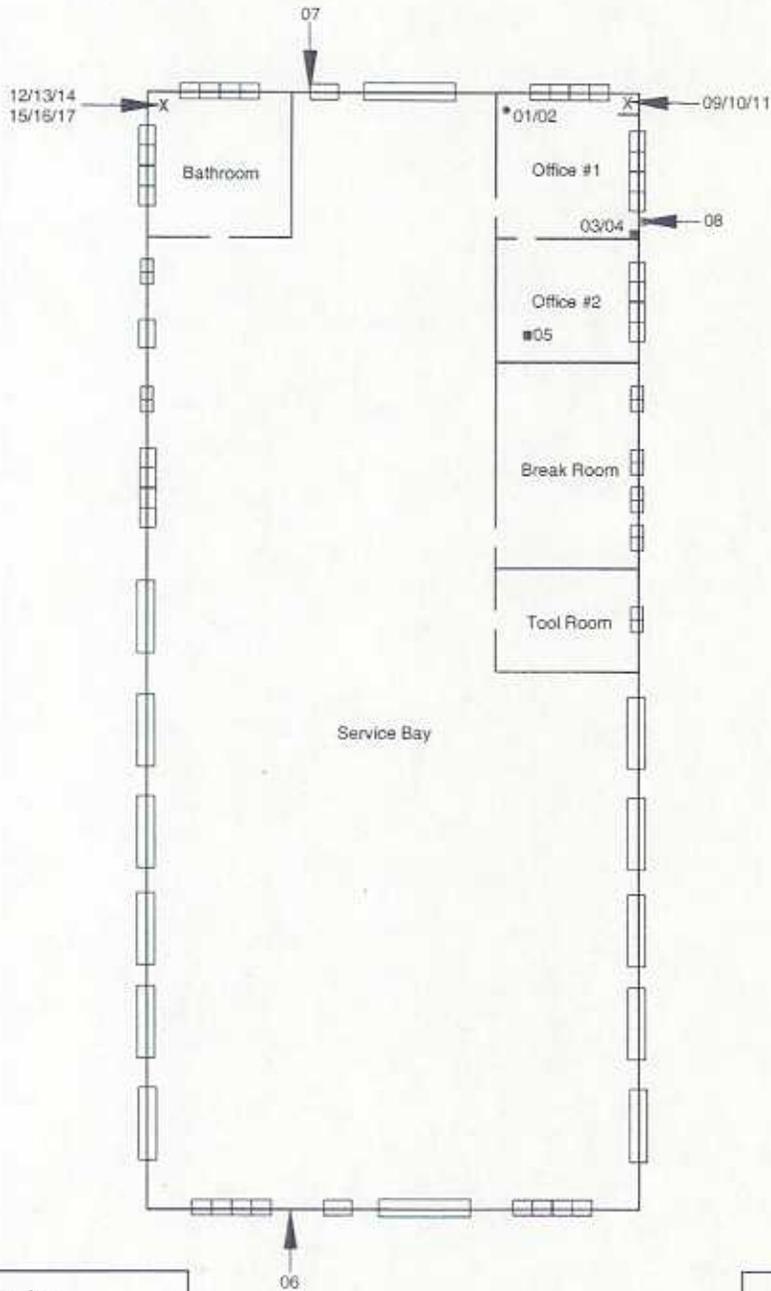
1.0 Drawing Not To Scale
 0 Window Glaze Is Assumed Positive

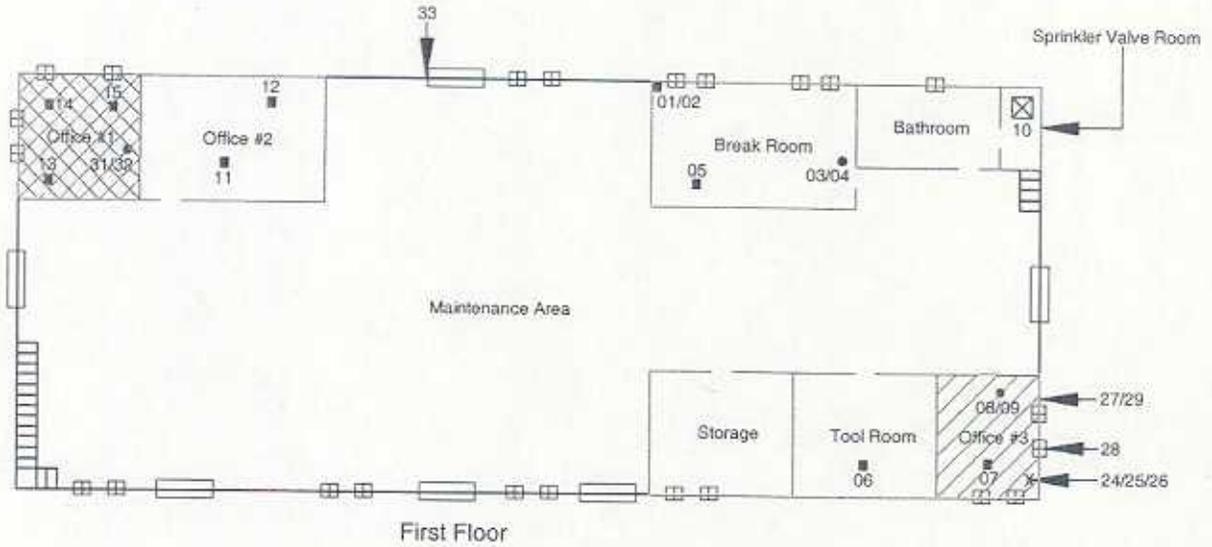
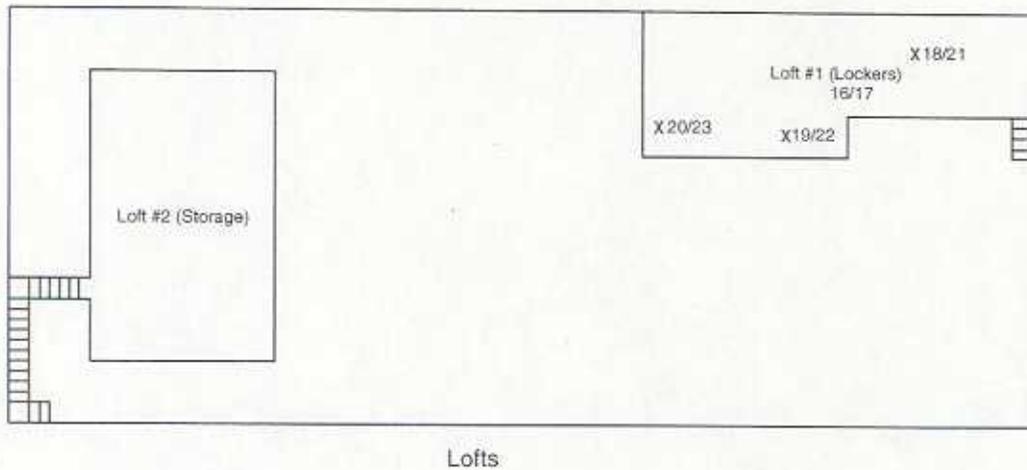
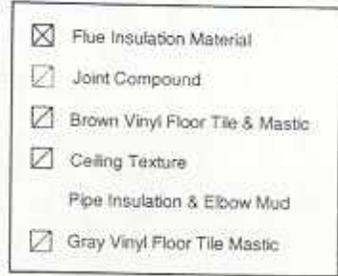
- 1.0 Drawing Not To Scale
- 2.0 Window Glaze Is Assumed Positive
- 3.0 Window Installation Caulk (Sample #28) Is Positive
