REVIEW OF PROJECT CHANNEL  
WITH RECOMMENDED MODIFICATIONS,  
TANGIER ISLAND, VIRGINIA

J. Woodville Holton, Jr., P.E., L.S.  
WATERWAY SURVEYS & ENGINEERING, LTD.  
Virginia Beach, Virginia

CYRIL GALVIN, COASTAL ENGINEER  
Springfield, Virginia

Final Report

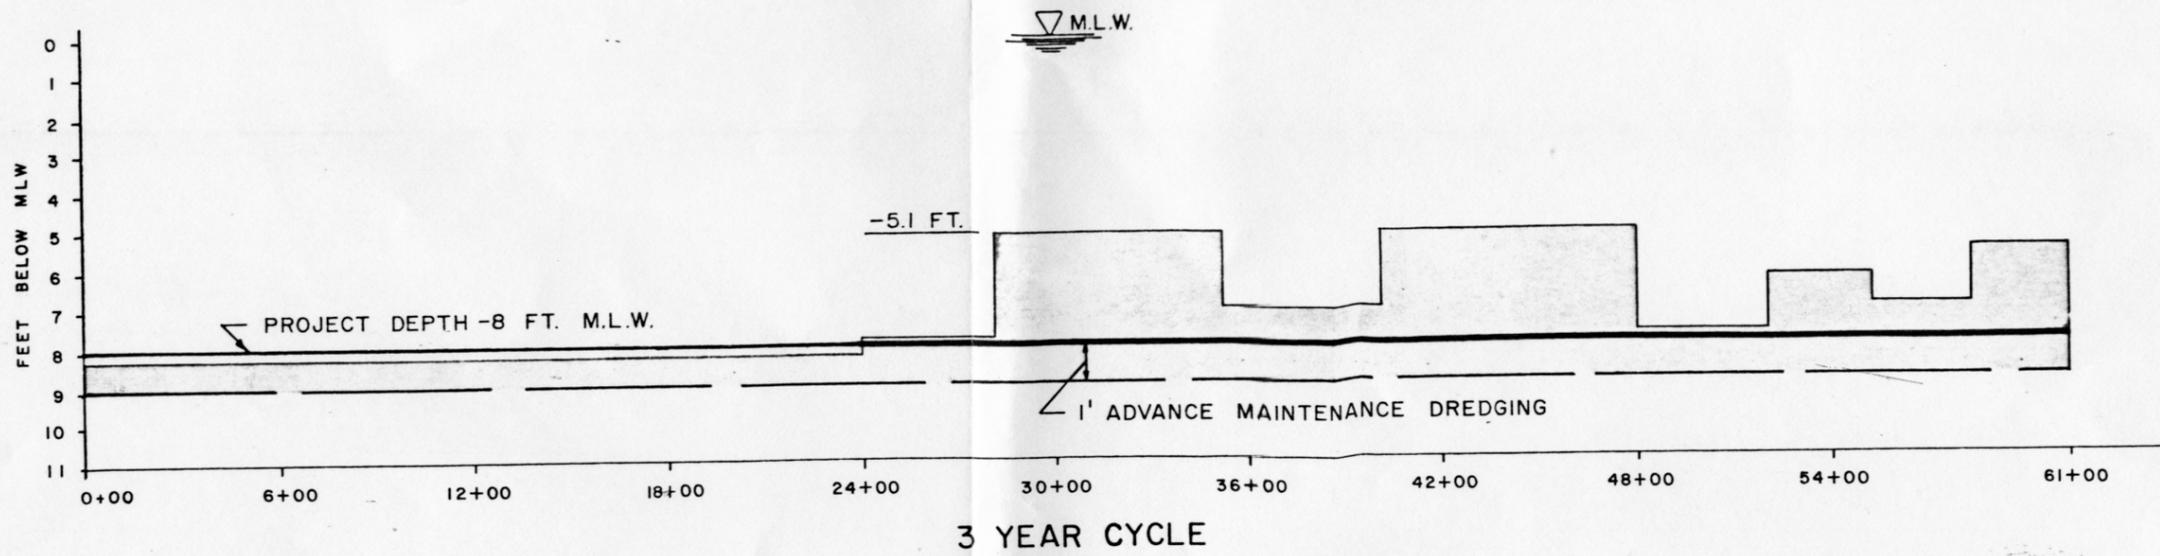
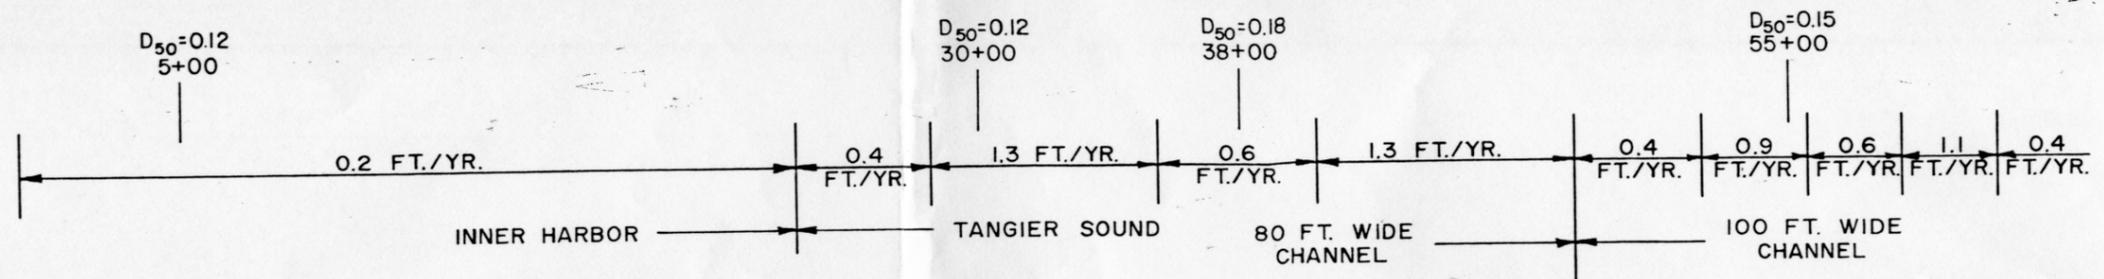
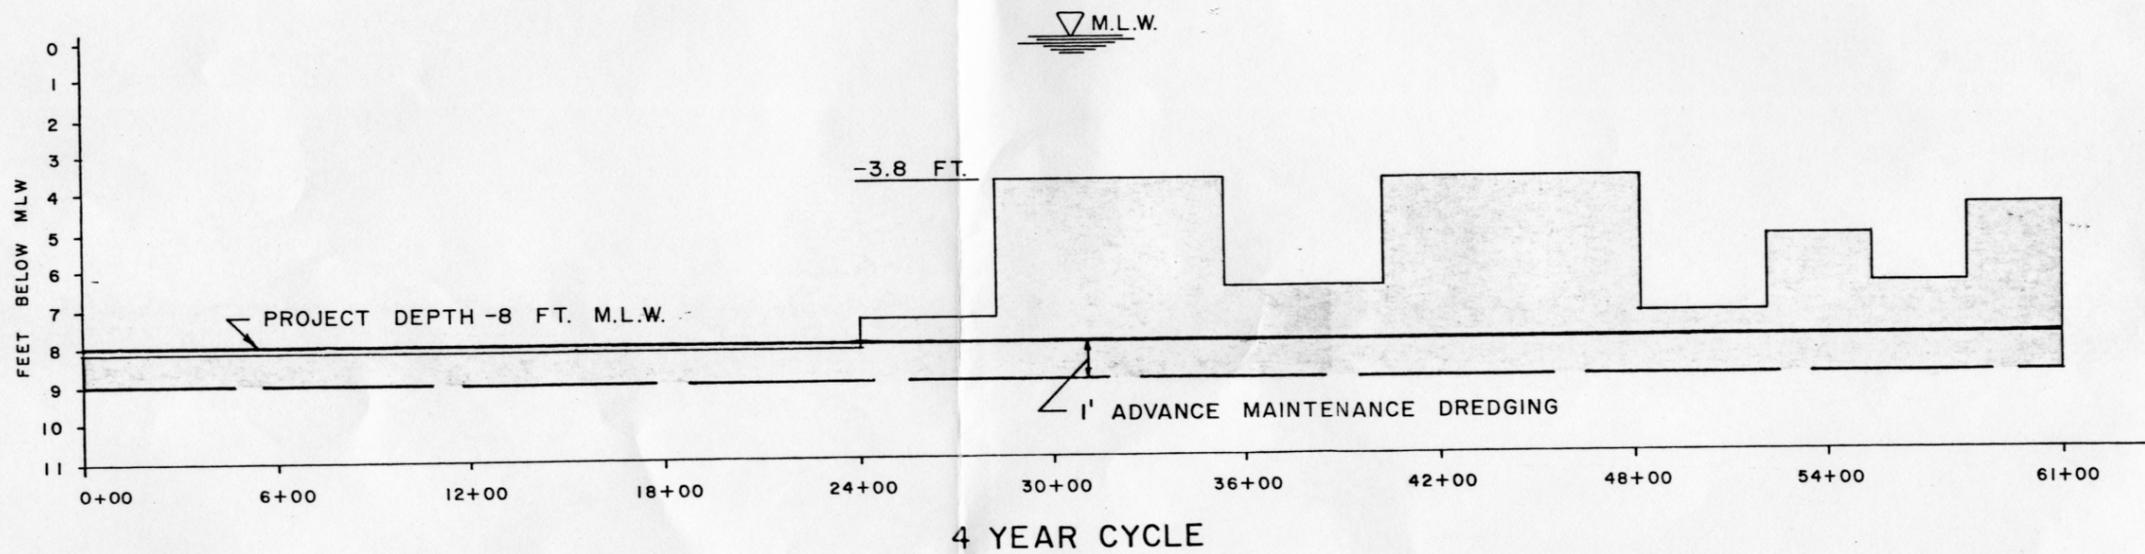
SHOALING RATES  
FIGURE 3  
EAST CHANNEL, TANGIER ISLAND

Shoaling rates in Tangier Sound varied widely with higher shoaling found in the 60 foot wide channel than in the 100 foot wide channel (Figure 3). The extra width provides additional capacity for sediment deposition. Widening of the 60 foot channel between stations 24+00 and 48+00 would provide additional bottom area, therefore, increase the channel capacity for sediment collection. This should have the affect of slowing the rate of channel depth reduction by shoaling in this area.

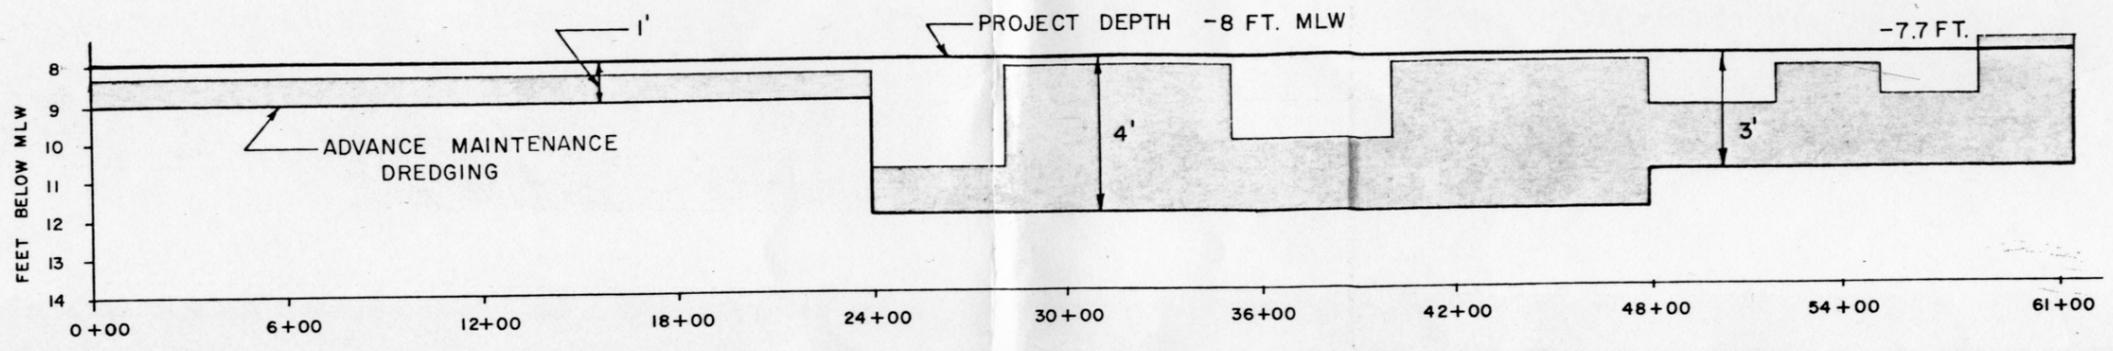
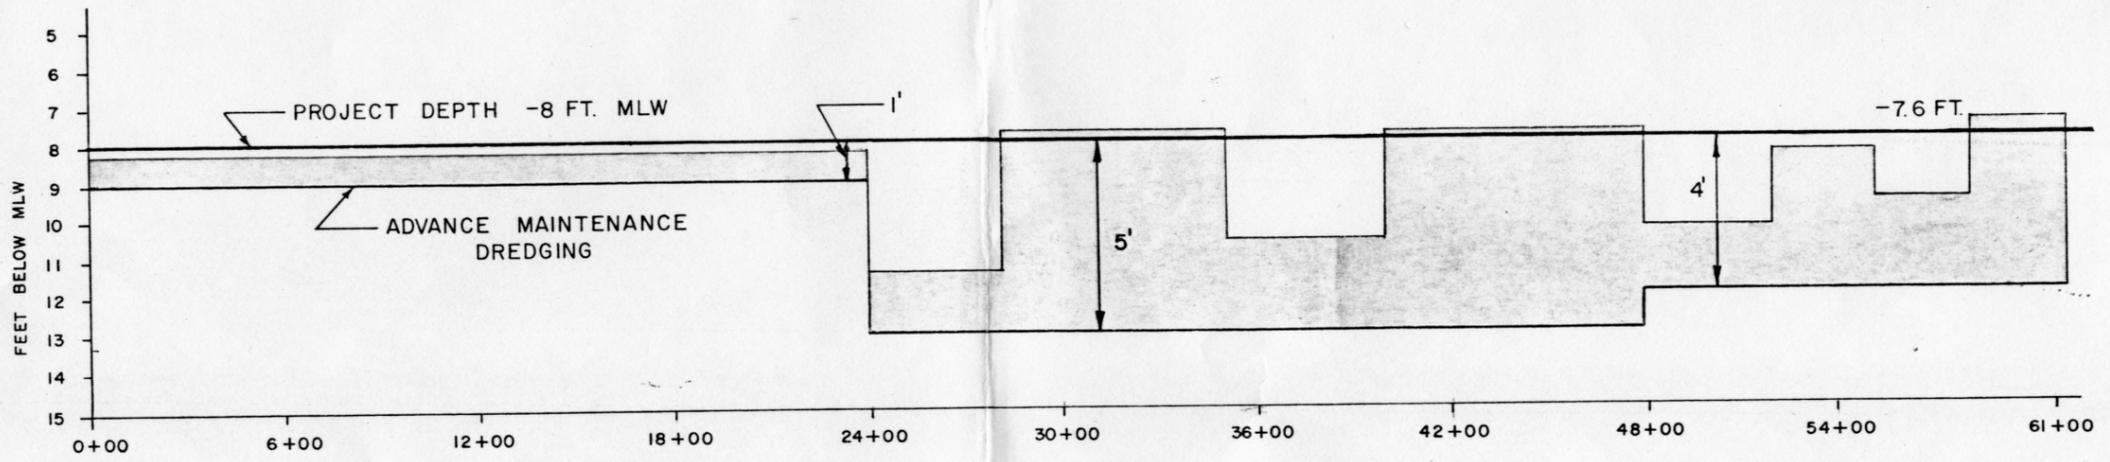
FIGURE 4

to Station 61+00) would be required. The shoaling rates existing between stations 24+00 and 28+00 do not justify the recommended dredging depth as shown on Figure 4, however, provision should be made for increased sediment deposition that possibly will occur due to the sudden increase in depth. If additional width were provided between Stations 24+00 and 48+00 it is predicted that the dredging depth in this area could be decreased by 1 foot for both dredging cycles.

A minimum navigable depth of 8 feet should be provided to accommodate fuel barges. Advance maintenance dredging with variable depths is recommended to insure the required navigable depth and to decrease the maintenance dredging frequency. As shown on Figure 4, advance maintenance at depths (MLW) of 9 feet (Station 0+00 to Station 24+00), 12 feet (Station 24+00 to Station 48+00), and 11 feet (Station 48+00 to Station 61+00), would provide 8 feet of navigable water at the end of 3 years. For a 4 year maintenance dredging cycle depths (MLW) of 9 feet (Station 0+00), 13 feet (Station 24+00 to Station 48+00), and 12 feet (Station 48+00

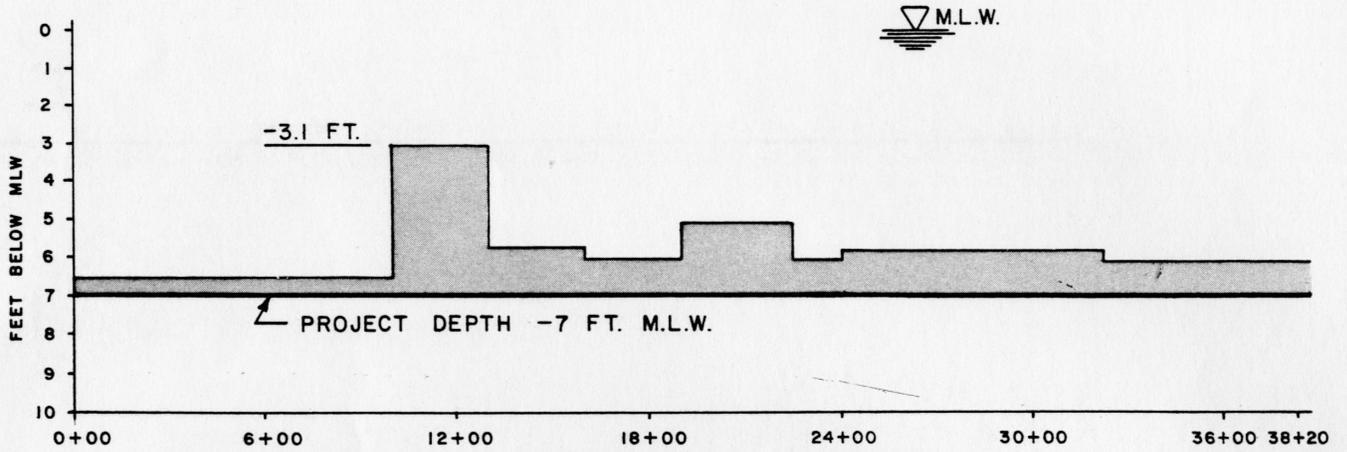
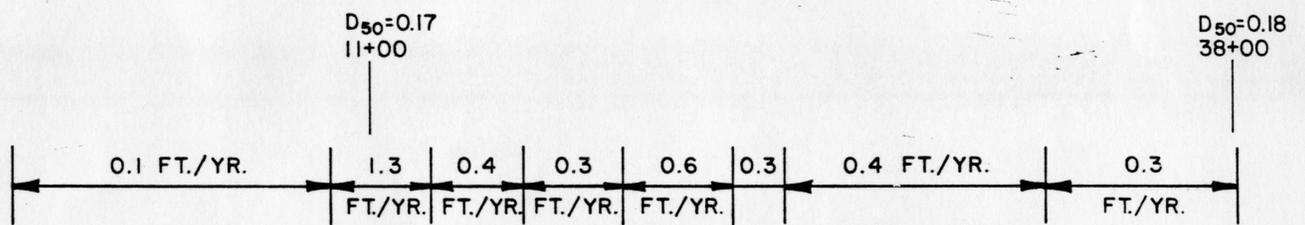
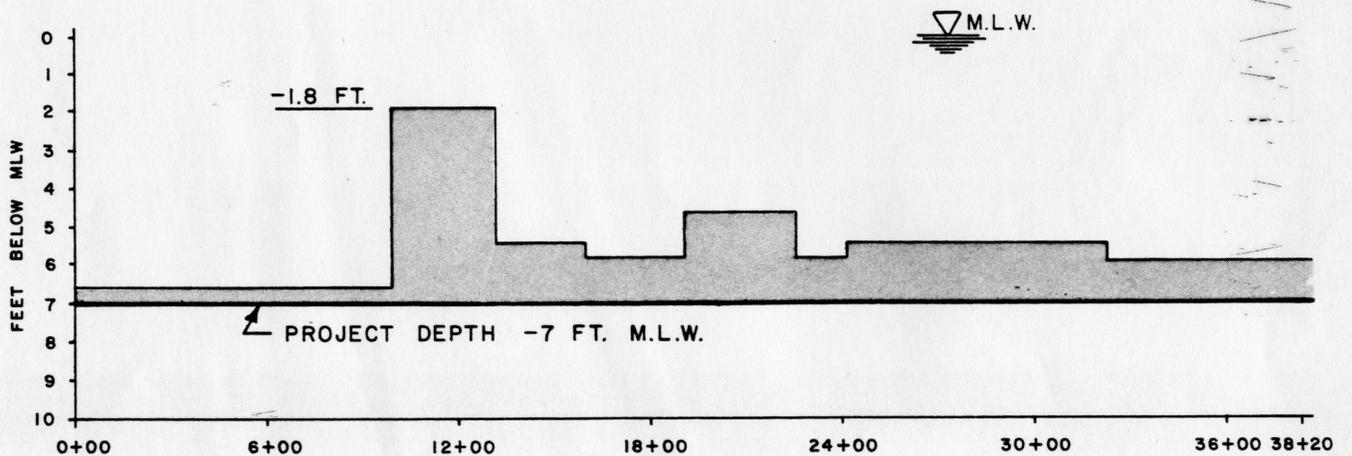
SHOALING RATES  
 FIGURE 5  
 WEST CHANNEL, TANGIER ISLAND

Shoaling rates for the West Channel were developed by using project condition surveys performed by the Corps of Engineers. Shoaling rates throughout this reach were found to be low with the exception of the area between Stations 10+00 and 13+00 which contained a shoaling rate of 1.3 feet per year. Based on the computed shoaling rates an analysis of this reach was performed for a 3 year dredging cycle and a 4 year dredging cycle (Figure 5). From this analysis it is predicted that after dredging to the project depth the usable depth would be 3.1 feet (MLW) in 3 years and 1.8 feet (MLW) in 4 years.

As opposed to the East Channel, wider channels will not decrease the shoaling rate. The high shoaling rate between stations 10+00 and 13+00 is hypothesized to be caused by a flood tide delta and therefore only an increase in depth should be considered. A minimum navigable depth of 6 feet should be provided to accommodate vessels using the East Channel. Advance maintenance dredging should be concentrated in the region of delta formation. Variable depths (Figure 6) are recommended to insure the required navigable depth and to increase the maintenance dredging frequency. Advance maintenance dredging at depths (MLW) of 10 feet (Station 10+00 to Station

13+00), and 8 feet (Station 13+00 to Station 38+20) would provide 6 feet of navigable water at the end of 3 years. For a 4 year maintenance dredging cycle, depths (MLW) of 11 feet (Station 10+00 to Station 13+00) and 8 feet (Station 13+00 to Station 38+20) would be required. Shoaling rates between stations 0+00 and 10+00 are so low that no advance maintenance dredging would be required for either cycle.

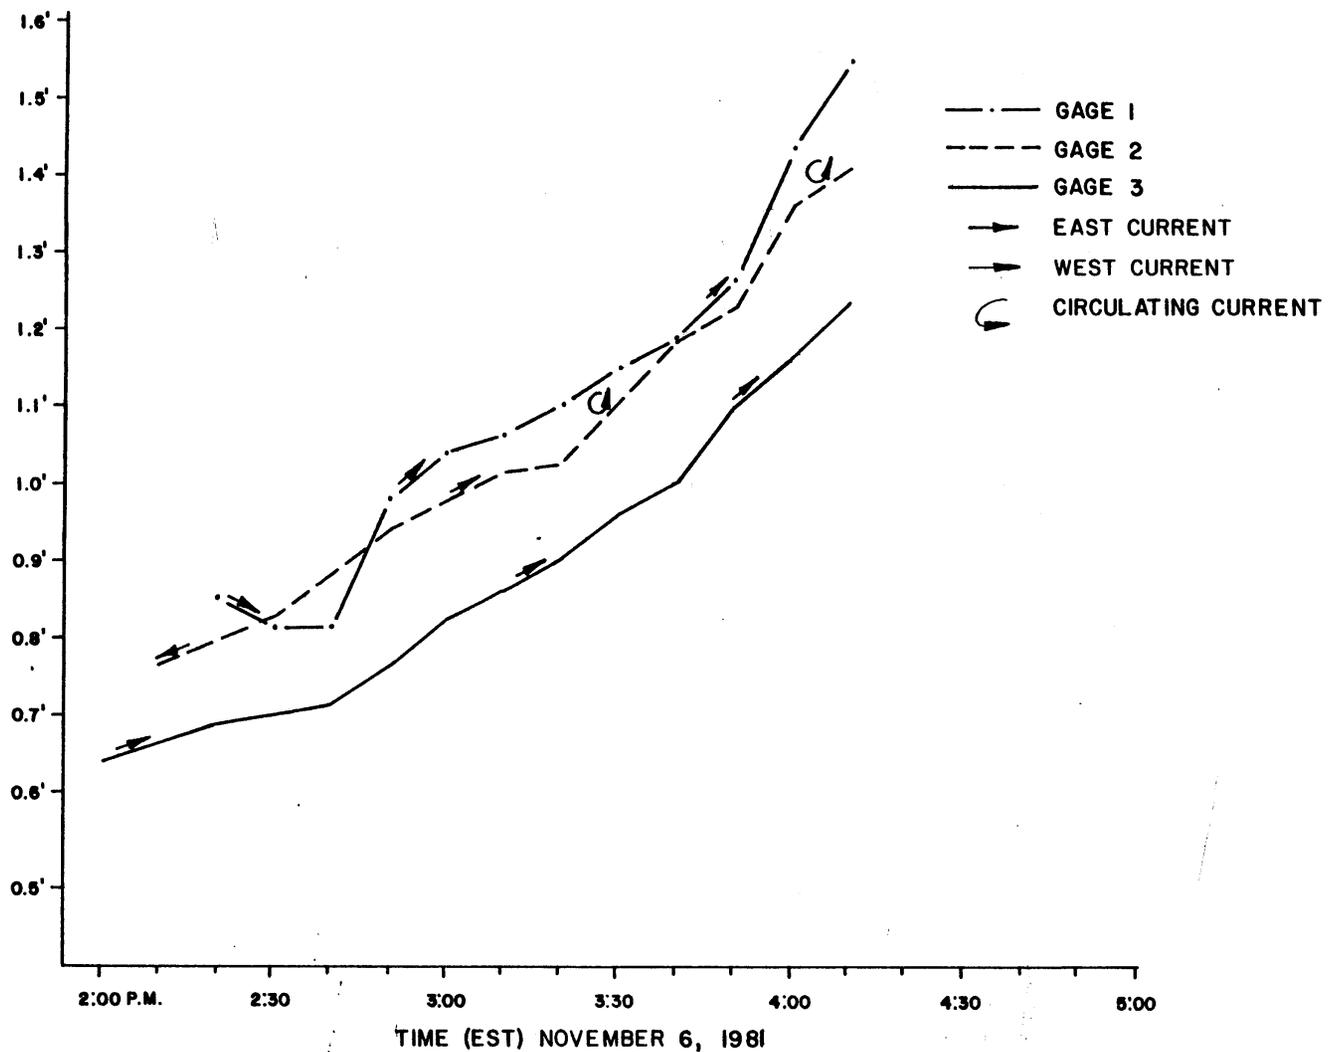
FIGURE 8  
TIDAL PHASING  
FLOOD CONDITION

Figure 8 reflects flood tide data over a greater tide range than Figure 9 and the data appears more consistent. The head differentials reported support the current directions observed.

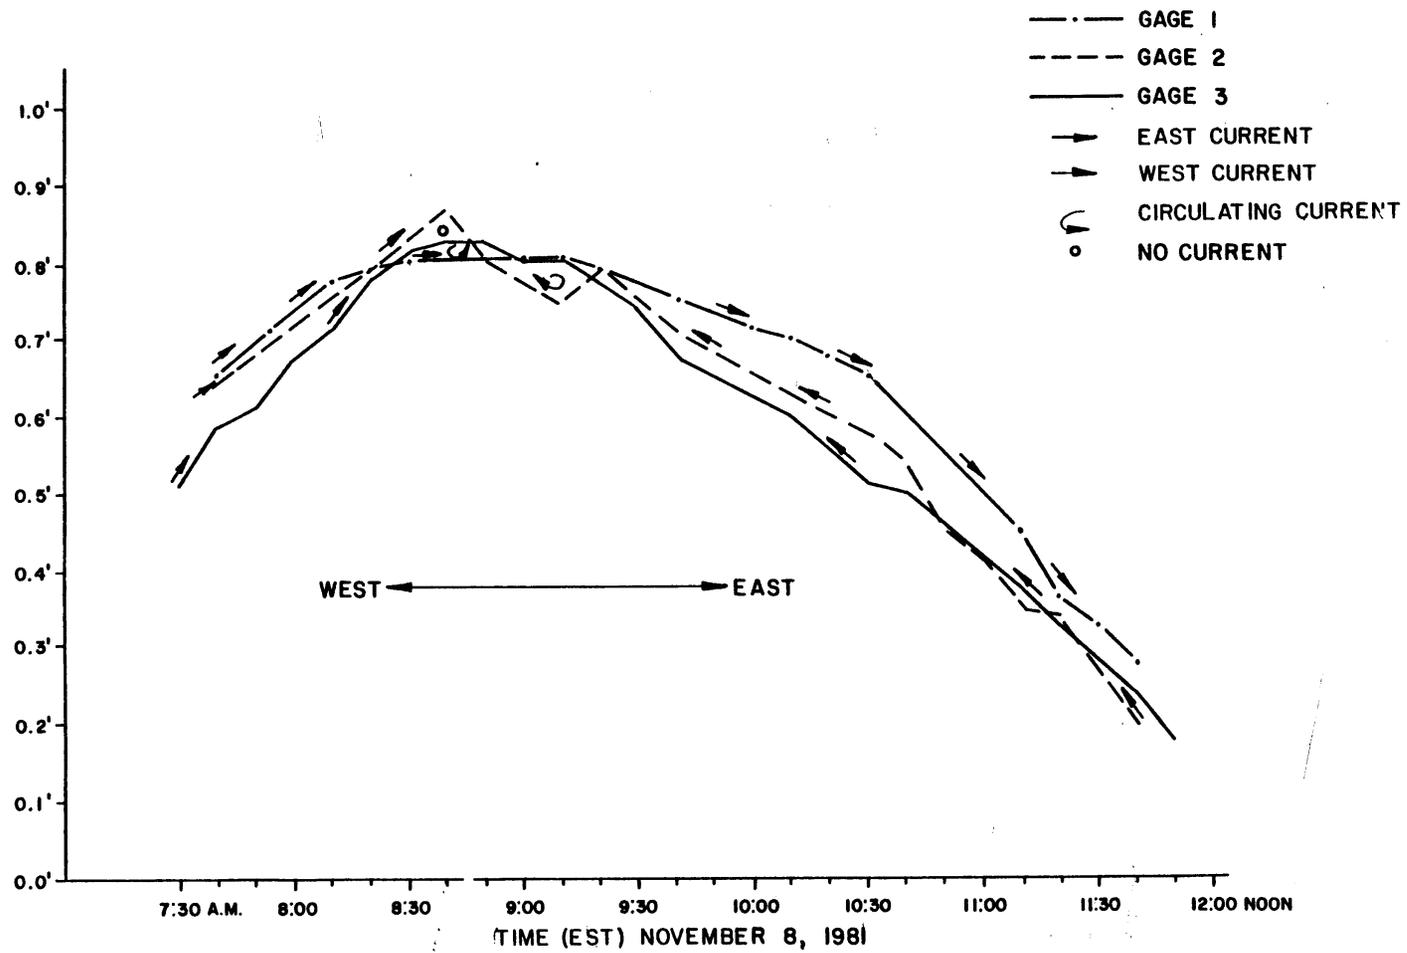
FIGURE 9  
TIDAL PHASING  
EBB CONDITION

Referring to Figure 9, a tidal head differential exists on the ebb tide between Gages 1 and 2, which would cause the current to flow west to east during that portion of the cycle mentioned. This is supported by the observed current at Gage 1 but not at Gage 2. It is likely that circulation patterns in the inner harbor influenced the observed current at Gage 2 as was also suggested by the observer at that station. The slight phase differential observed between Gages 2 and 3 is probably not significant because of the limiting accuracies in recording the tide levels and in the procedure used to set Gage 3.

In summary, Figure 9 indicates a convergence of the gage readings at all three gages suggesting that a reversal in the current direction at Gage 1 occurred shortly after the reporting period. Other evidence including visual observations on other days and local reports indicate that this switch does occur and the controlling hydraulic gradient is east to west on the ebb tide condition. Figure 8 and other visual information supports the fact that the hydraulic gradient is west to east on the flood tide condition. Figure 10 reflects the results of the above determination, which coincide with the flood and ebb directions predicted by the NOS Tide Tables as discussed in reference to Table 1.

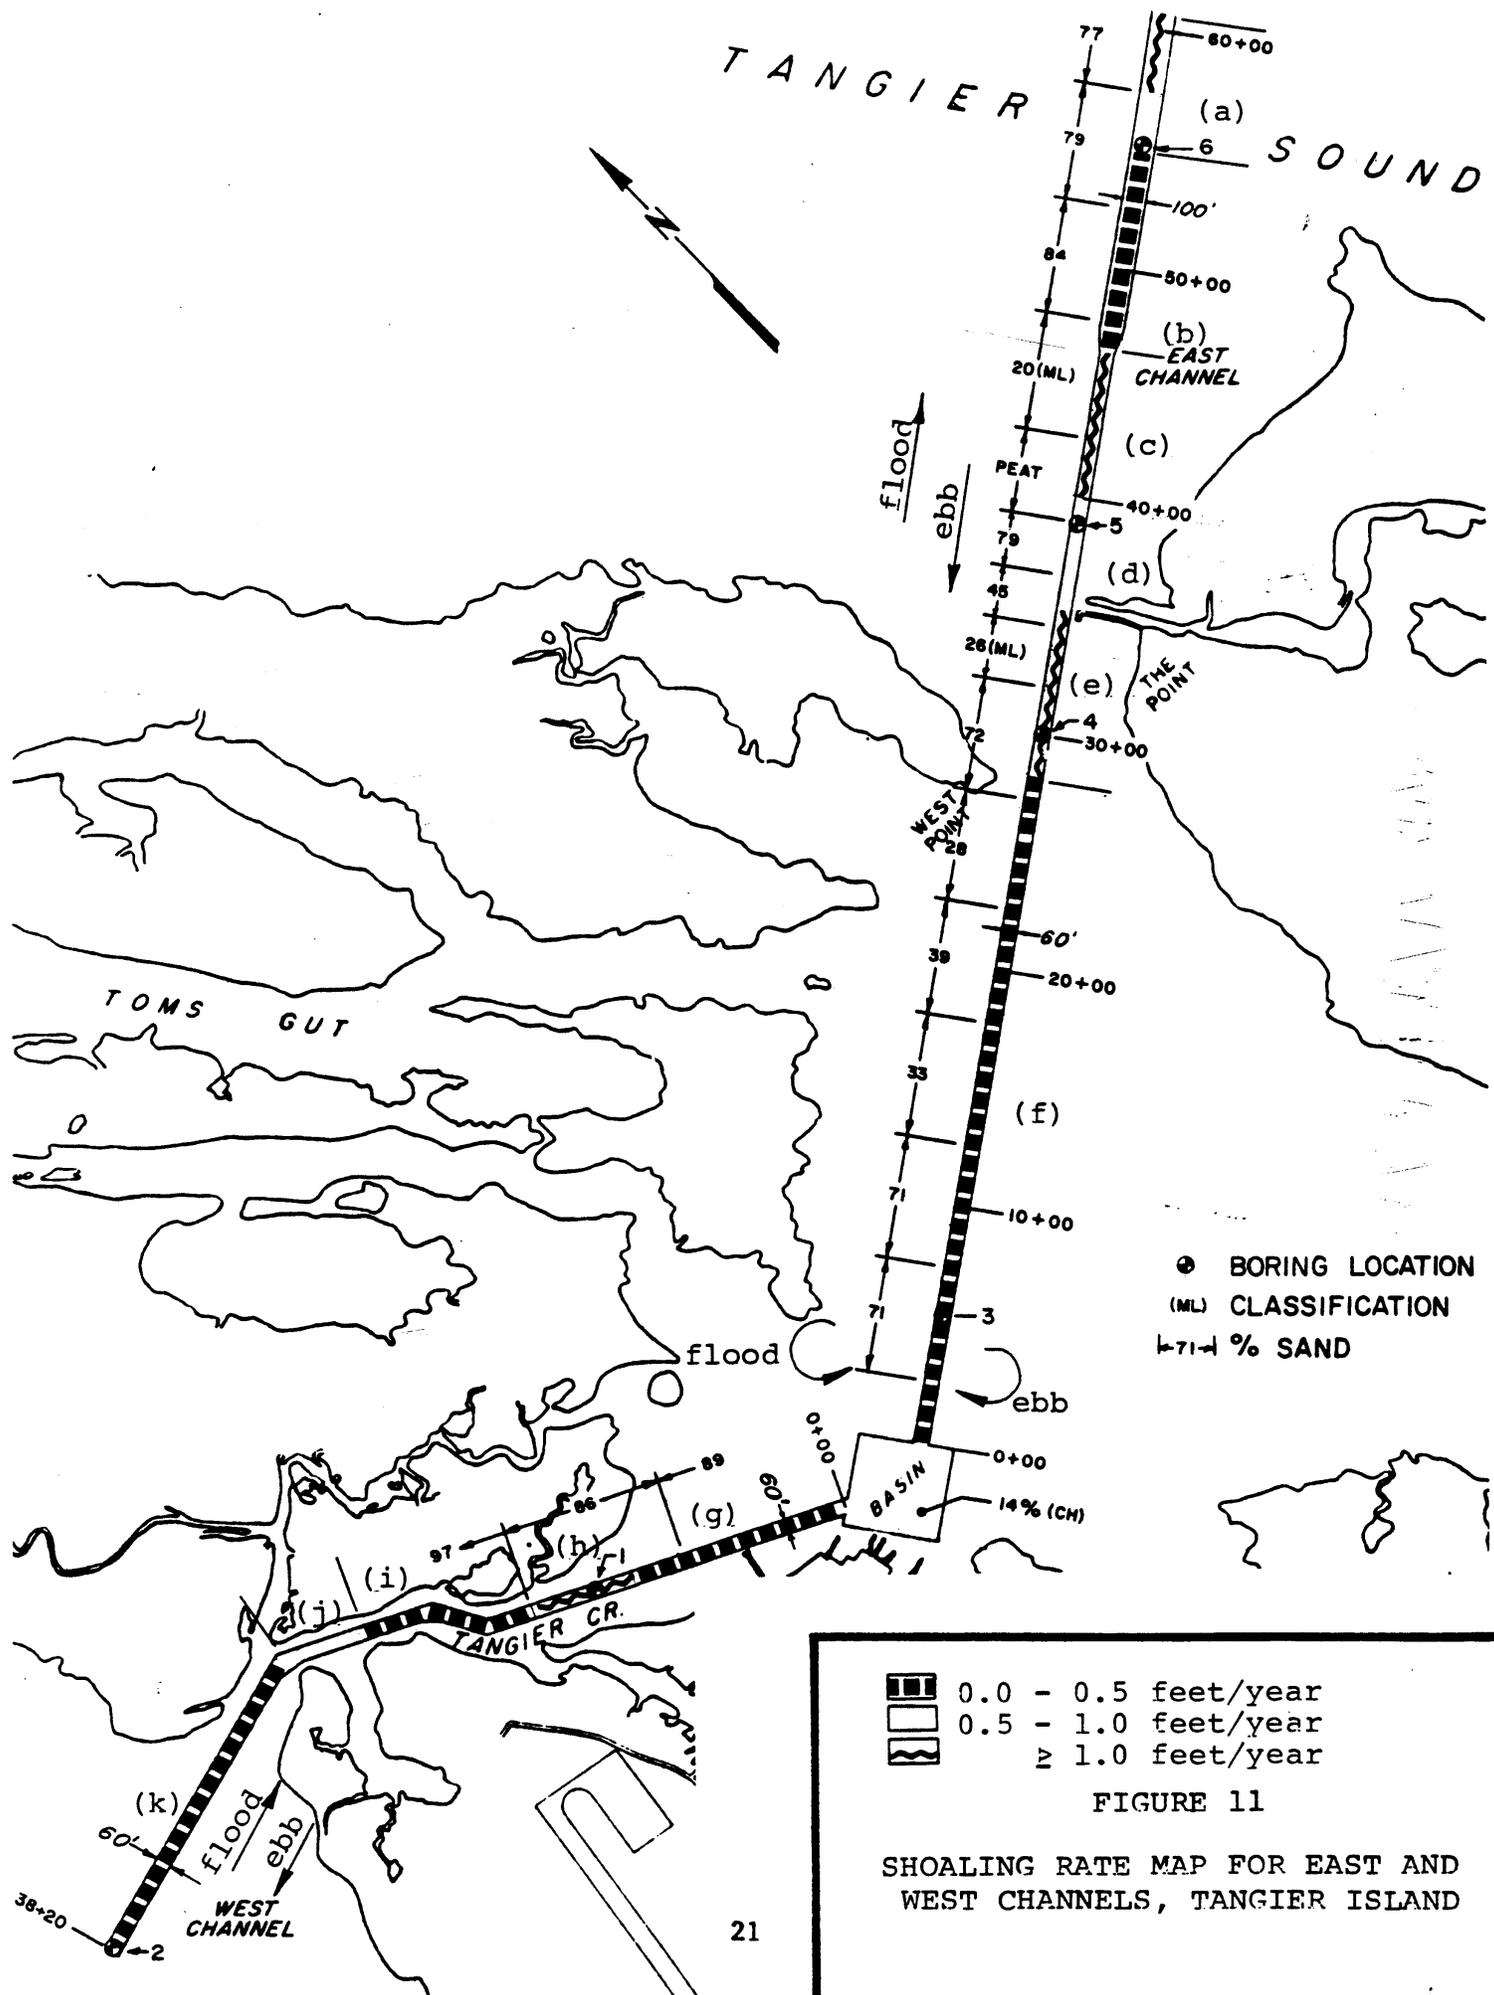
FIGURE 11

Figure 11 shows the shoaling rates along both the East and West Channels, as well as the sand concentrations in the channels. Areas of the channel represented by white and wavy line segments in Figure 11 have among the highest shoaling rates ranging from 0.6 - 1.3 feet/year. Table 4 lists the location, the shoaling rates in feet/year, and our interpretation of the transport mechanisms creating heavy shoaling. As Table 4 suggests, the shoaling in East Channel is caused by longshore transport from wind-waves along the east shore of Tangier. In contrast, the heavy shoaling in west channel results from flood and ebb deltas, a tidal phenomenon.

The following paragraphs elaborate on specific areas of each channel including those given in Table 4. The discussion is broken down by channel segments lettered consecutively (a to k) starting at station 61 + 00 in East Channel and ending at Station 38 + 20 in West Channel as shown in Figure 11.

The segments between 54+00 - 61+00 (segment a of Figure 11) have high shoaling rates ( $>0.6$  feet/year) and a high percentage of fine sands (78%). The source of this sand is the eastern shore of Klinefelters Island. Southeast winds, which are common during the summer months, can set up longshore transport to the north carrying sediments across Tangier Sound to this segment of East Channel. This transport direction is evidenced by the existing shoreline which forms a nob at the north end of Klinefelters Island. This local shoreline feature may be the beginning of an accreting spit much like the one located at the south end of Tangier Island. The shoaling pattern established by the southeast winds is represented by black hatching in Figure 13.

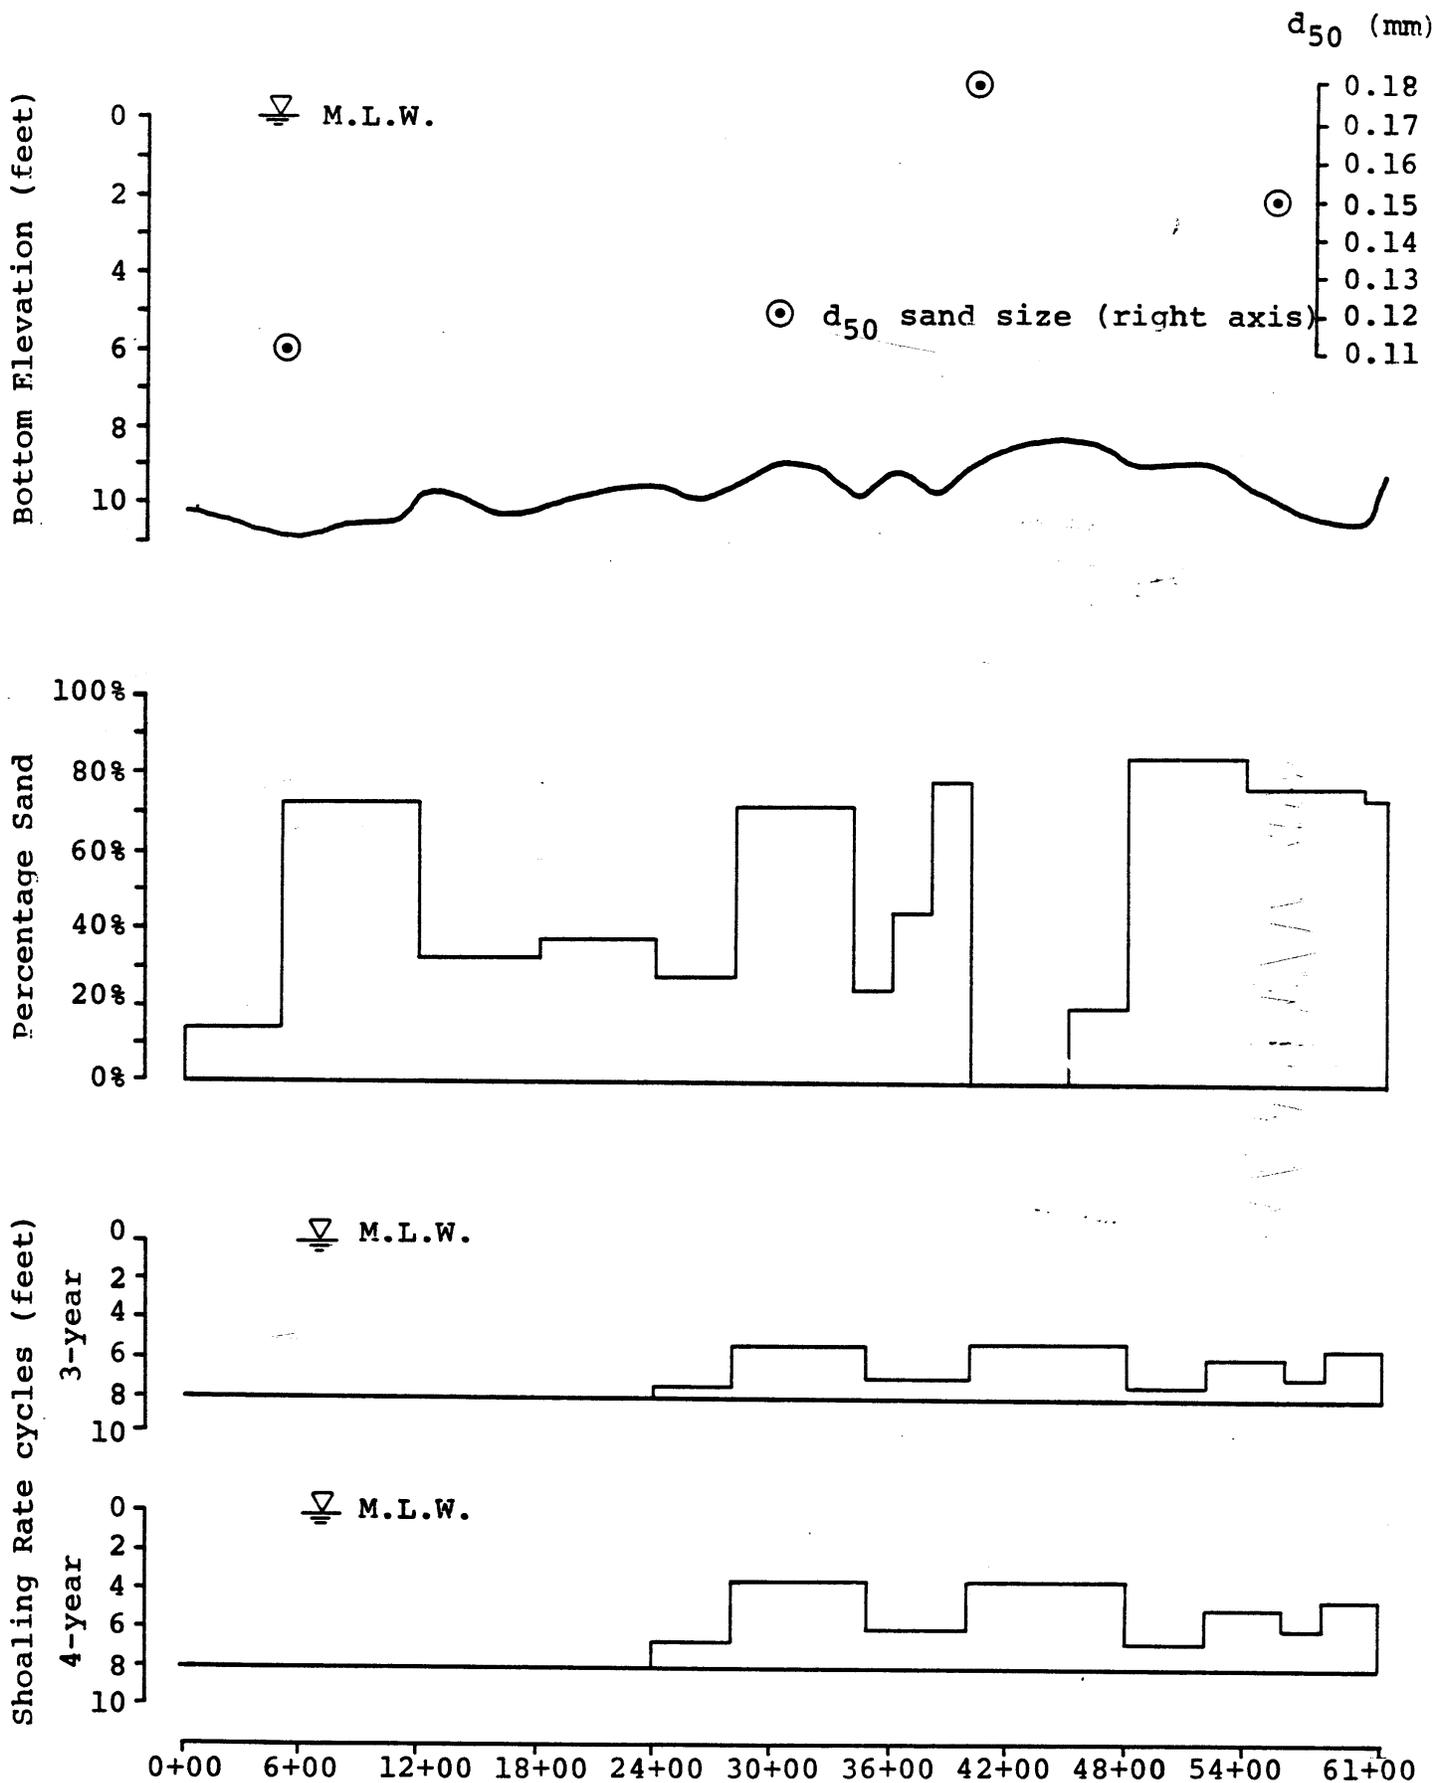
FIGURE 12

Figure 12 summarizes the sediment characteristics and shoaling behavior for Stations 0+00 - 61+00 (Channel a-f segments) in East Channel. As shown at the top of Figure 12, the  $d_{50}$  sand size ranges in value from 0.11 - 0.18 mm. Bottom elevations in East Channel vary between 9 and 11 feet below MLW. The middle bar graph of Figure 12 indicates that the percentages of sand ranges from 0% - 84%. Finally, the lower bar graphs show the shoaling rate for both 3 and 4 year cycles taken from Figure 3. Figure 12 points out that the areas of heavy shoaling are not necessarily composed of all sands as might be expected initially.

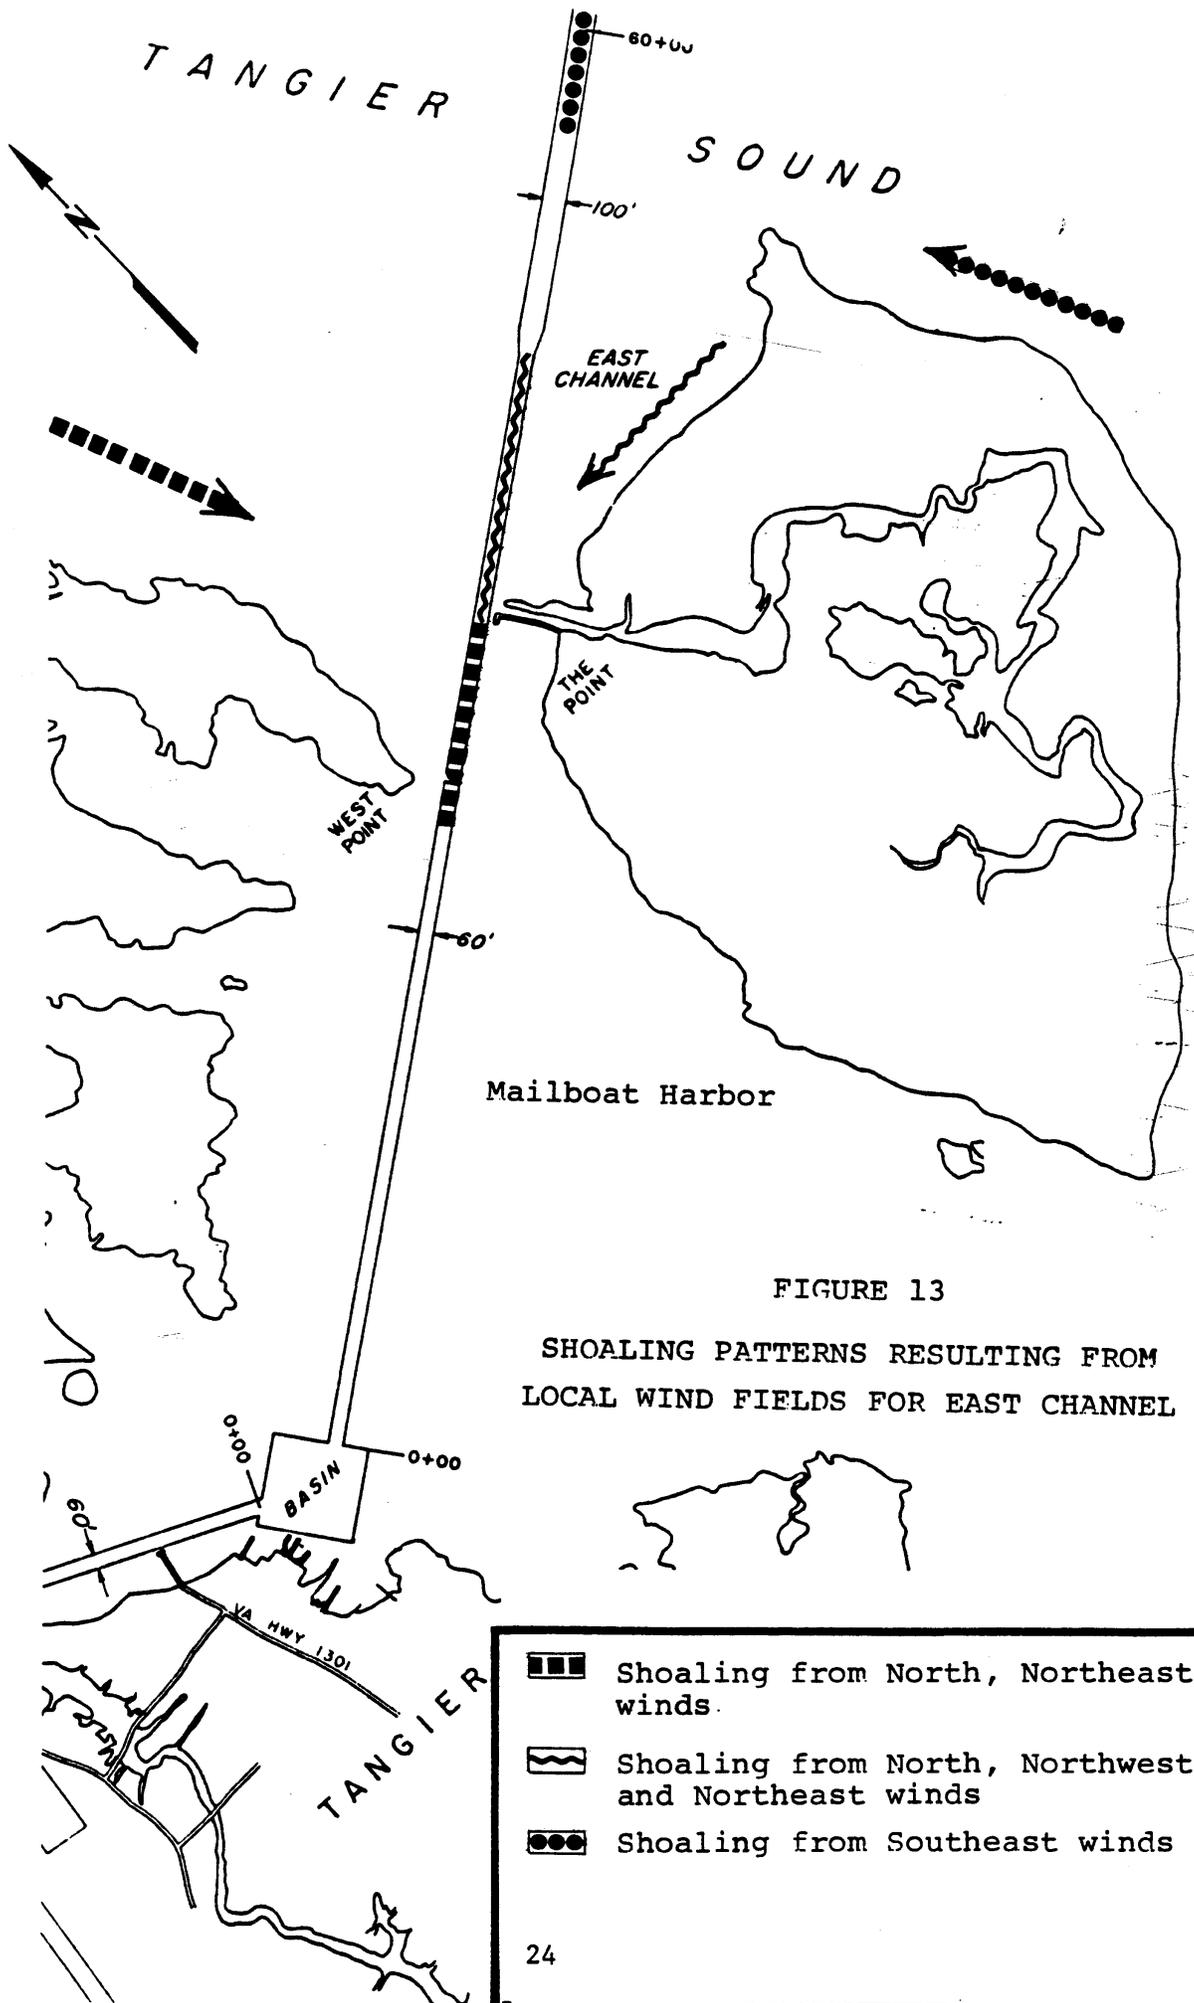
FIGURE 13  
SHOALING PATTERNS RESULTING FROM  
LOCAL WIND FIELDS FOR EAST CHANNEL

The next segment of channel, stations 40+00 - 48+00 (segment c) is the most vulnerable area to shoaling (shoaling rates are 1.3 feet/year). Northeast winds cause a longshore transport along the northern shore of Klinefelters Island which is carried into the channel. Transport in this direction was shown by the accretion behind the timber groin on the north

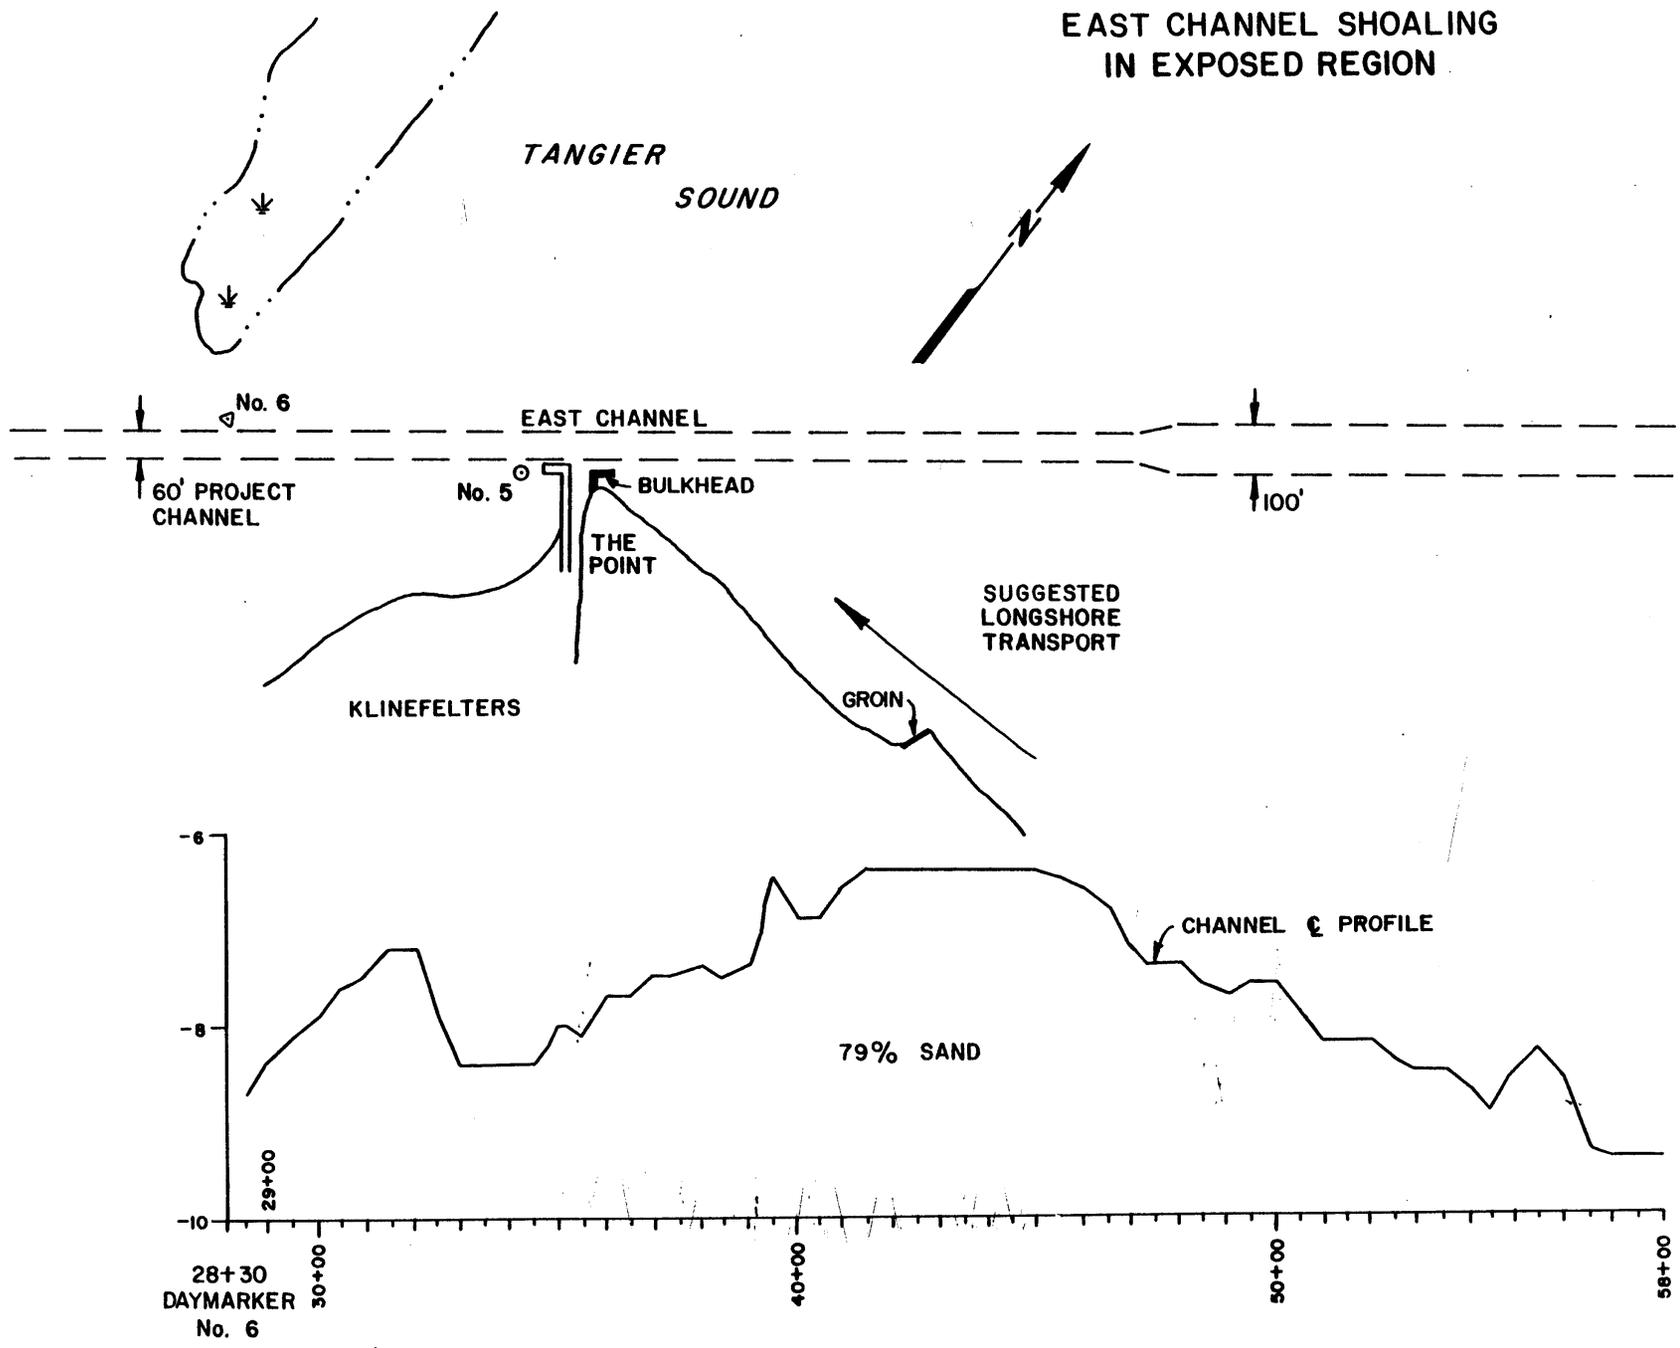
FIGURE 14

Stations 28+00 - 36+00 (segment e) represent another area of heavy shoaling. The rates were found to be 1.3 feet/per year. The major source of sediment in this section is due to north and northwest winds which cause longshore transport along the east shore of Tangier Island. This shoaling pattern is represented by the bold squares in Figure 13. High levels of sand (72%) are found in 28+00 - 32+00 with similar percentages of silts and clays (74%) between 32+00 - 36+00. The silts and clays are deposited just past the bar described previously (segment d) at Station 36+50. After passing the bar, the channel area increases thereby lowering the velocity

and allowing the fine material to settle out. The high levels of sand at the entrance into Mailboat Harbor are a result of the constriction of the flow area between West Point and Klinefelters Island. As in the case with the bar, located at 36+50, the velocities are increased, which in turn puts the silts and clays in suspension leaving the sand behind. The silts and clays are then deposited as the flow area widens into Mailboat Harbor. Silt and clay deposits in the channel just inside Mailboat Harbor are as high as 72%.
