REVIEW OF PROJECT CHANNEL  
WITH RECOMMENDED MODIFICATIONS,  
TANGIER ISLAND, VIRGINIA

J. Woodville Holton, Jr., P.E., L.S.  
WATERWAY SURVEYS & ENGINEERING, LTD.  
Virginia Beach, Virginia

CYRIL GALVIN, COASTAL ENGINEER  
Springfield, Virginia

Final Report

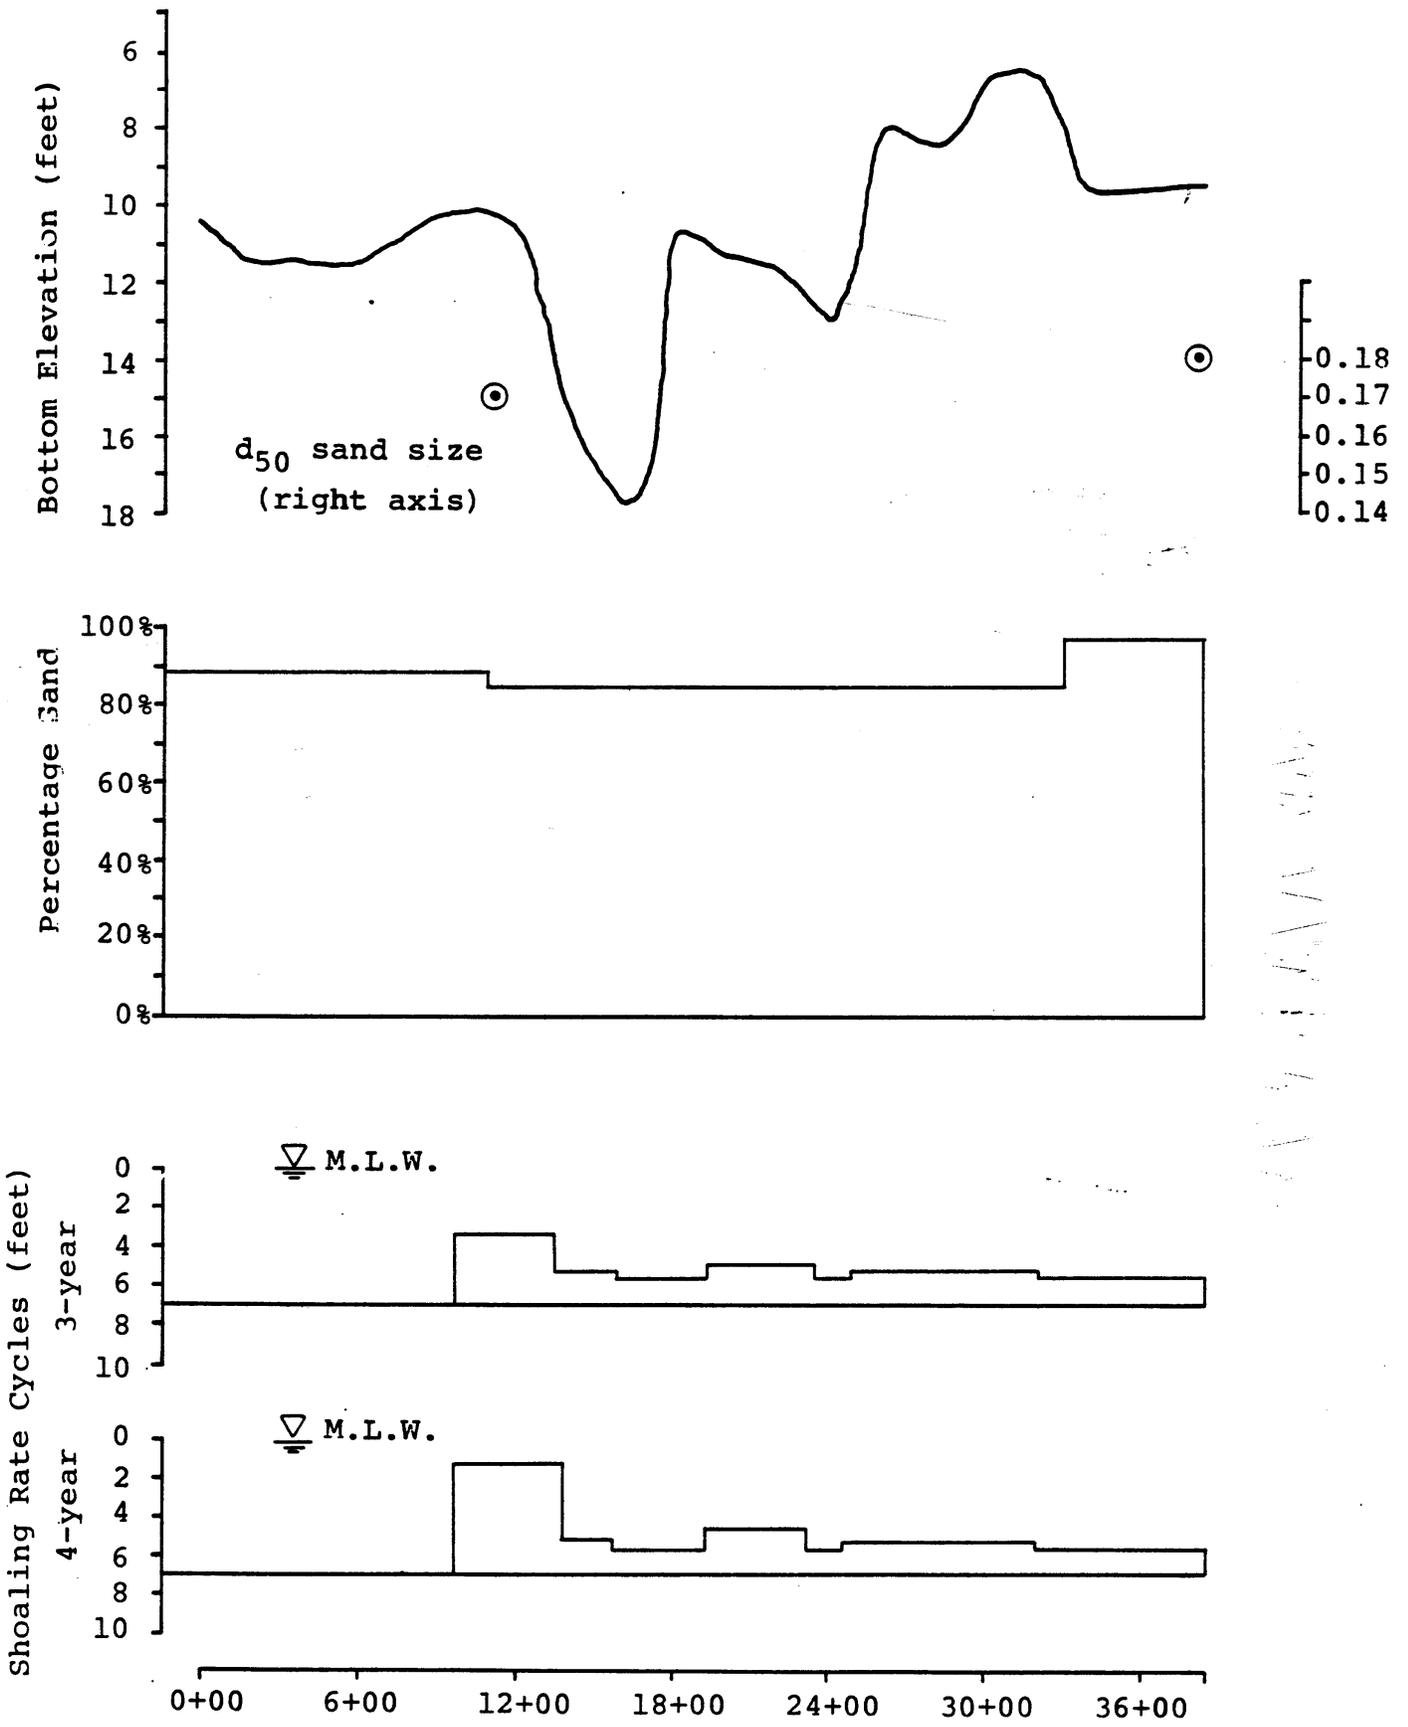
FIGURE 15  
 SEDIMENT CHARACTERISTICS AND SHOALING BEHAVIOR IN WEST CHANNEL

Figure 15 summarizes the sediment characteristics and shoaling behavior for West Channel in a form identical to Figure 12. The Stations in Figure 15 between 0+00 and 38+50 W are subdivided into segments g thru k on Figure 11.

Unlike East Channel, the West Channel is composed entirely of fine sands (>86%). West Channel also has a greater variation in bottom topography with elevations ranging between 6.5 to 18.0 feet below MLW. D<sub>50</sub> sand sizes for West Channel are between 0.15 and 0.18 mm, which is similar to the sizes found in East Channel. Our interpretations of the West Channel segments is given in the following paragraphs.

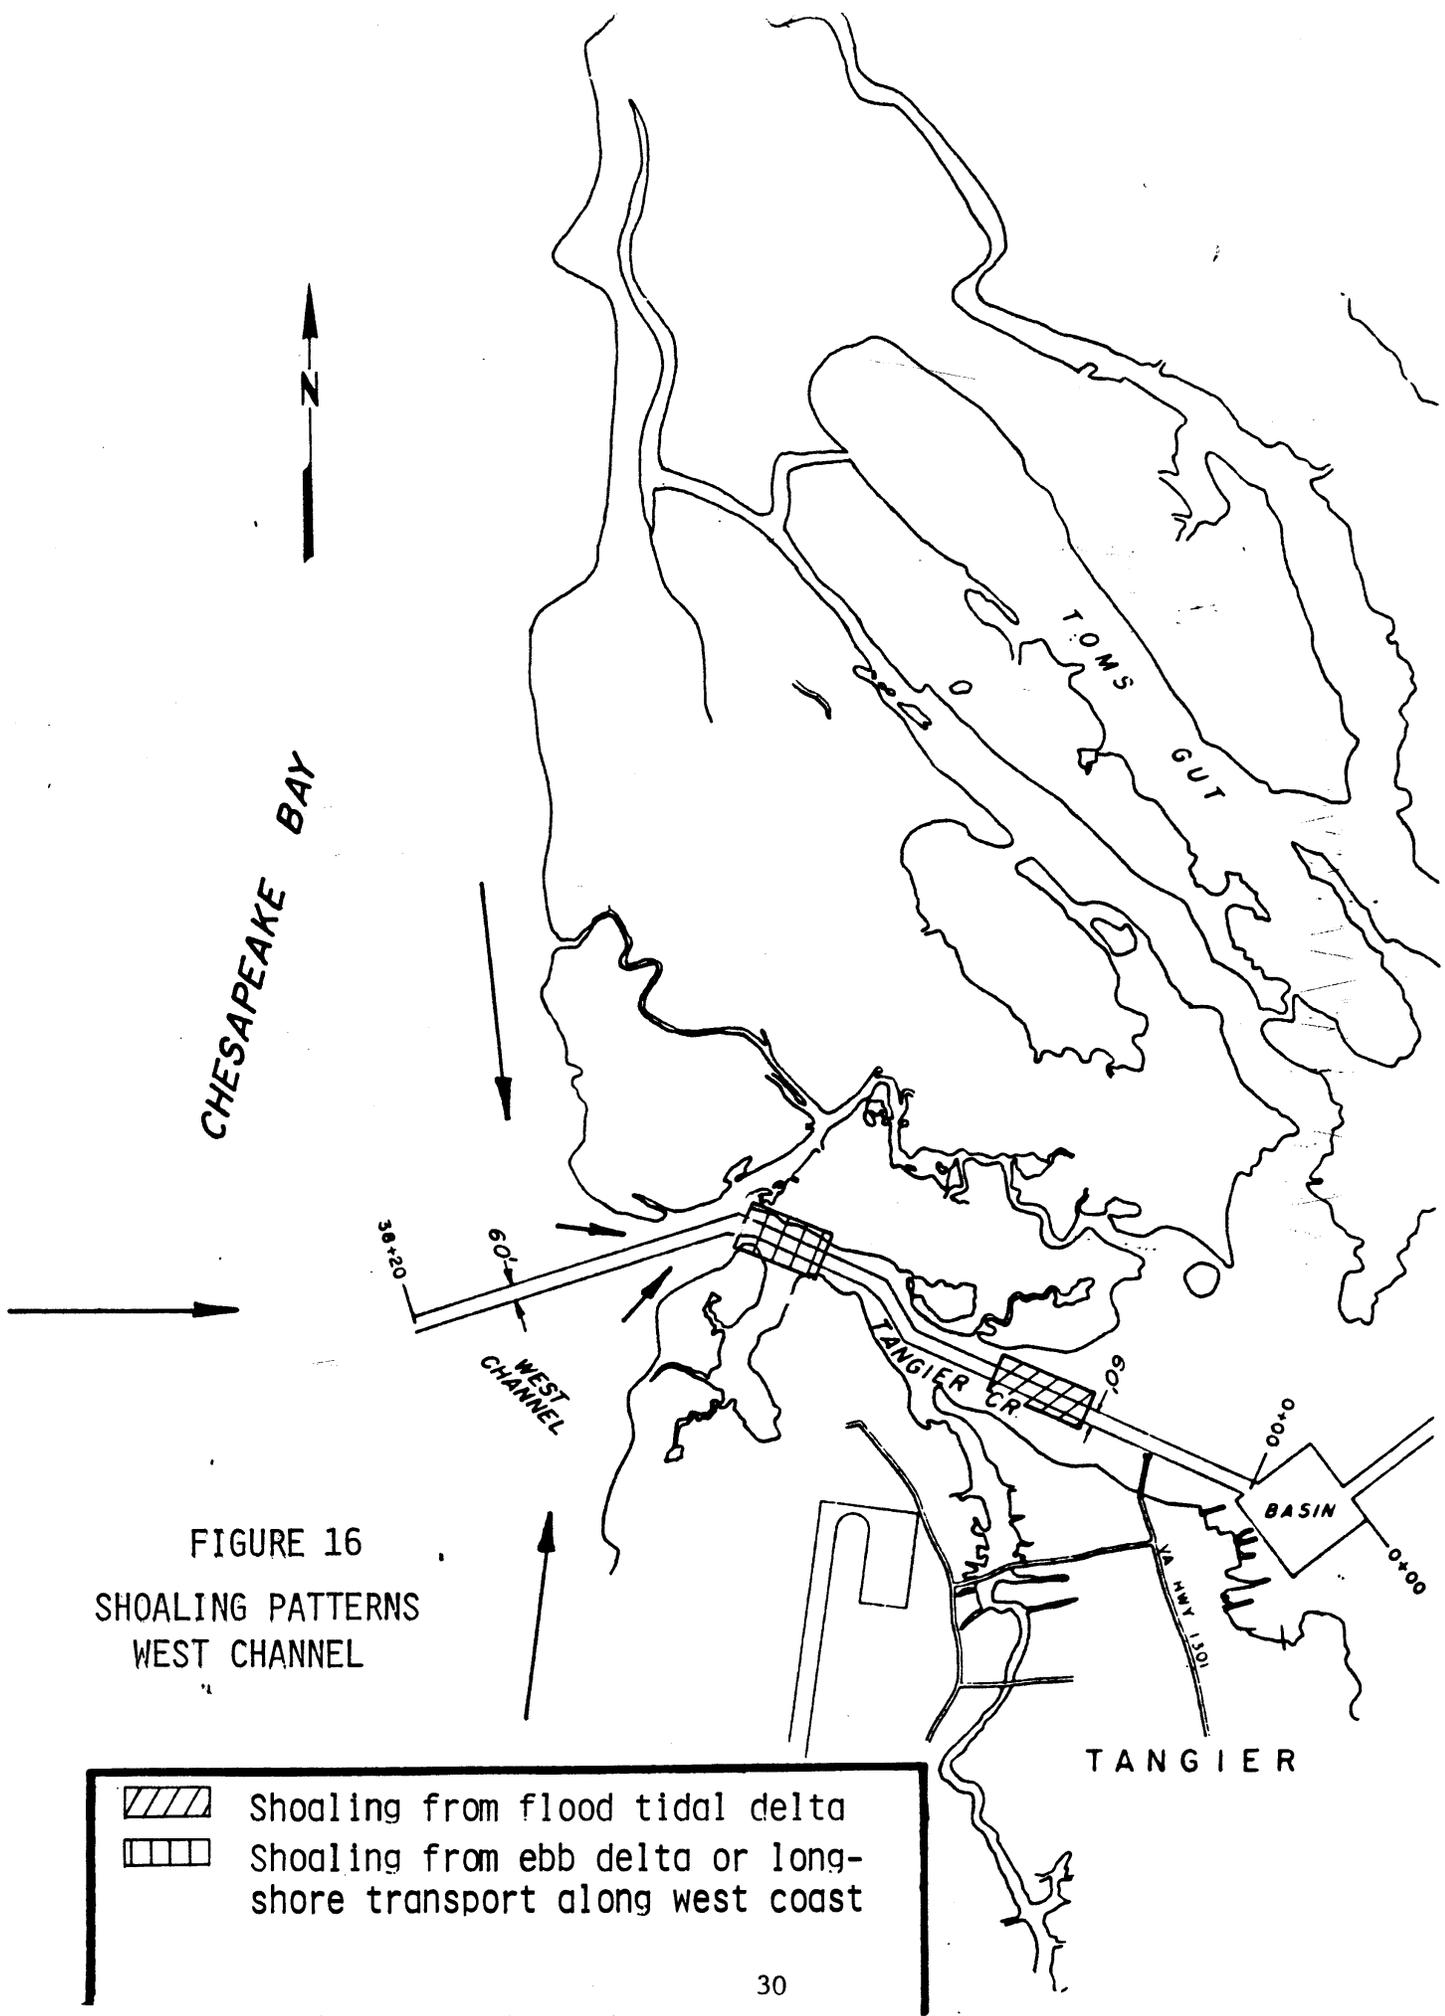
FIGURE 16  
SHOALING PATTERNS  
WEST CHANNEL

Stations 10+00 - 13+00 (segment h) have the highest shoaling rates of any channel segment in West Channel. The rates are 1.3 feet/year. The shoal in this area is most likely a flood tidal delta. Tidal flood currents flow southeast into Mailboat Harbor as shown in Figure 11. In this segment of channel, the flow area begins to widen thereby decreasing the velocities and causing the sands to be deposited. The most likely source of this sand comes from sediments scoured from the adjacent channel segment (Stations 13+00 to 20+00) discussed in the following paragraph. This shoaling pattern is shown in Figure 16.

Stations 20+00 - 24+00 (segment j) have moderately high shoaling rates of 0.6 feet/year. The shoaling in this area is possibly due to an ebb tidal delta. The shoaling is less than in channel segment (h) (stations 10+00 - 13+00) because changes in flow area are not as great in this section. Shoaling could also be caused by sediment transport moving north or south along the west coast of Tangier Island and directed into the West Channel entrance. Note that this section of channel is also susceptible to winds from the west which could cause sediments to funnel into this area as shown by the arrows in Figure 16.
