A & G COAL CORPORATION

ISON ROCK RIDGE SURFACE MINE

**AQUATIC RESOURCES MITIGATION PLAN
PRE-CONSTRUCTION NOTIFICATION
NATIONWIDE PERMIT 21**

MARCH, 2007
DRA PROJECT No. 07-316B1

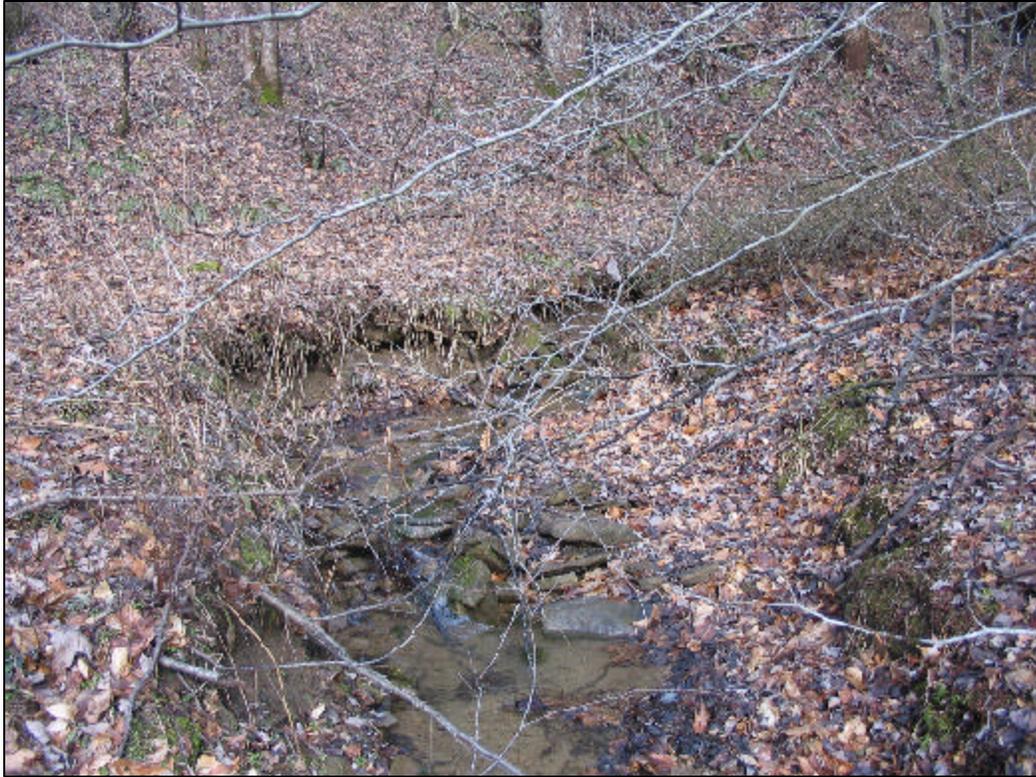
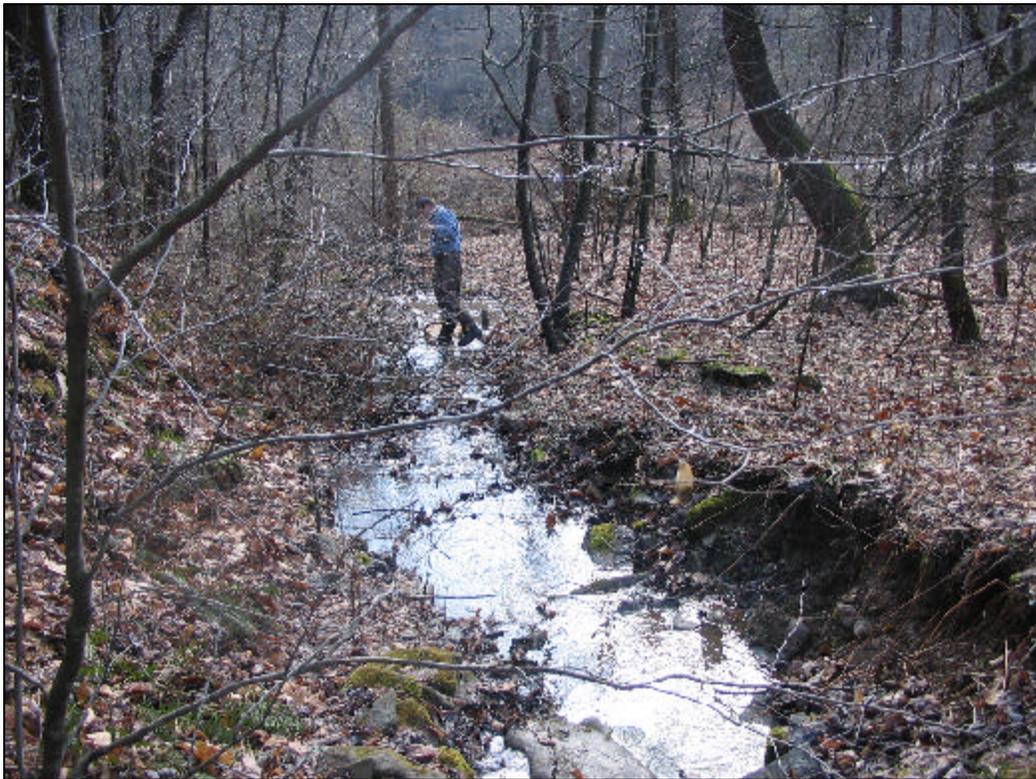
PROJECT NO. 08-3188

ABS-2 is located in an unnamed tributary to Looney Creek (UTLC-4) and originates from the toe of a pre-SMCRA fill. The stream at ABS-2 has been previously disturbed due to pre-SMCRA mining which has caused severe bank erosion.

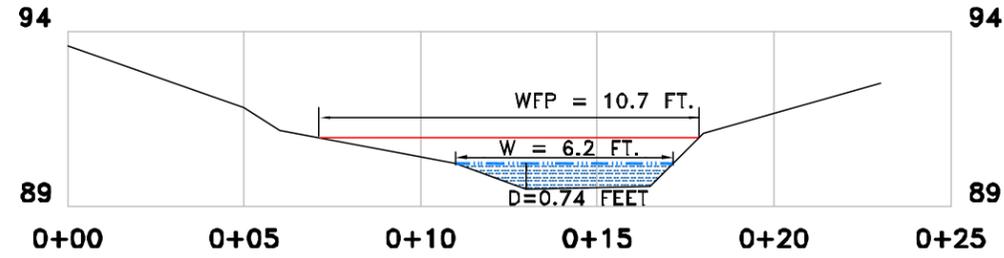
RIFFLE CROSS SECTION

Channel SINUOSITY (K)	1.03
Sinuosity is an index of channel pattern, determined from a ratio of stream length divided by valley length (SL/VL); or estimated from a ratio of valley slope divided by channel slope (VS/CS).

<i>Stream Type</i>	B4
--------------------	-----------

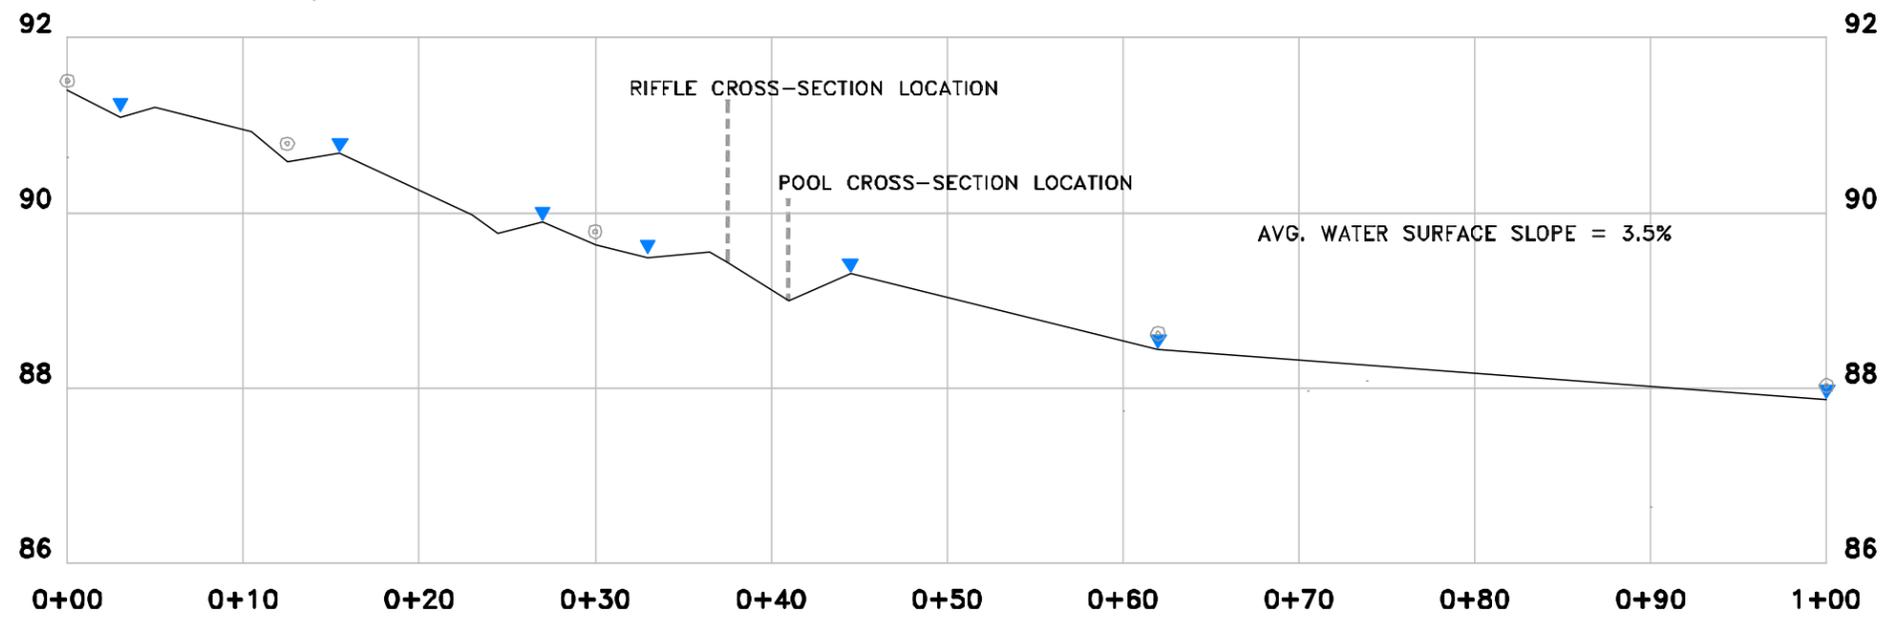
UTPC-1 LONGITUDINAL PROFILE

VERTICAL SCALE: 1"=2'
HORIZONTAL SCALE: 1"=10'
