December 3, 2015

Nansemond River Beachfront (NRB) (AOC-1) Remedial Investigation (RI) Work Plan

Former Nansemond Ordnance Depot
Formerly Used Defense Site

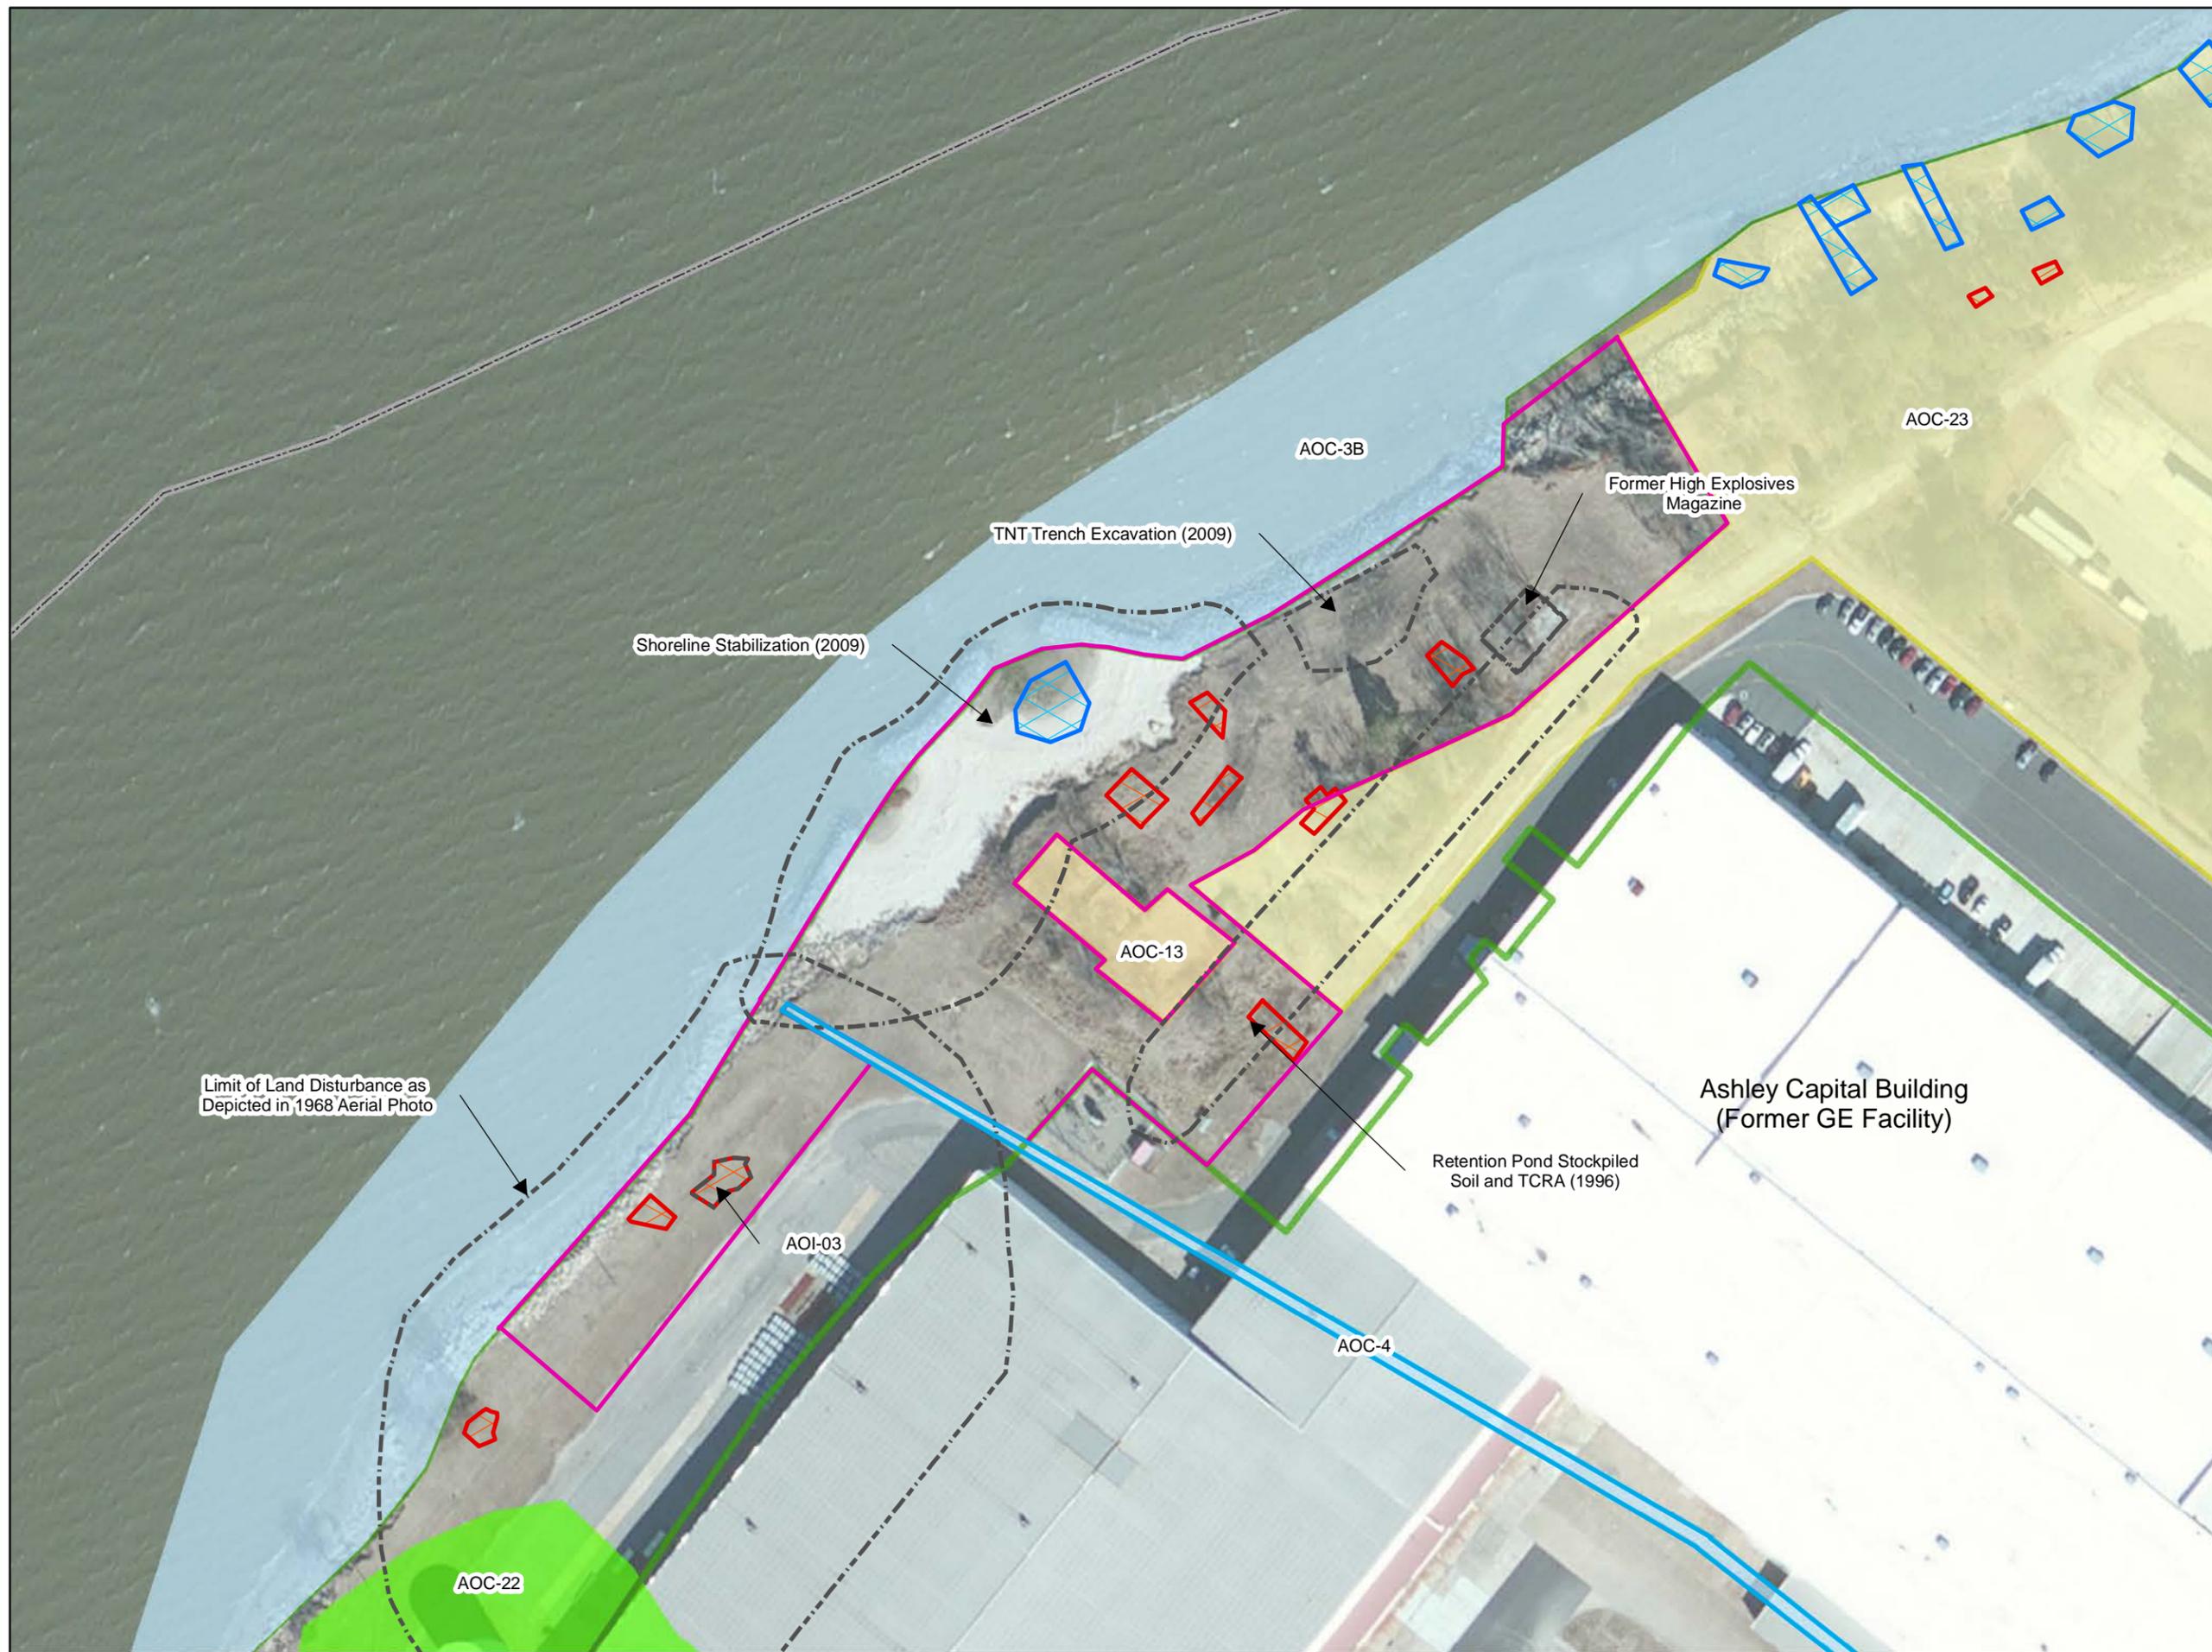
Figure 2-2
Site Features
Nansemond River Beachfront
Former Nansemond
Ordnance Depot (FNOD)
Suffolk, Virginia

- Bulk TNT and miscellaneous MEC/MD removed along the northern boundary of the NRB.
- Several munitions removals and investigations conducted at NRB from 2000 through 2014.
- Ten Areas of Interest (AOIs) identified within NRB using geophysics during investigation of the Shoreline MEC Munitions Response Site (MRS).
- Intrusive investigation of the AOIs completed in March 2014.
- With the exception of AOI-03 and AOI-47, subsurface findings were limited to rusted metal of a non-munitions origin.

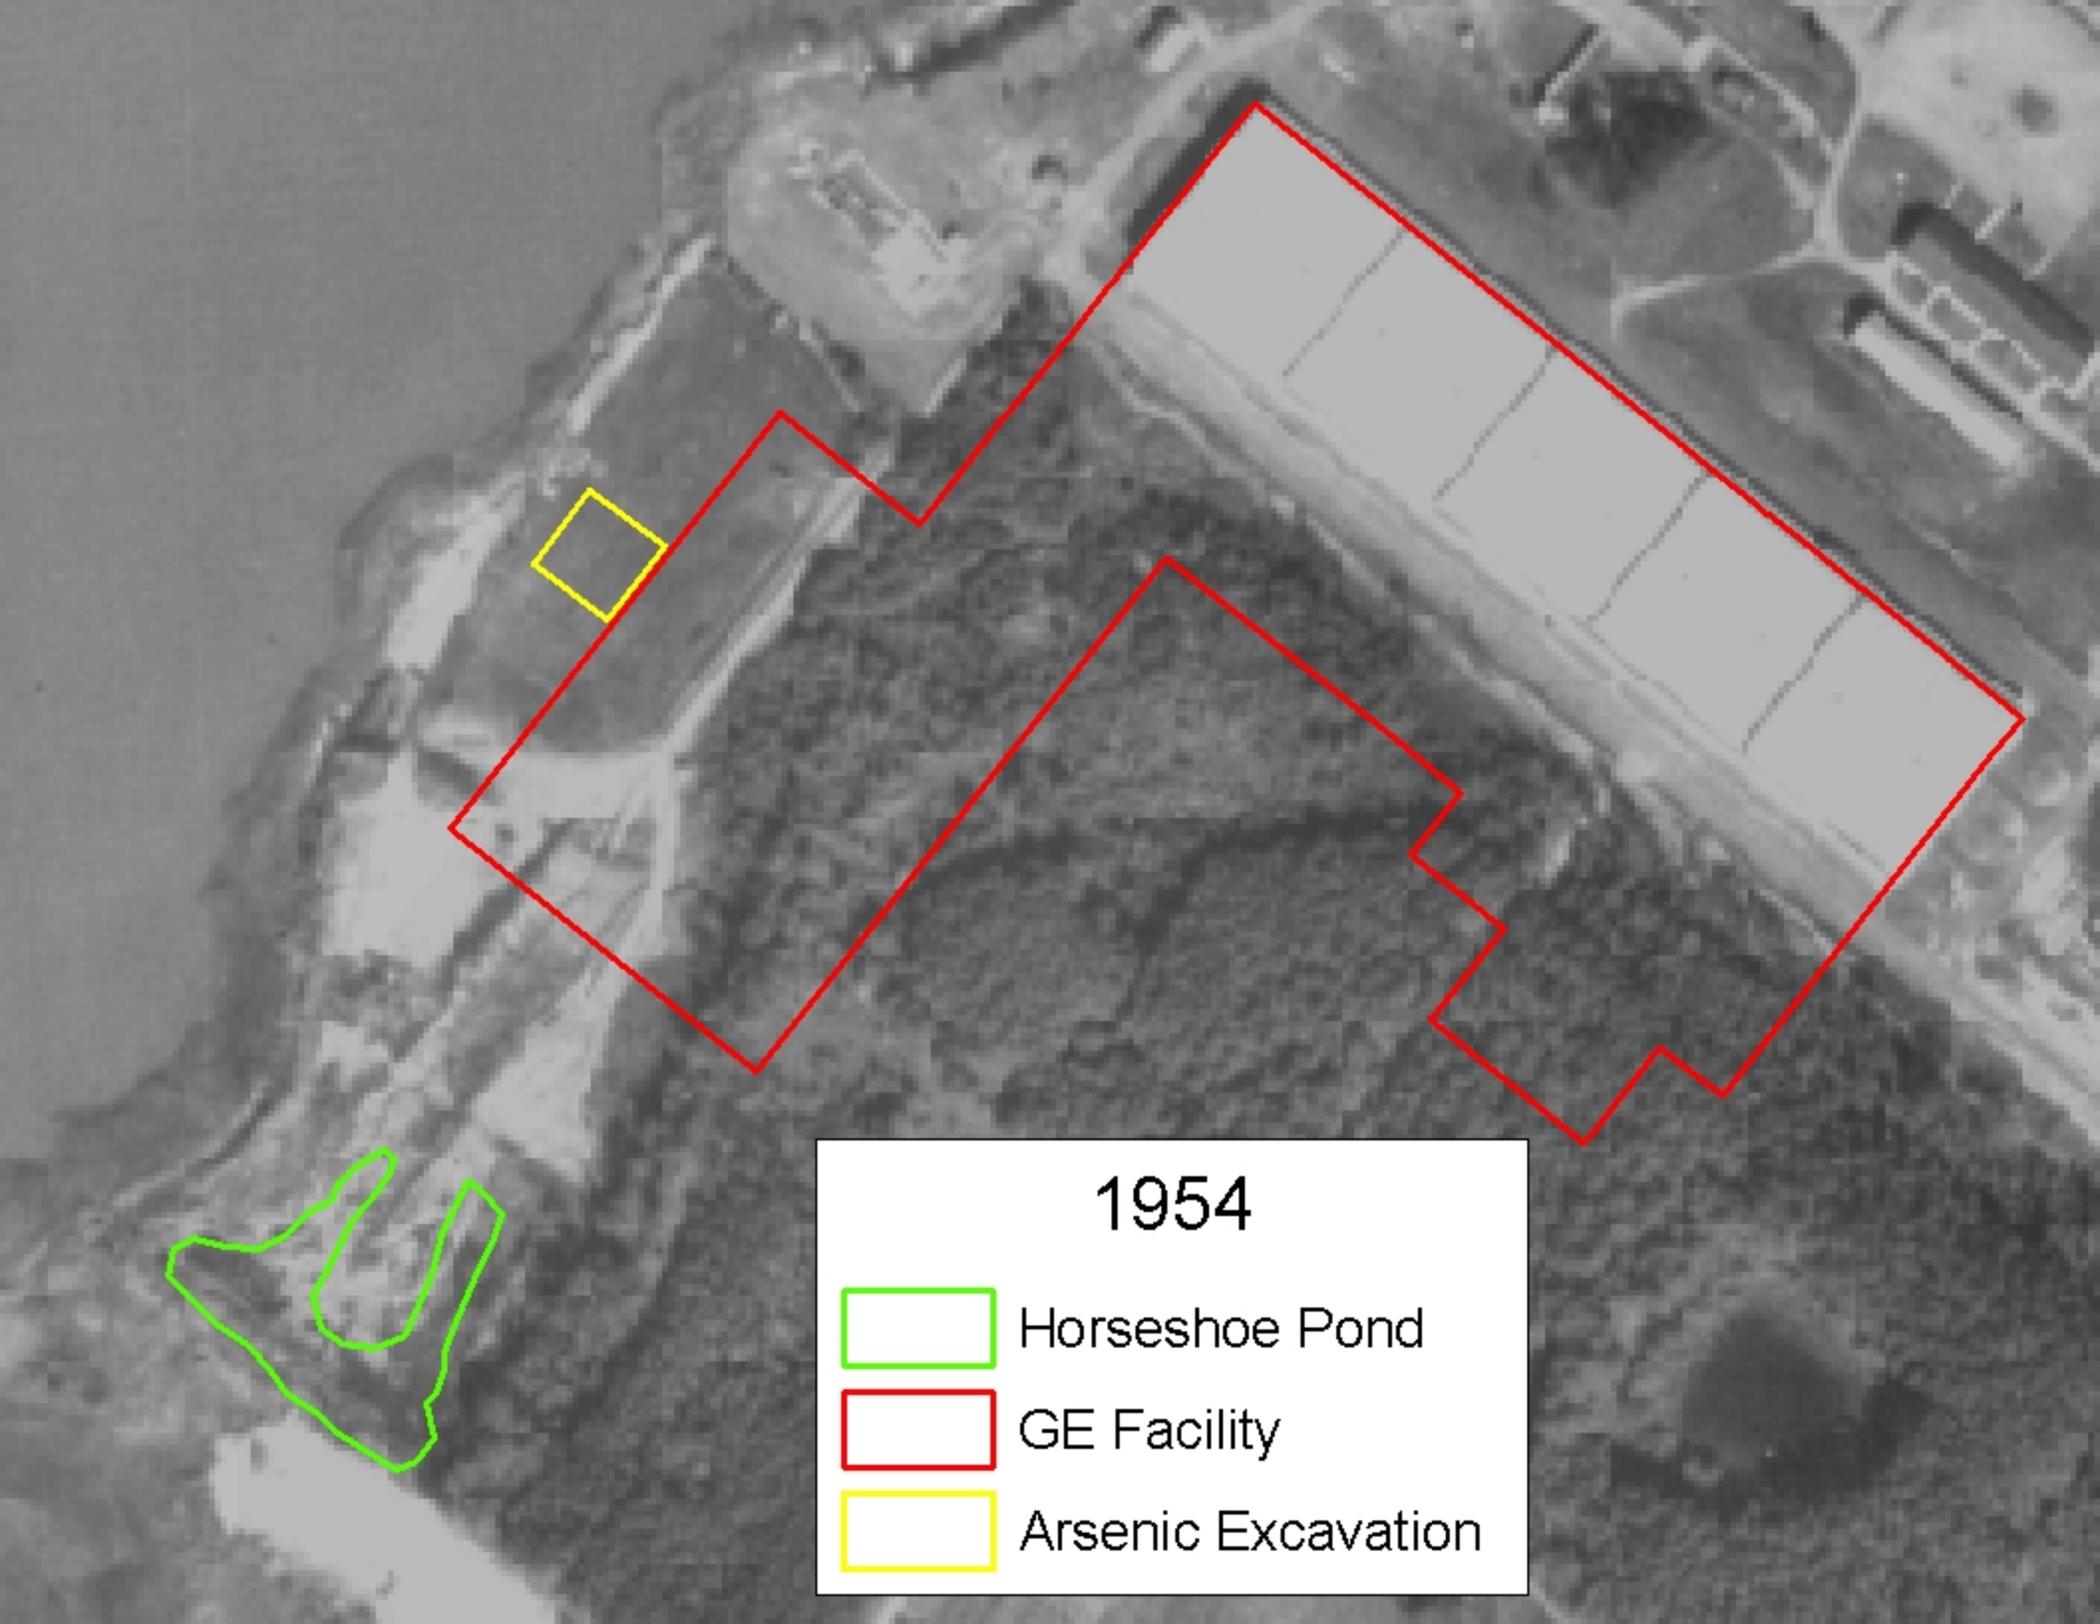
- At AOI-03, a 6-in layer of consolidated black material (non-munitions related) observed at approximately 3 ft bgs.
- AOI-3 within area of land disturbance depicted in 1968 photo
- AOI-3 also in are potentially disturbed by expansion of Ashley Capital Building (formerly GE Facility)
- USACE currently holding in-house discussions regarding potential sources of black material and resulting sampling approach

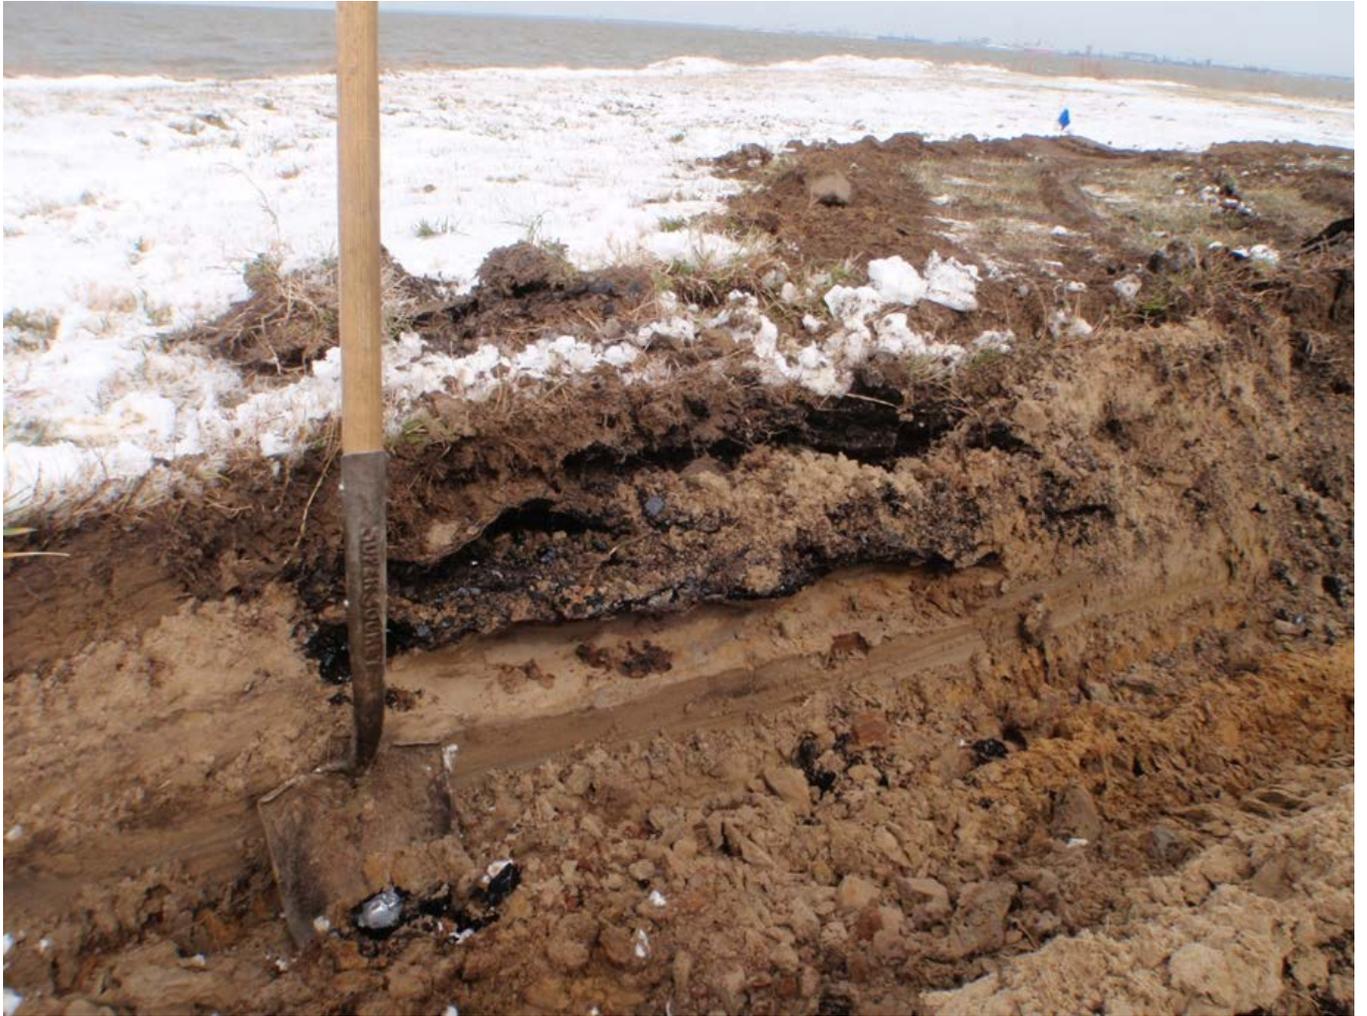
AOI-03 Trench 2: Possible layer of non-MD black consolidated layer.

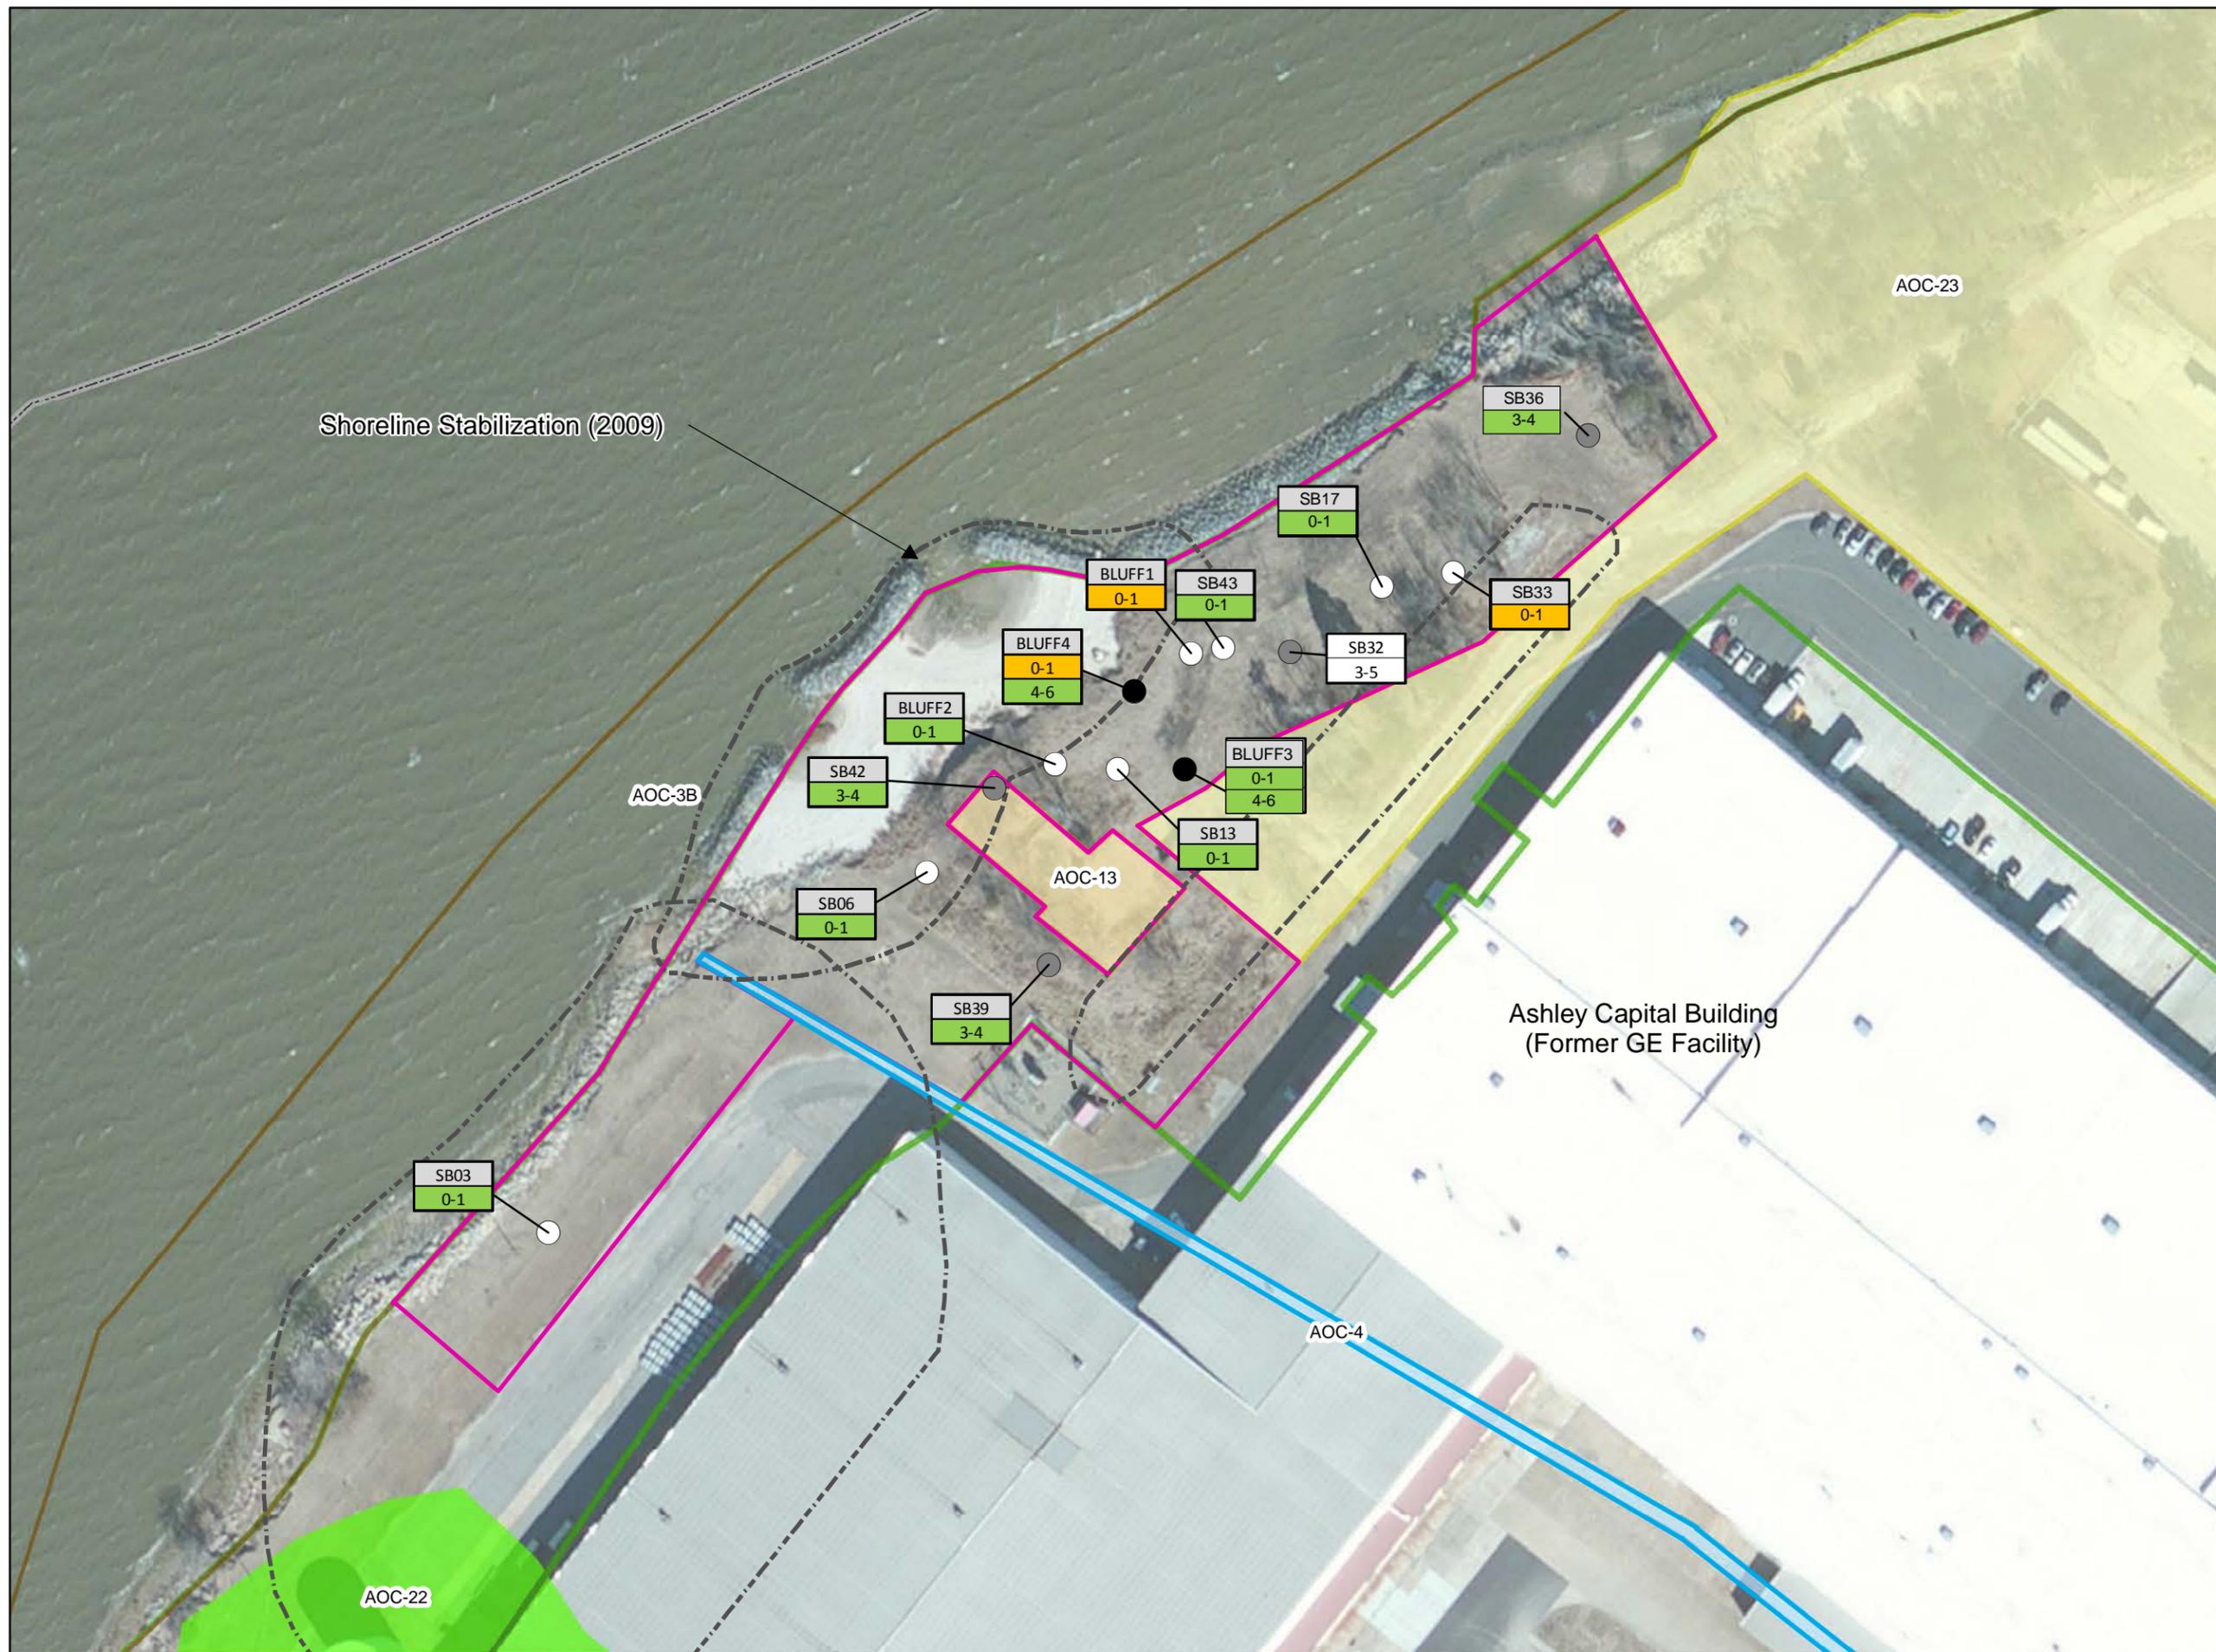
Figure 3-2
Soil SVOC Screening Criteria Exceedances
Nansemond River Beachfront
Former Nansemond Ordnance Depot (FNOD)
Suffolk, Virginia

SAMPLE ID	DEPTH (FEET)
	- No analyte exceed screening criteria and background concentrations (if available).
	- One or more analytes exceed screening criteria and background concentrations (if available).

Note:
Soil samples within shoreline stabilization area were collected prior to shoreline stabilization

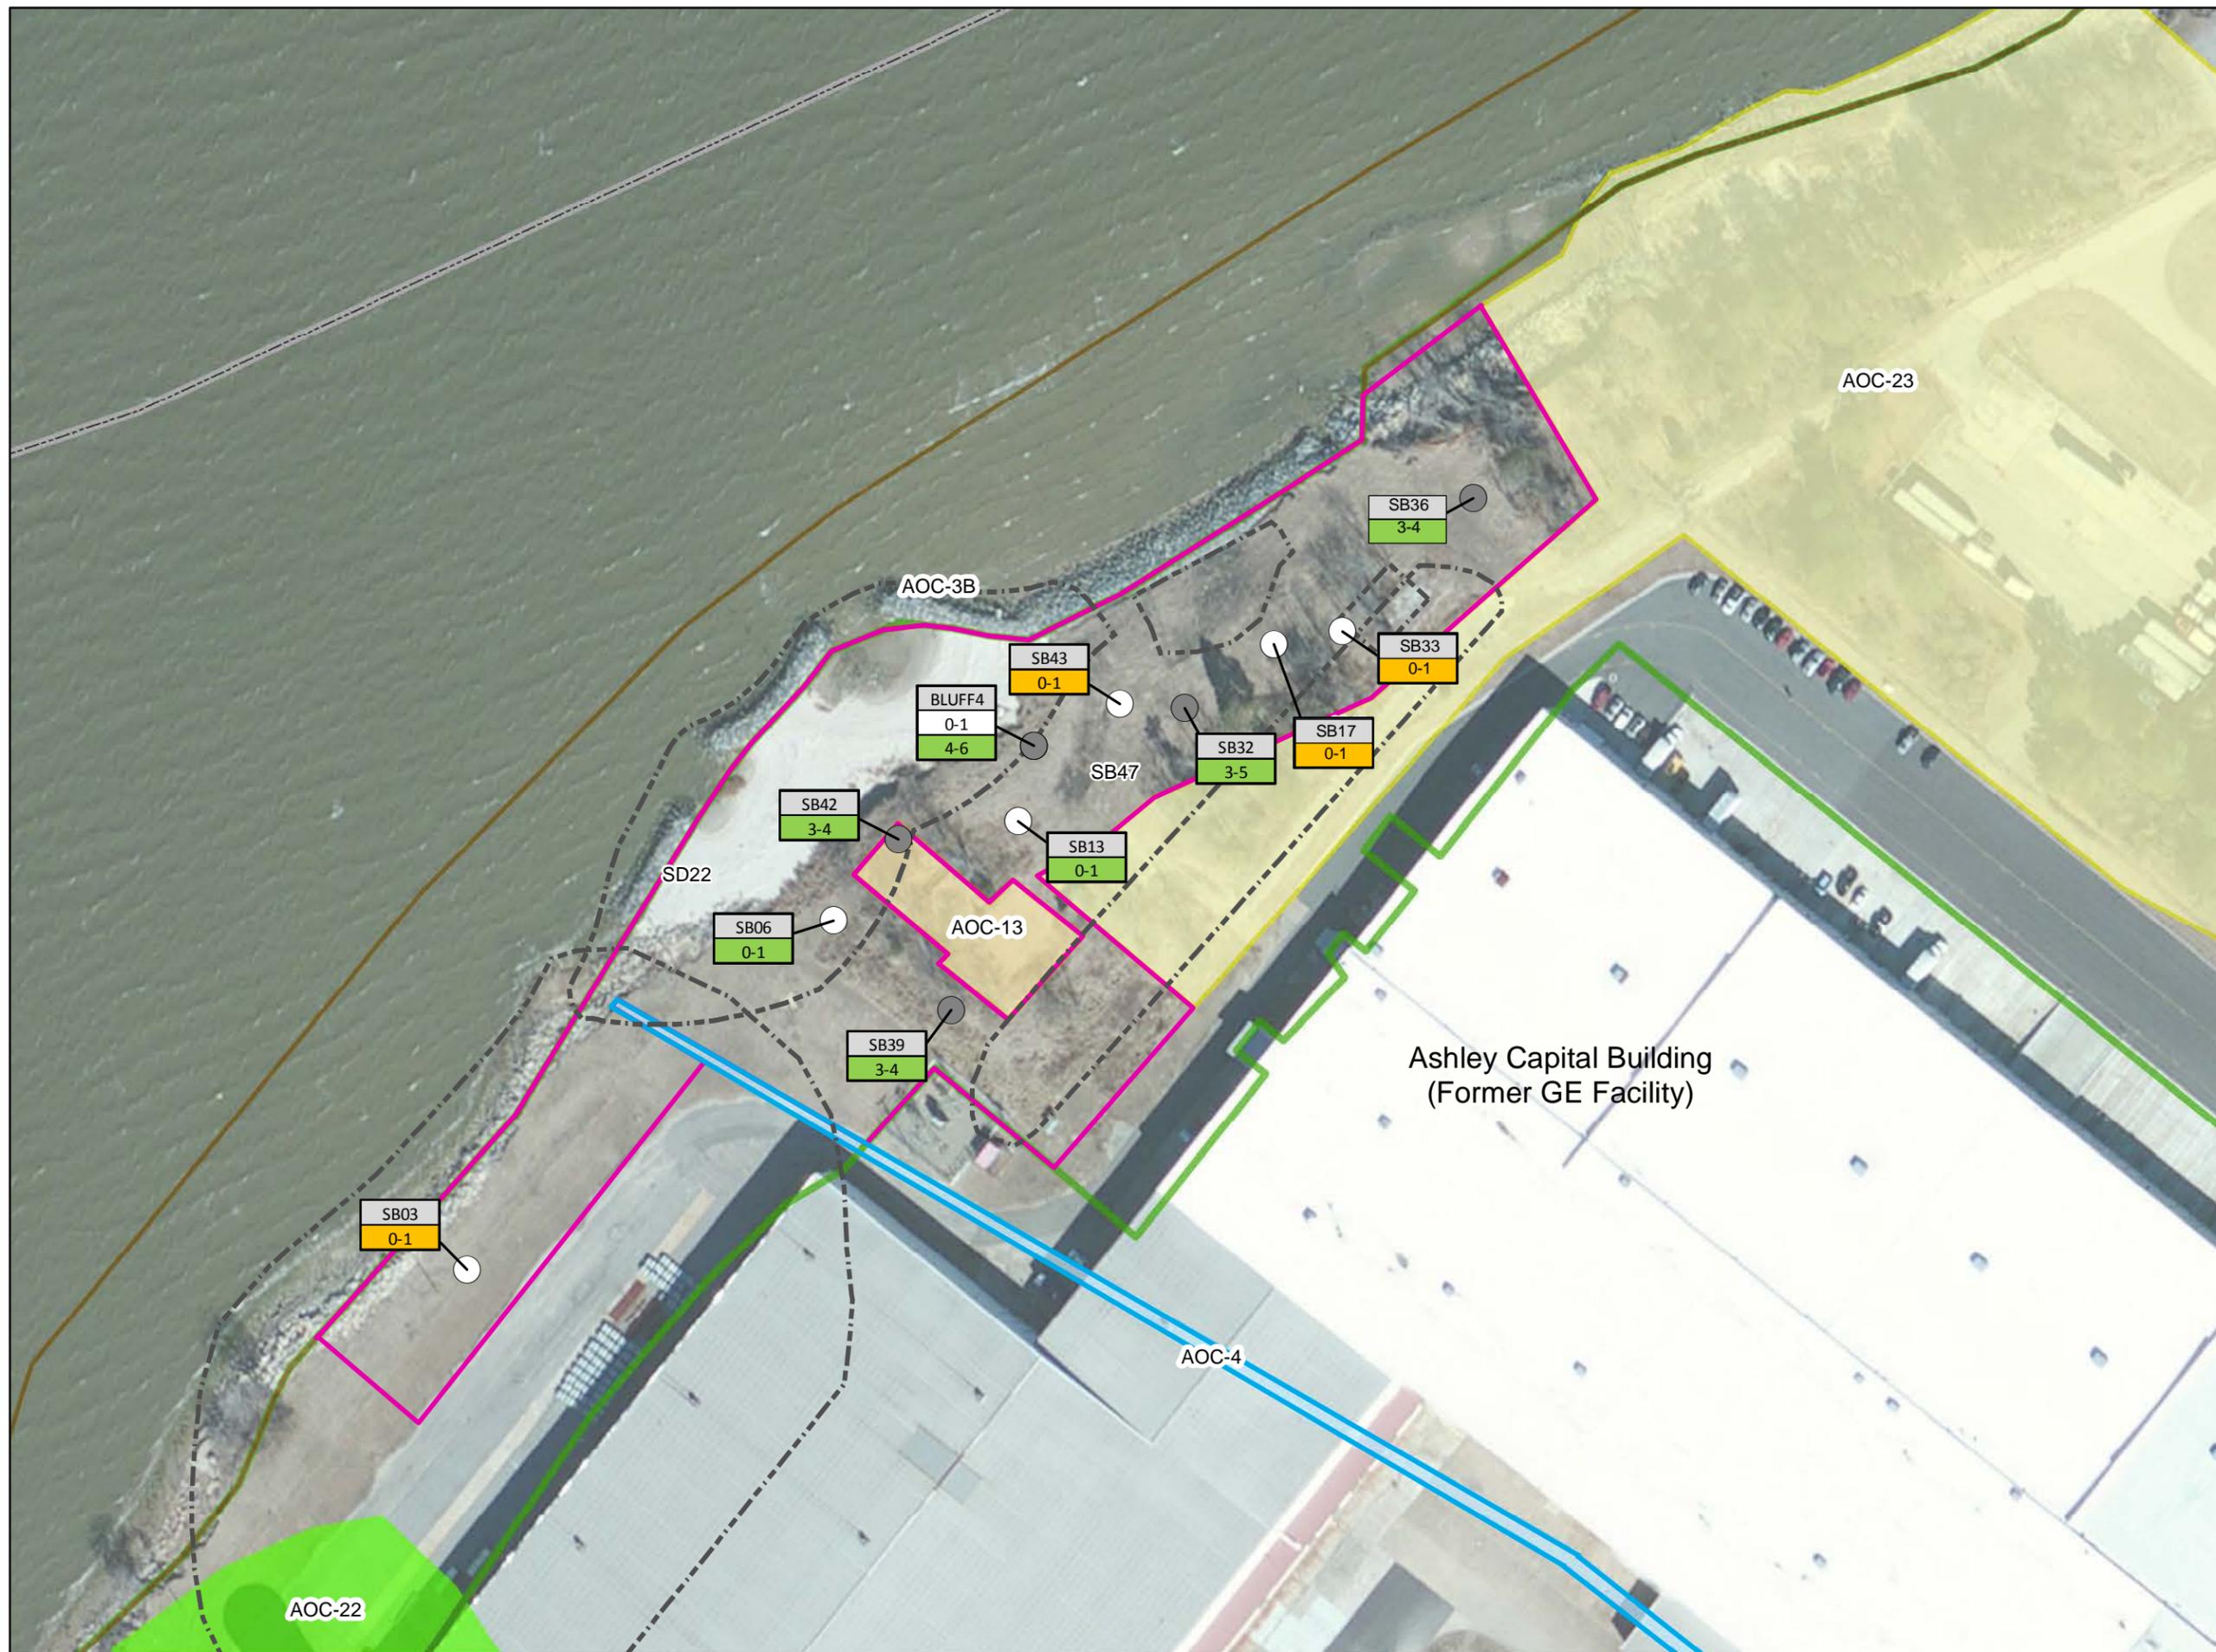
Figure 3-3
Soil Pesticide Screening Criteria Exceedances
Nansemond River Beachfront
Former Nansemond Ordnance Depot (FNOD)
Suffolk, Virginia

SAMPLE ID	DEPTH (FEET)
Green Box	- No analyte exceed screening criteria and background concentrations (if available).
Yellow Box	- One or more analytes exceed screening criteria and background concentrations (if available).

Note:
Soil samples within shoreline stabilization area were collected prior to shoreline stabilization

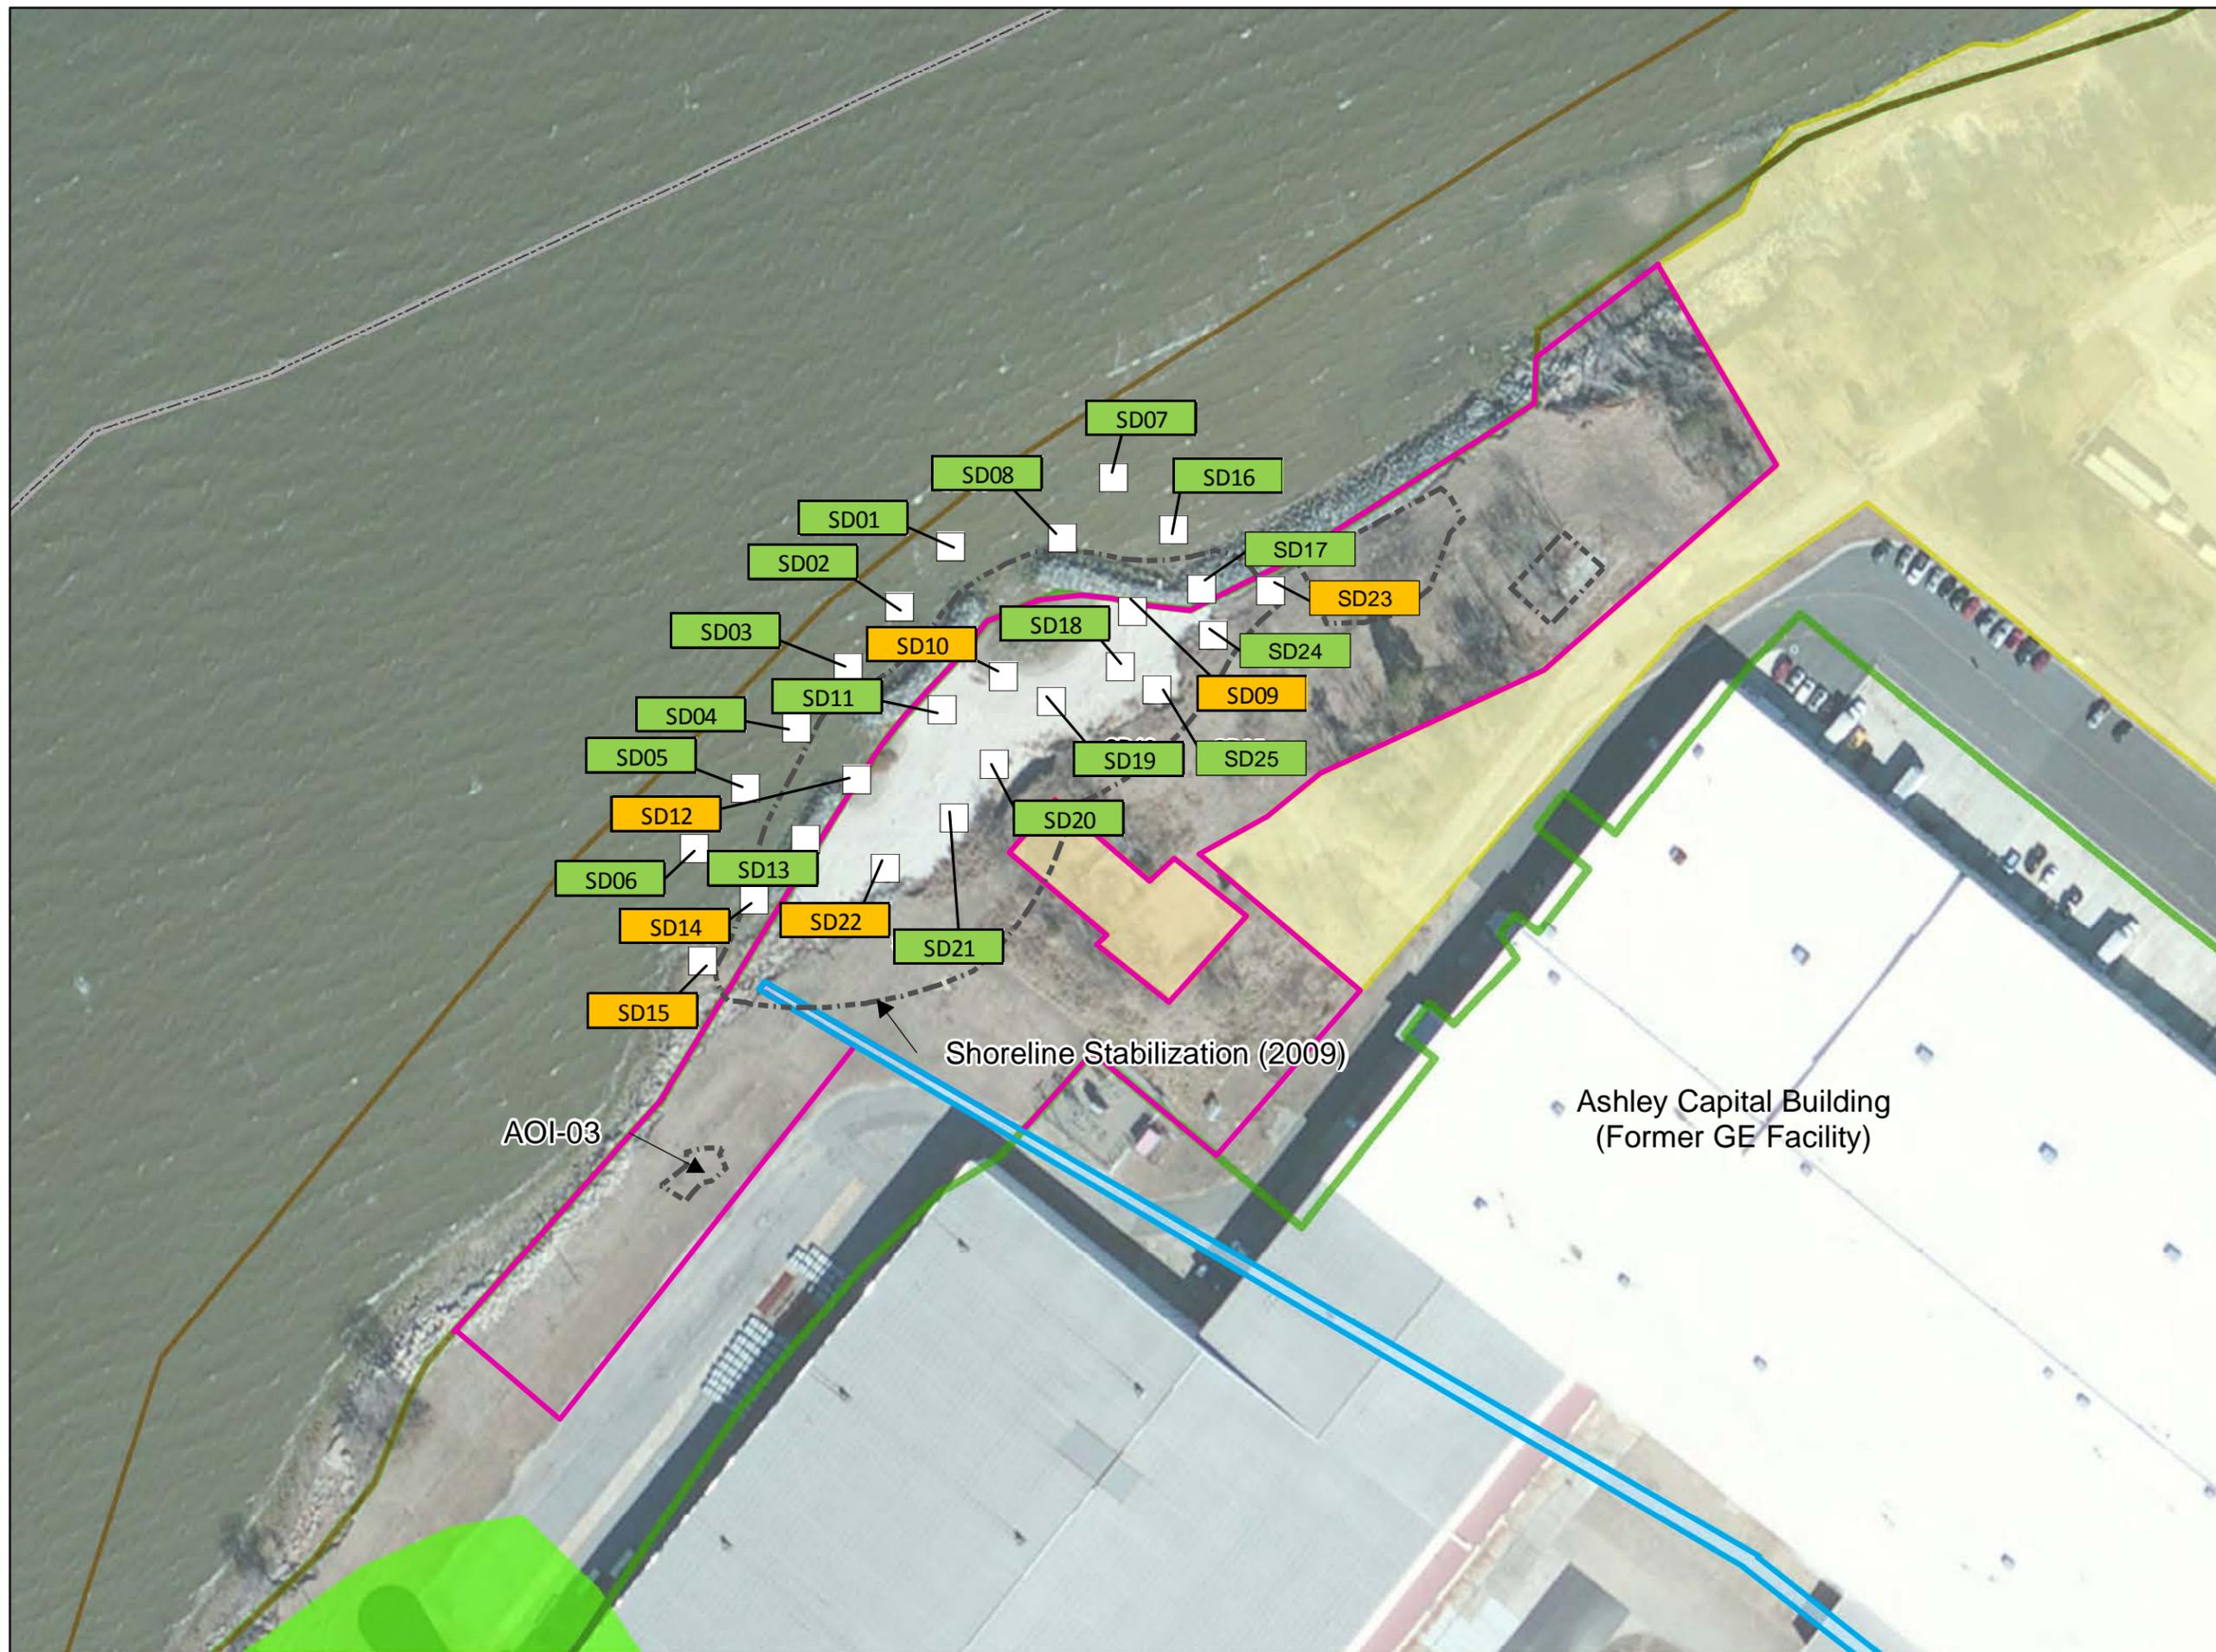
Figure 3-8
Sediment Metal Screening Exceedances
Nansemond River Beachfront
Former Nansemond Ordnance Depot (FNOD)
Suffolk, Virginia

- No analyte exceed screening criteria and background concentrations (if available).
- One or more analytes exceed screening criteria and background concentrations (if available).

Note:
Sediment samples within shoreline stabilization area were collected prior to shoreline stabilization.

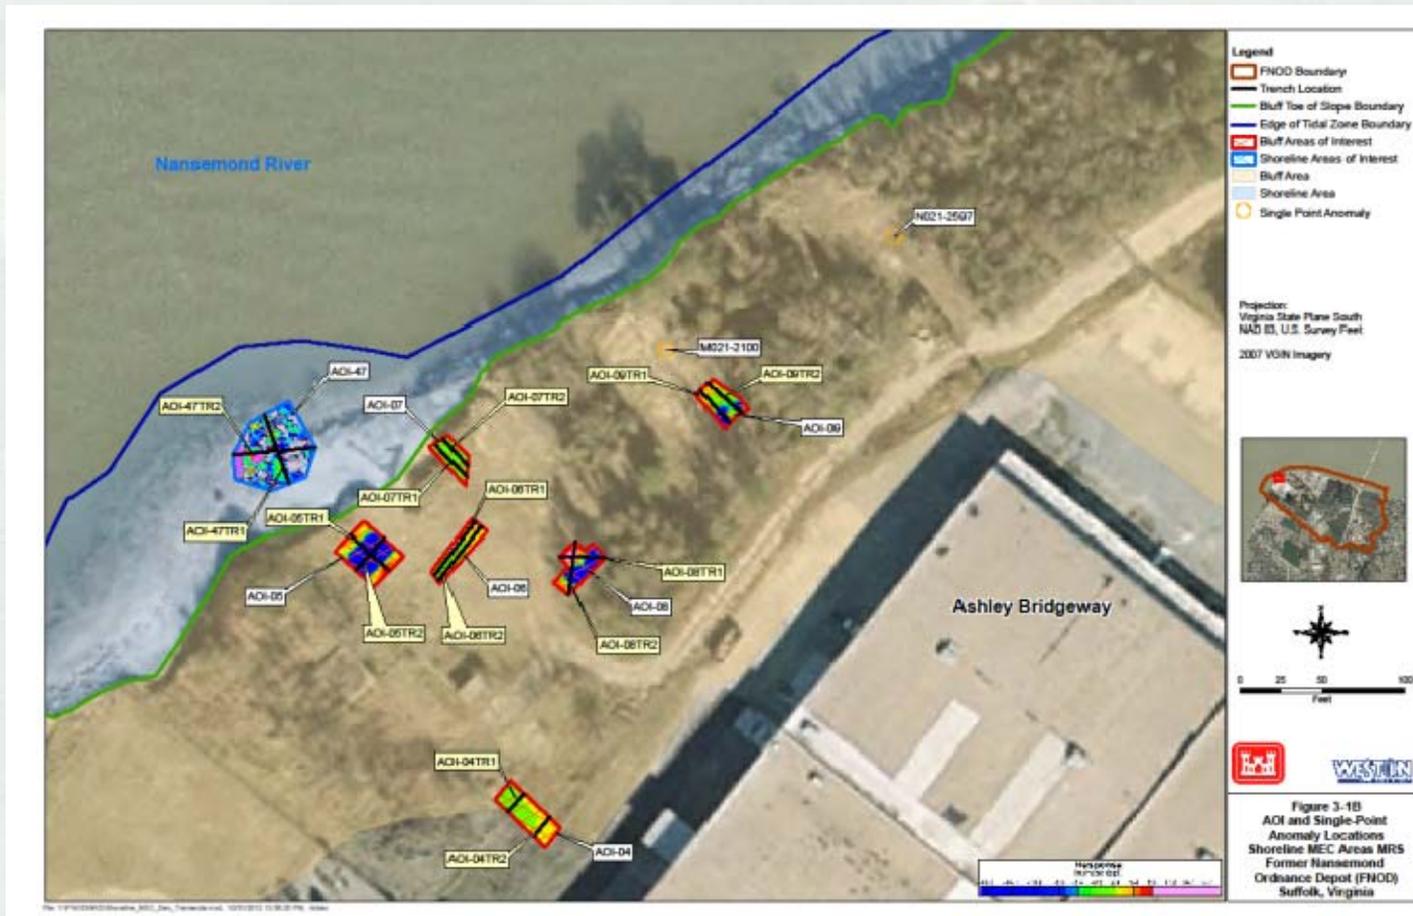
AOI 47

- AOI-47 located within the stabilized shoreline. Total of 20 metal expended fuze boosters discovered from the ground surface to a depth of 5 inches bgs.
- Discovery consistent with historical findings of MD occasionally discovered along Nansemond River shoreline following significant weather events.
- Any additional investigations for AOI-47 will be conducted under the MMRP MEC Shoreline MRS investigation.
