December 3, 2015

Nansemond River Beachfront (NRB) (AOC-1) Remedial Investigation (RI) Work Plan

Former Nansemond Ordnance Depot
Formerly Used Defense Site

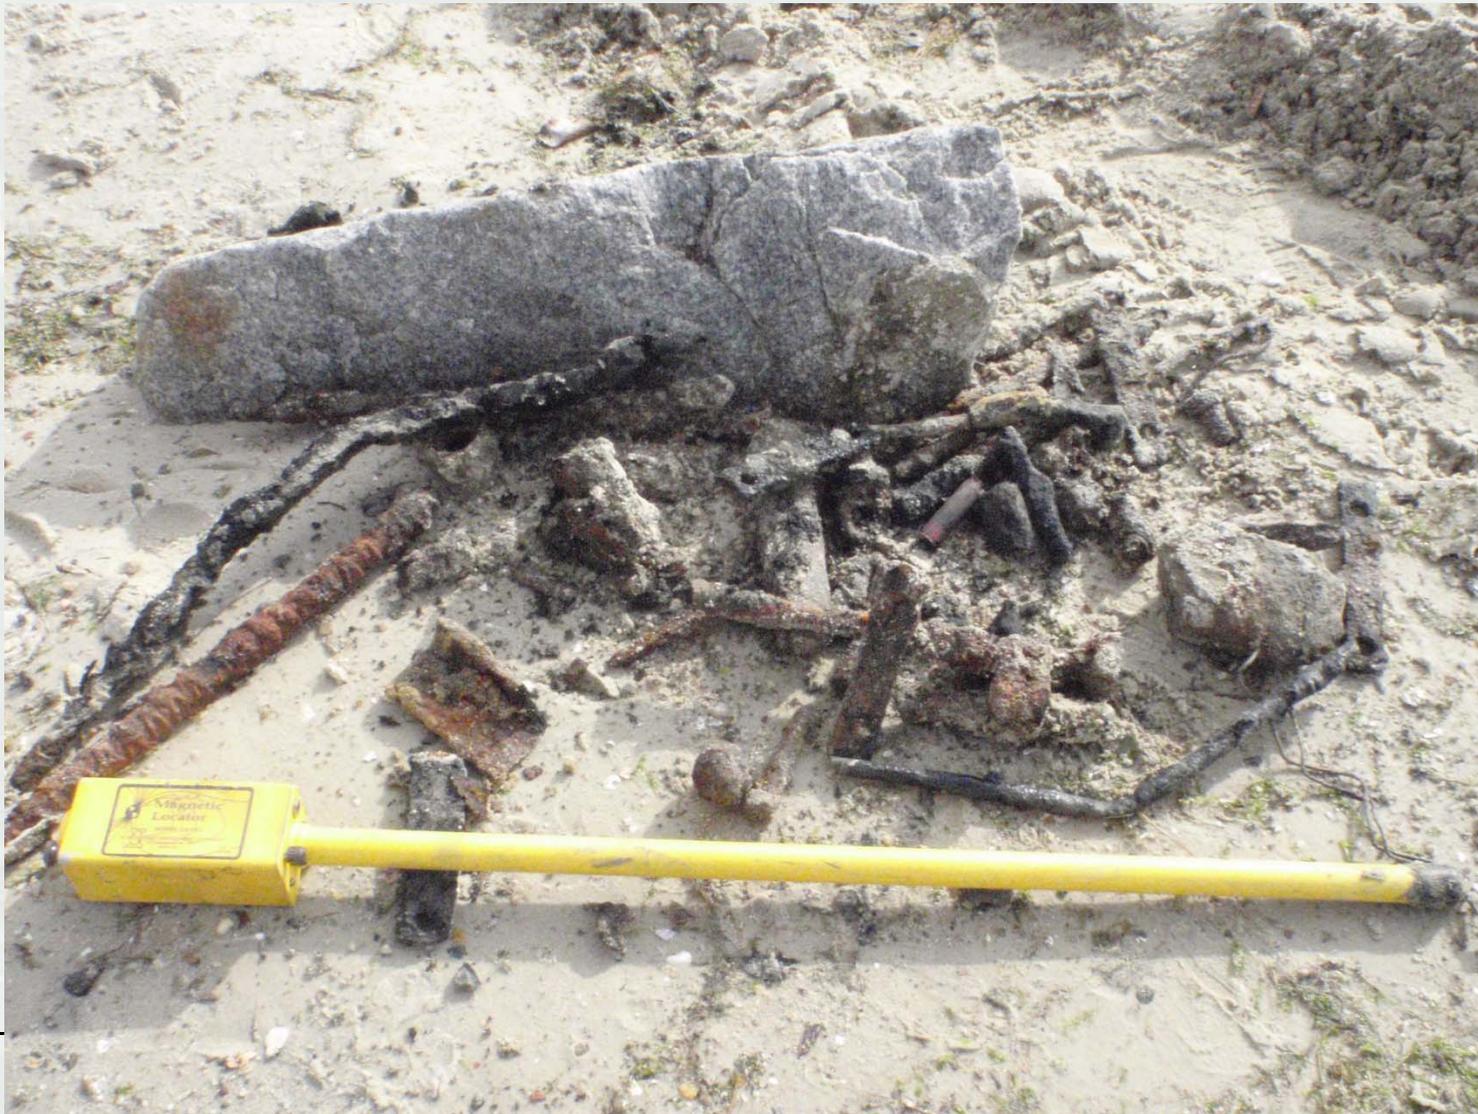
AOI 47

Work conducted On 2014

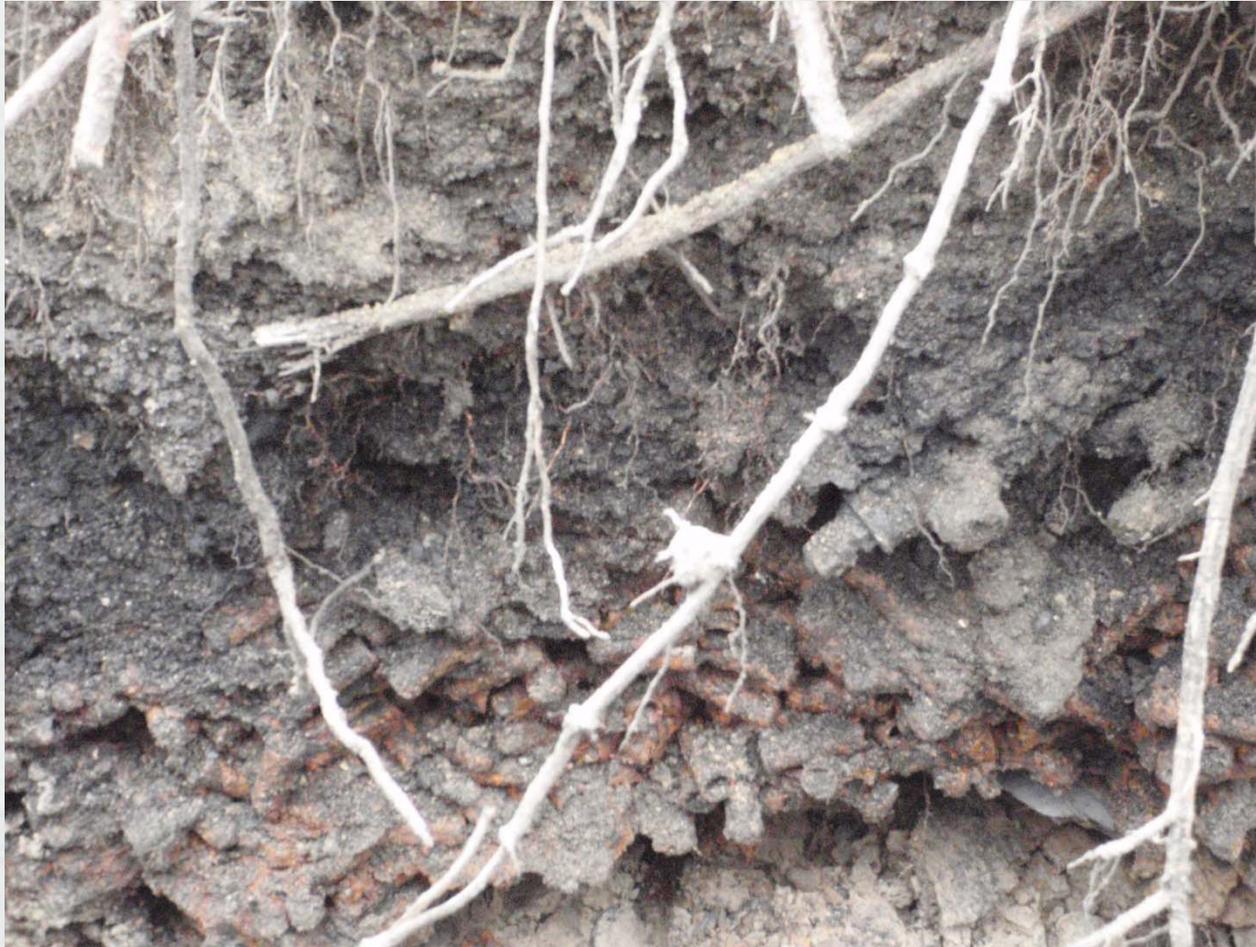
AOI 37

Intrusive Investigation on 2014

The circular feature area of approximately 2.7 acres is associated with Area of Interest (AOI-36) and AOI-37 and is based on the anticipated fragmentation distance of 200 feet for the munitions items found at AOI-36 and AOI-37

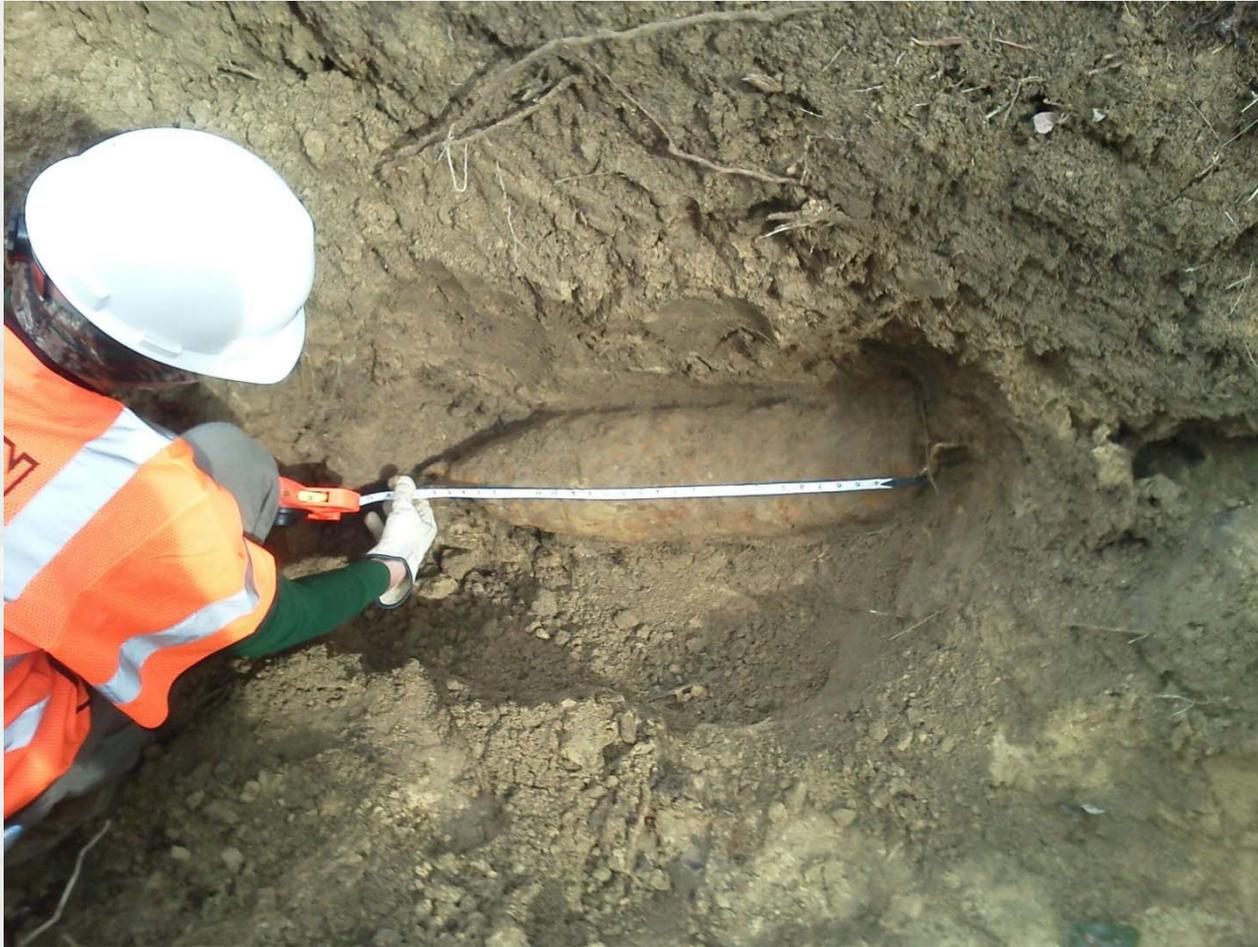
AOI 36

Intrusive Investigation on 2014

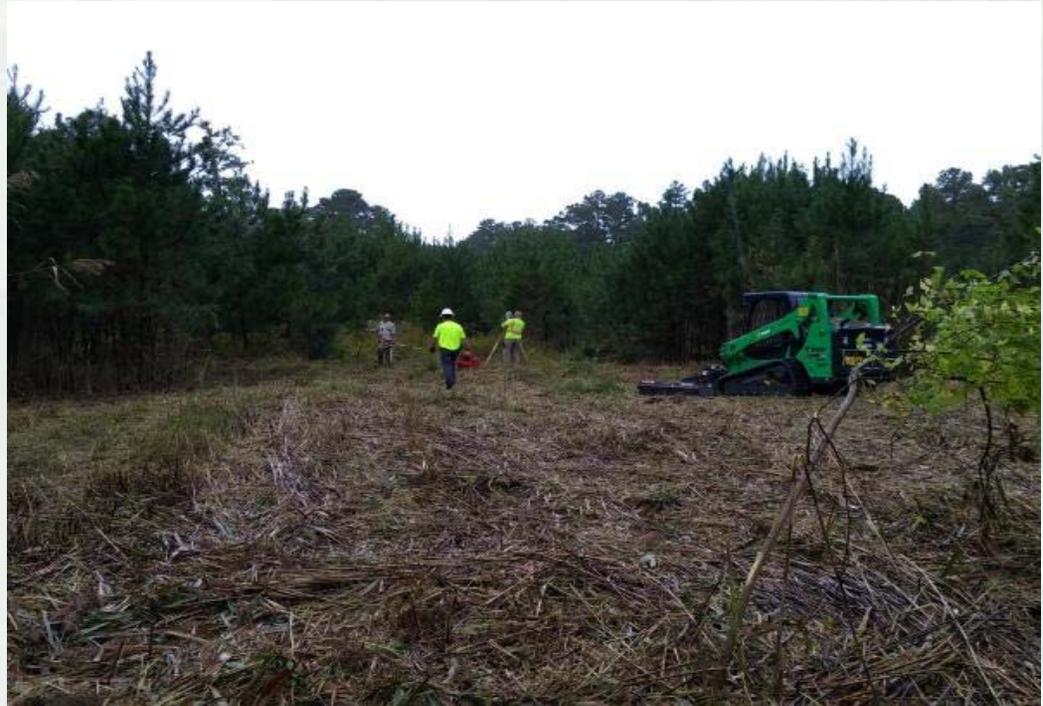
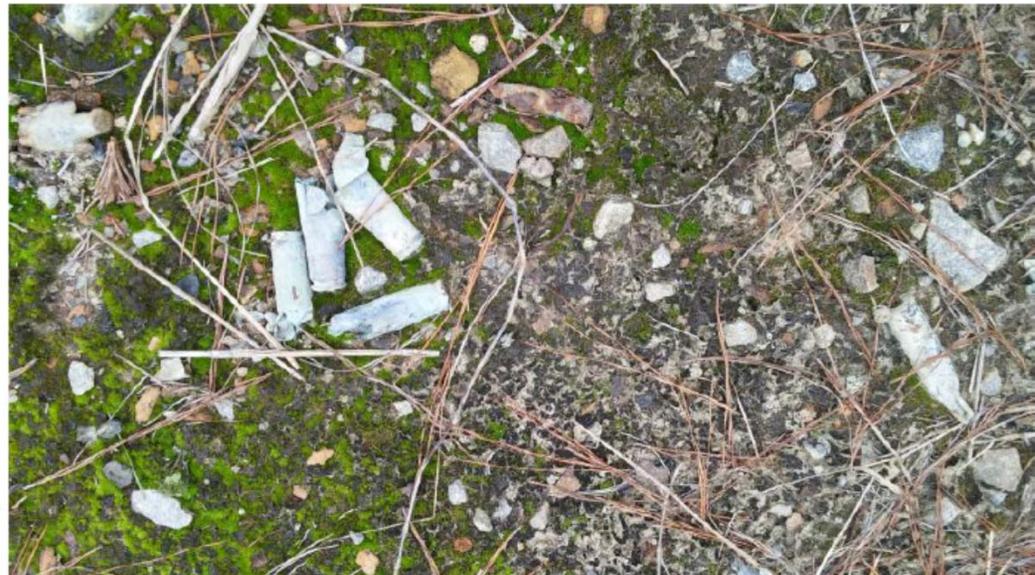
- Significant construction and metallic debris (potentially landfilled) was located in all three areas of munitions investigation (two grid areas and border area) during survey and vegetation removal activities
- In Sub-Area A, a few locations with munitions casings on the ground surface were identified following vegetation removal. These locations are outside the planned MEC

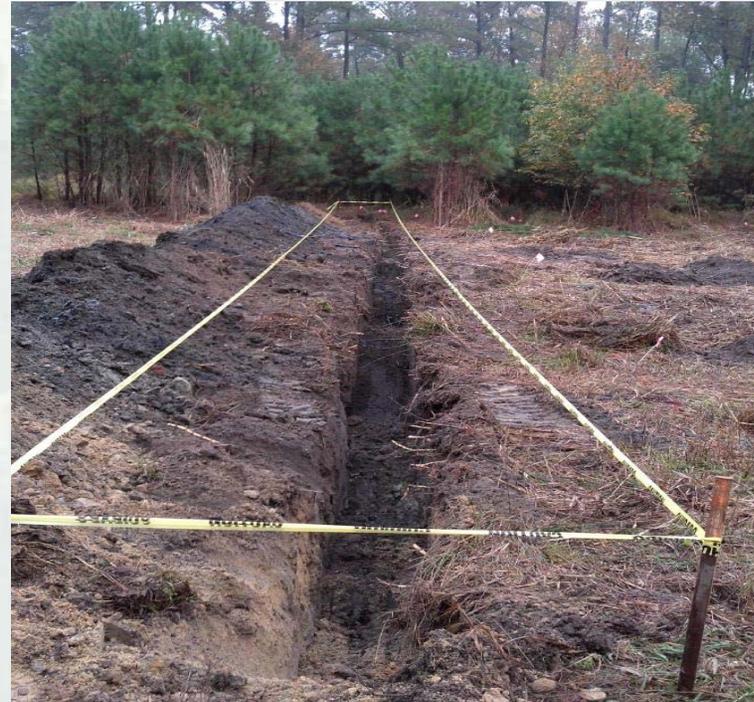
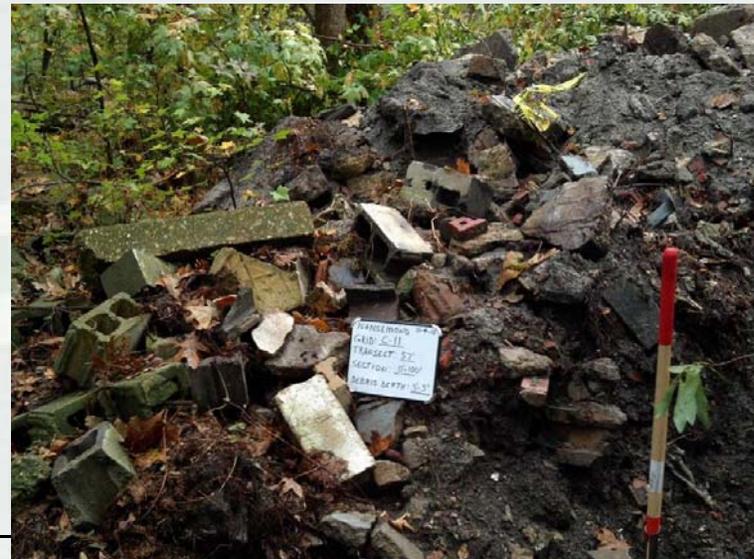
- AECOM conducted MEC investigation transects and trenching/test pits in eight 100x100 ft investigation grids. These grids included B-11, B-12, C-11, C-12, C-13, D-4, E-2, and E-3
- In the first five grids investigated, B-11, B-12, C-11, C-12, and C-13, saturated response areas were encountered caused by construction debris fill to depths of 3 to 5 ft below ground surface (bgs). Hand digging hundreds of anomalies along the investigation transects in saturated areas was replaced with mechanical excavation
- For all eight investigation grids, trenching or test pits were conducted to characterize anomalies/debris below 2 ft bgs and identify the depths of these materials, if feasible.
- **No munitions related debris or MEC/MPPEH was encountered in the eight investigation grids**

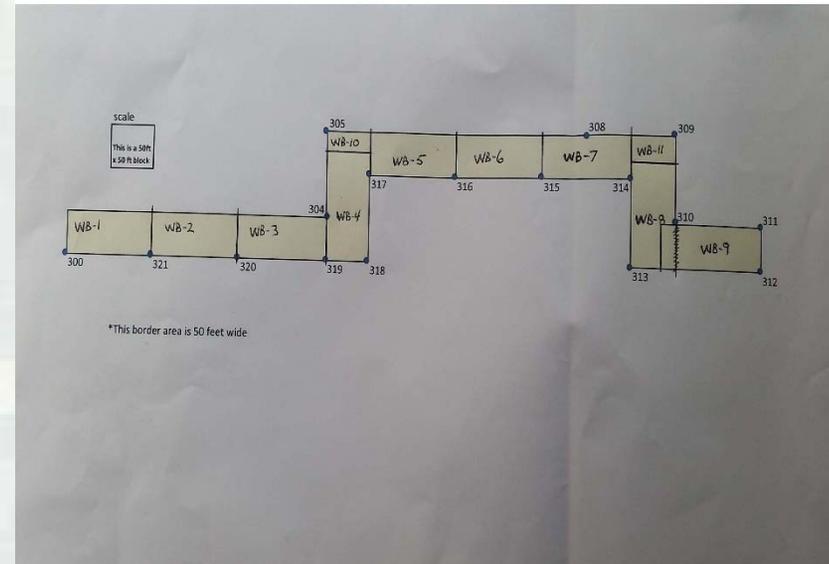
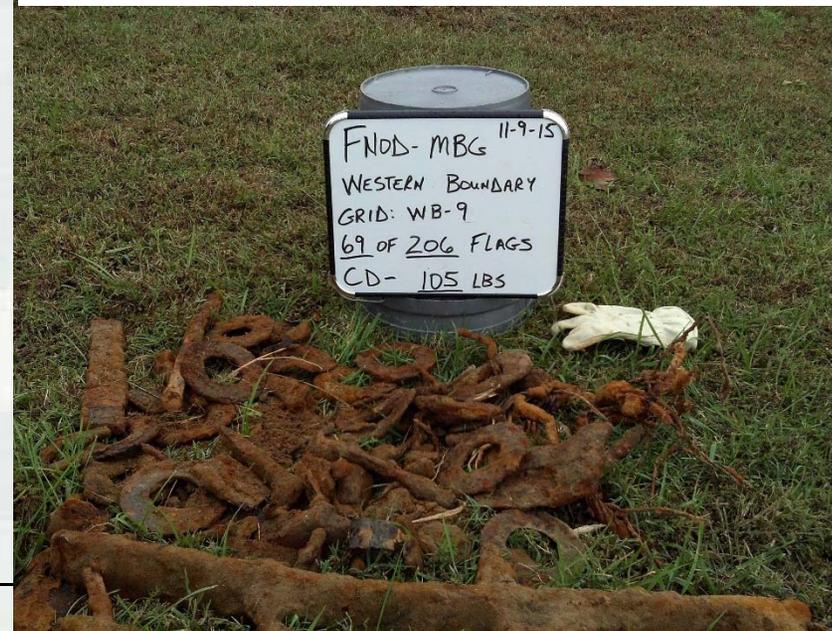
- MEC investigation of the border area included a 100% sweep. The border area was divided into 9 investigation grids by the UXO team (grids WB-1 through WB-9).
- In grids WB-1 and -2, non-MEC trash/debris areas were encountered and limits approximated. Excavator test pits determined the non-MEC debris/trash in this location to be approximately 1 to 2 ft deep
- In the remaining border area outside of the trash/debris areas, a 100% sweep was completed in each grid. All detected anomalies were identified and recovered using mag & dig techniques except for two anomalies in grid WB-8. These anomalies were determined to be below 5 feet depth and could not be dug safely due to groundwater infiltration and caving concerns.

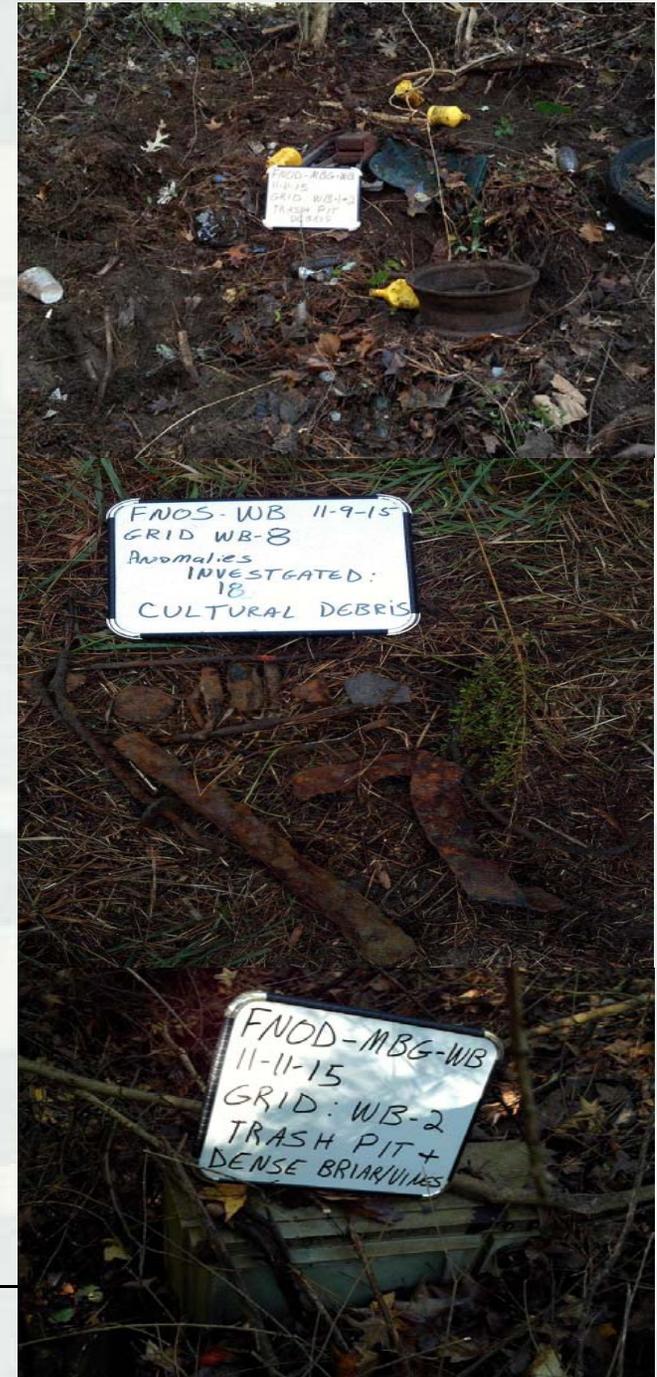
- Significant construction and metallic debris (potentially landfilled) was identified on the surface in border area planned for investigation
- WB-9 which is about 50ftx100ft, 206 anomalies were flagged. Dug 69 of the 206 anomalies and all were non-munitions related cultural debris (attached photo of grid with flags and photo of debris they were finding).
- In WB-8, 128 anomalies were found and dug approximately 20 and found all non-munitions related cultural debris. In WB-7 28 anomalies were found and dug them all were non-munitions related cultural debris.
- This pattern of lower anomaly counts continued a little further as team moved westward, but there were cultural debris/trash disposal areas in the vicinity of WB-1 and WB-2 based on visual observations.
- **No munitions related debris or MEC/MPPEH was encountered in the border area**
