2001 Accomplishments

- James River Beachfront
- Track K Dump/Tire Pile
- Nansemond River Beachfront
- Pits 12 & 18 - Ordnance Survey Areas

The Corps made visible progress in 2001 at the Former Nansemond Ordnance Depot (FNOD) by completing four large removal actions involving debris and in some cases ordnance and explosives (OE). This fact sheet summarizes the removal actions completed at James River Beachfront, Nansemond River Beachfront, Track K Dump, and Pits 12 and 18.

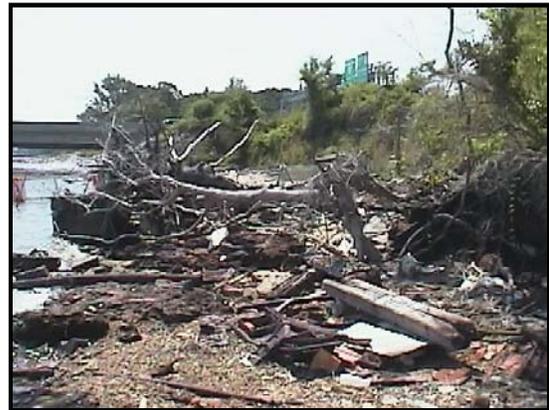
BEFORE

During the removal, the Corps found debris including scrap metal, concrete slabs, slag material (refuse from burnt ordnance), bricks, and other construction debris.

Removal efforts took place during the summer of 2001 and were complete in October. The most noticeable change is the installation of a revetment wall with a stone facing to protect the shoreline from erosion.

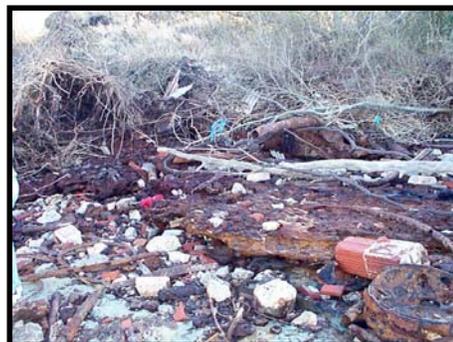
BEFORE

The Corps found metal slag (refuse from burnt ordnance) with questionable content on the beach. This material has since been classified as non-hazardous. No live Ordnance and Explosives were found.

The initial removal action reached a depth of 2 to 3 feet and was completed in September 2001. The visible large debris was removed to an on-site container, characterized for disposal, and disposed of as non-hazardous waste.
