EVALUATION OF LONG-TERM DREDGED MATERIAL DISPOSAL

TANGIER ISLAND,
VIRGINIA

Prepared for Dredging Management Branch
Norfolk District, Corps of Engineers

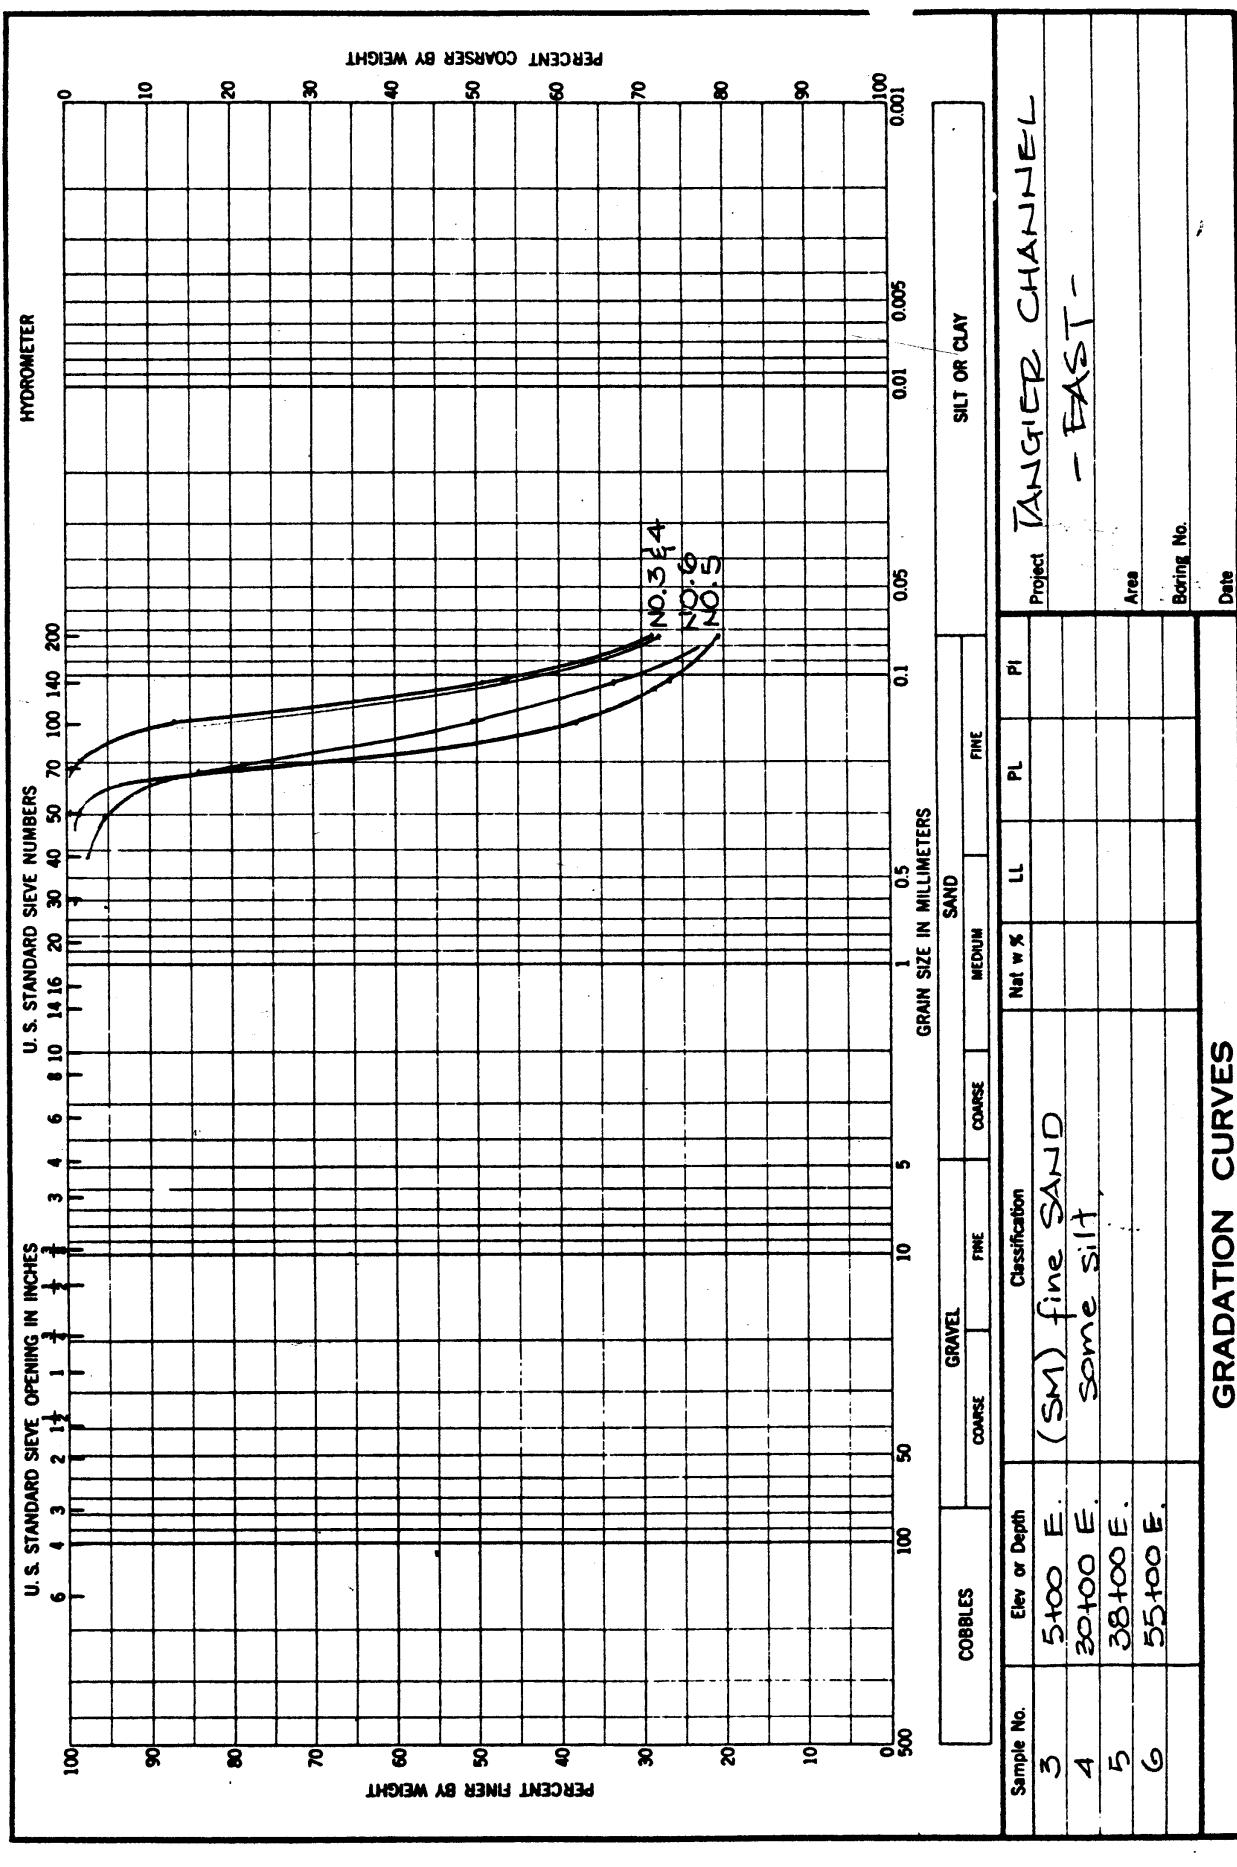
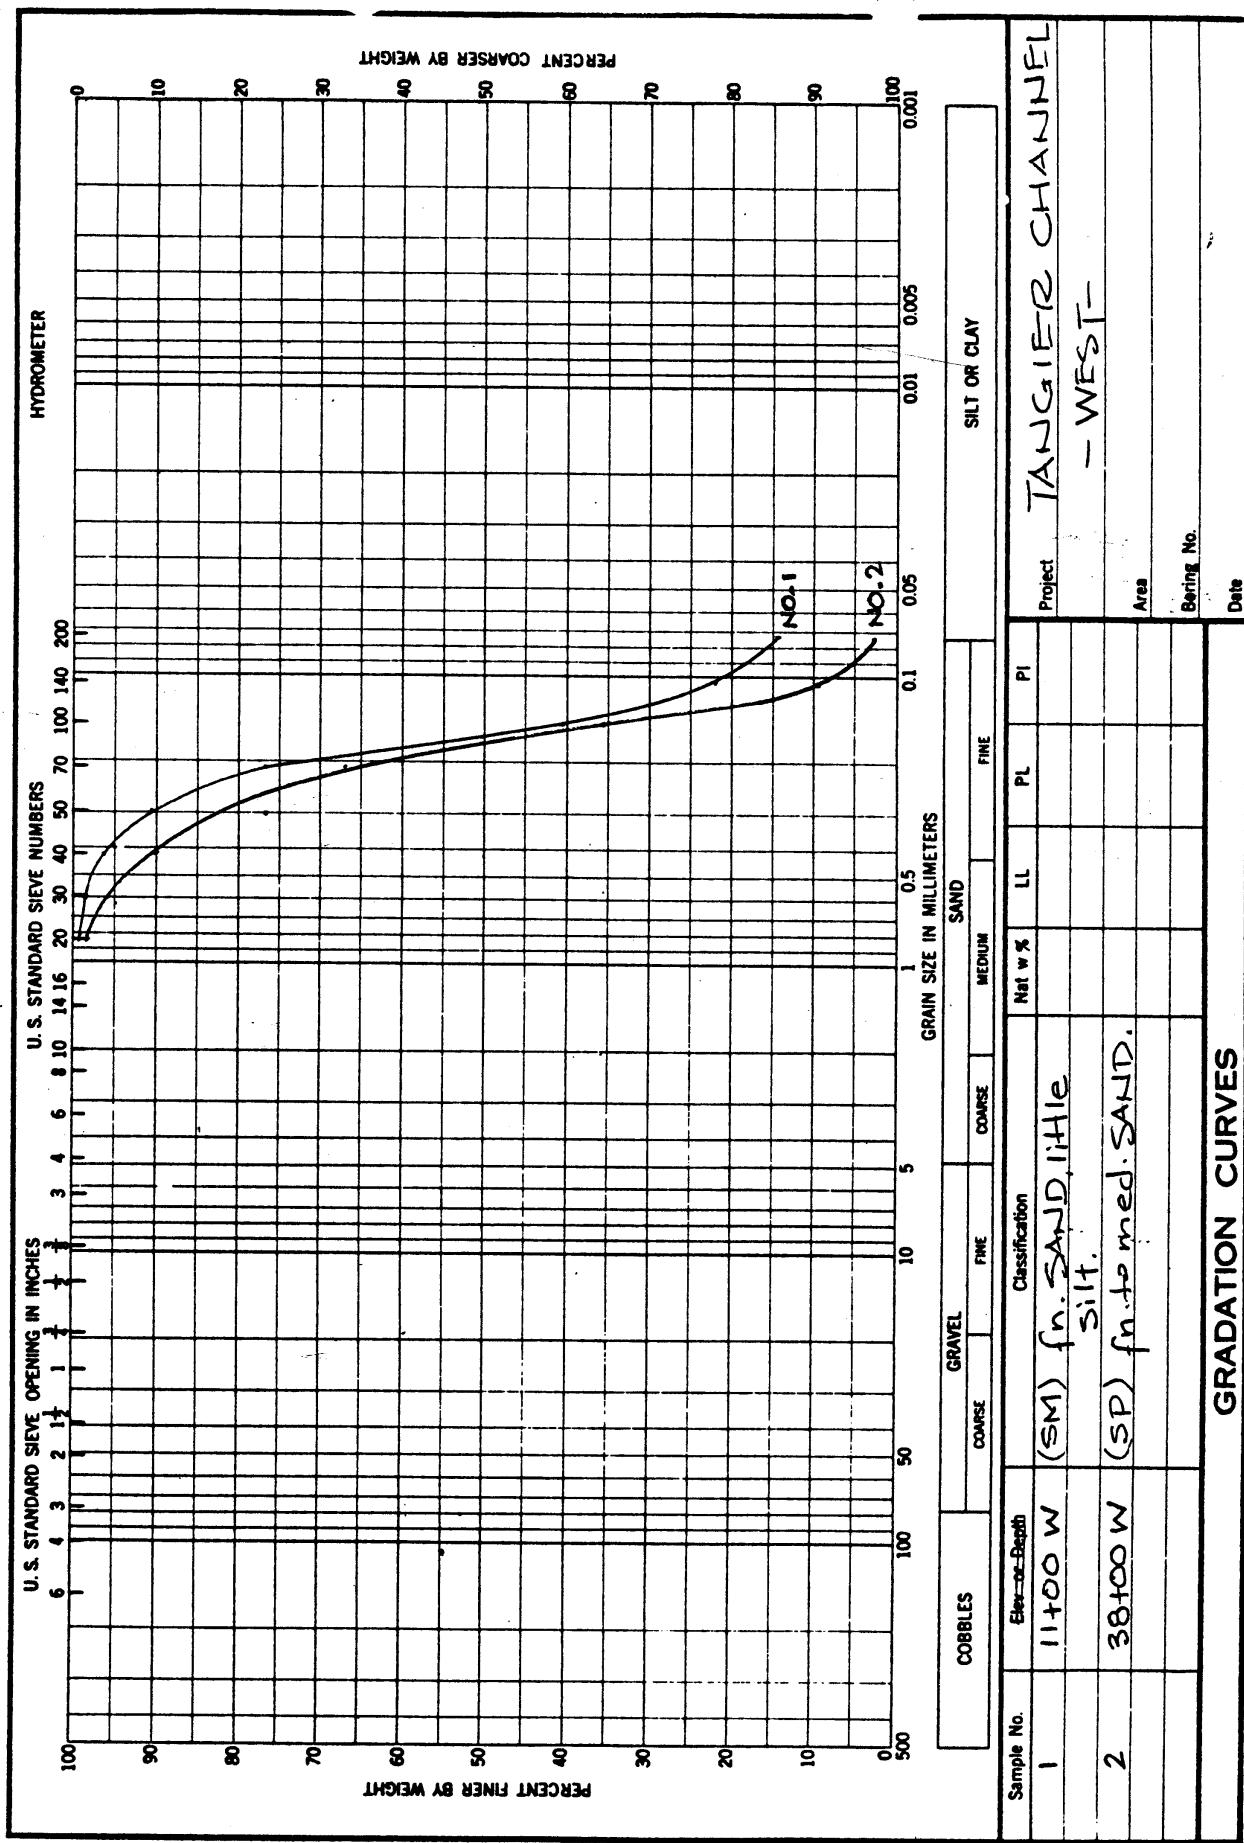
PROJECT CHANNEL SEDIMENTS

* SEE GRADATION CURVES.
