FIGURE 8 (MOD)
BEACH NOURISHMENT AND
STORMWATER OUTFALL EXTENSIONS
DETAILED PLAN VIEW (3 OF 11)

FIGURE 30
 EMERGENCY DUNE RESTORATION
 PROPOSED TERMINAL GROIN BORROW AREAS
 DETAILED PLAN VIEW

FIGURE 31
 TYPICAL SECTIONS (SHEET 1 OF 2)

FIGURE 32
 TYPICAL SECTIONS (SHEET 2 OF 2)

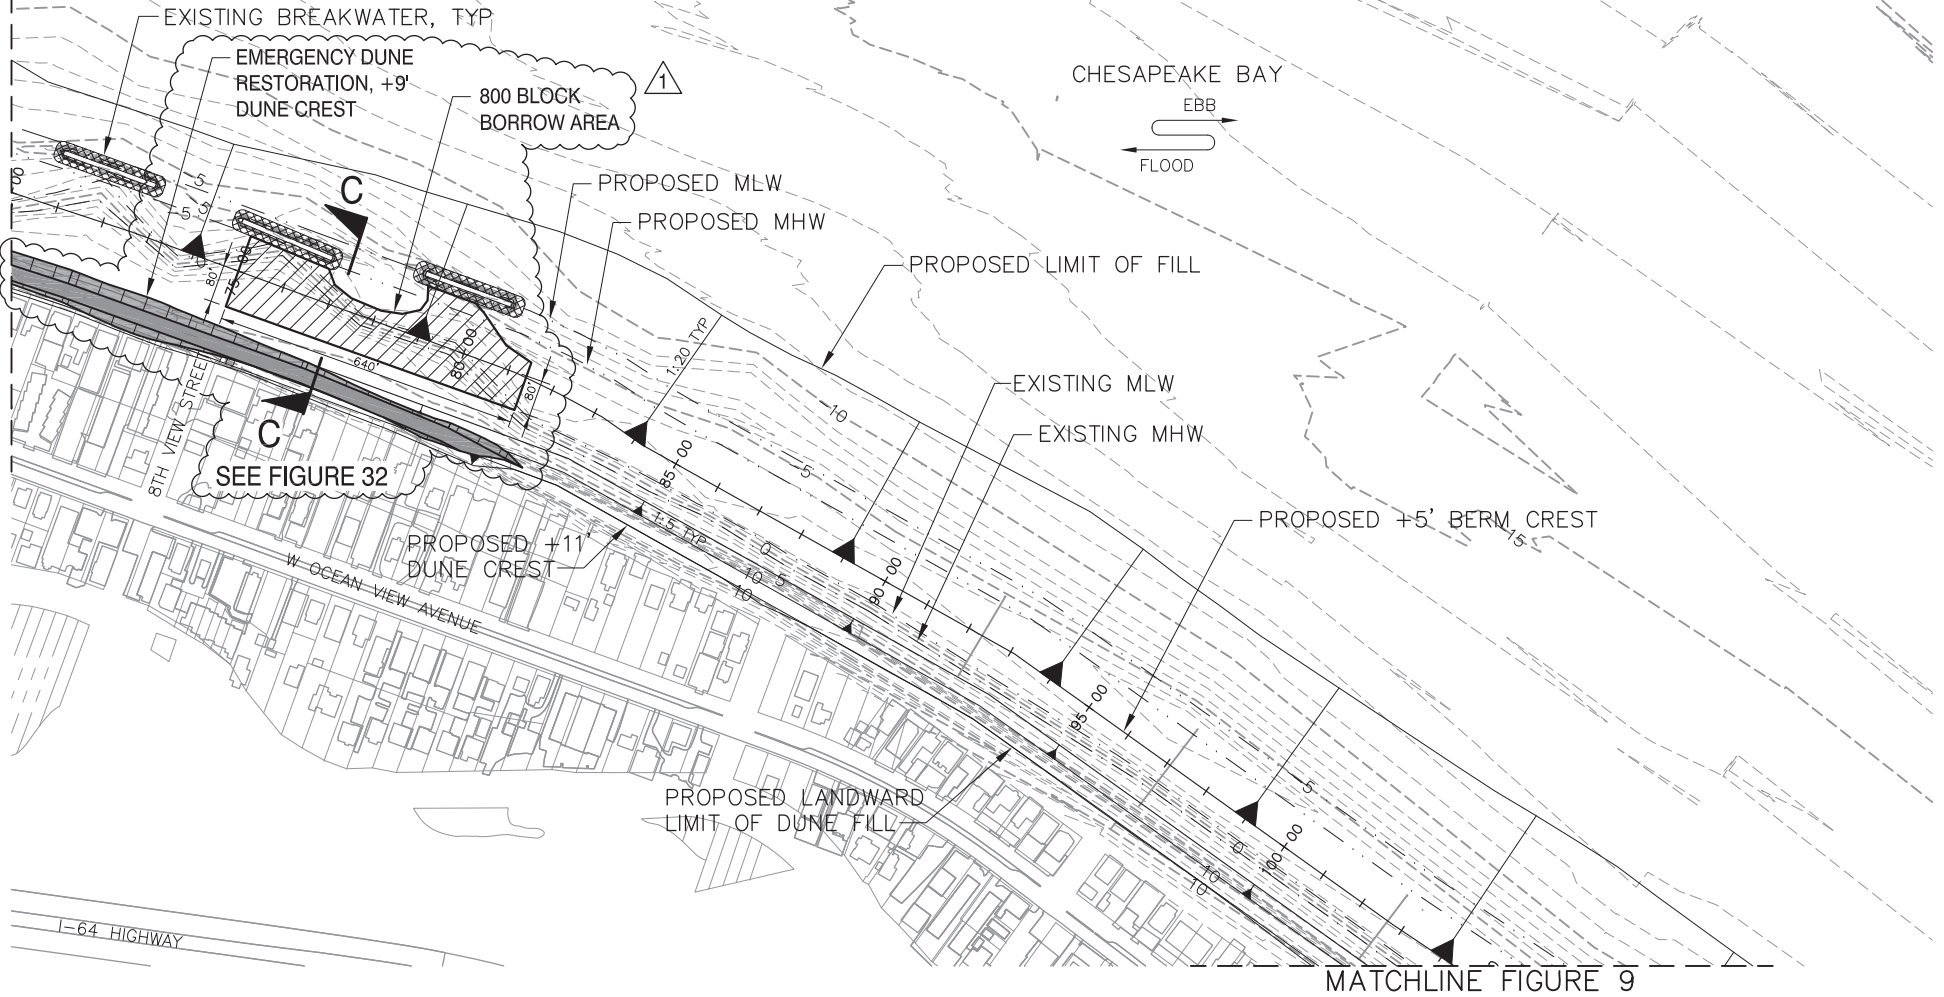
PROPOSED EMERGENCY DUNE RESTORATION (2010)

PROPOSED BORROW AREA

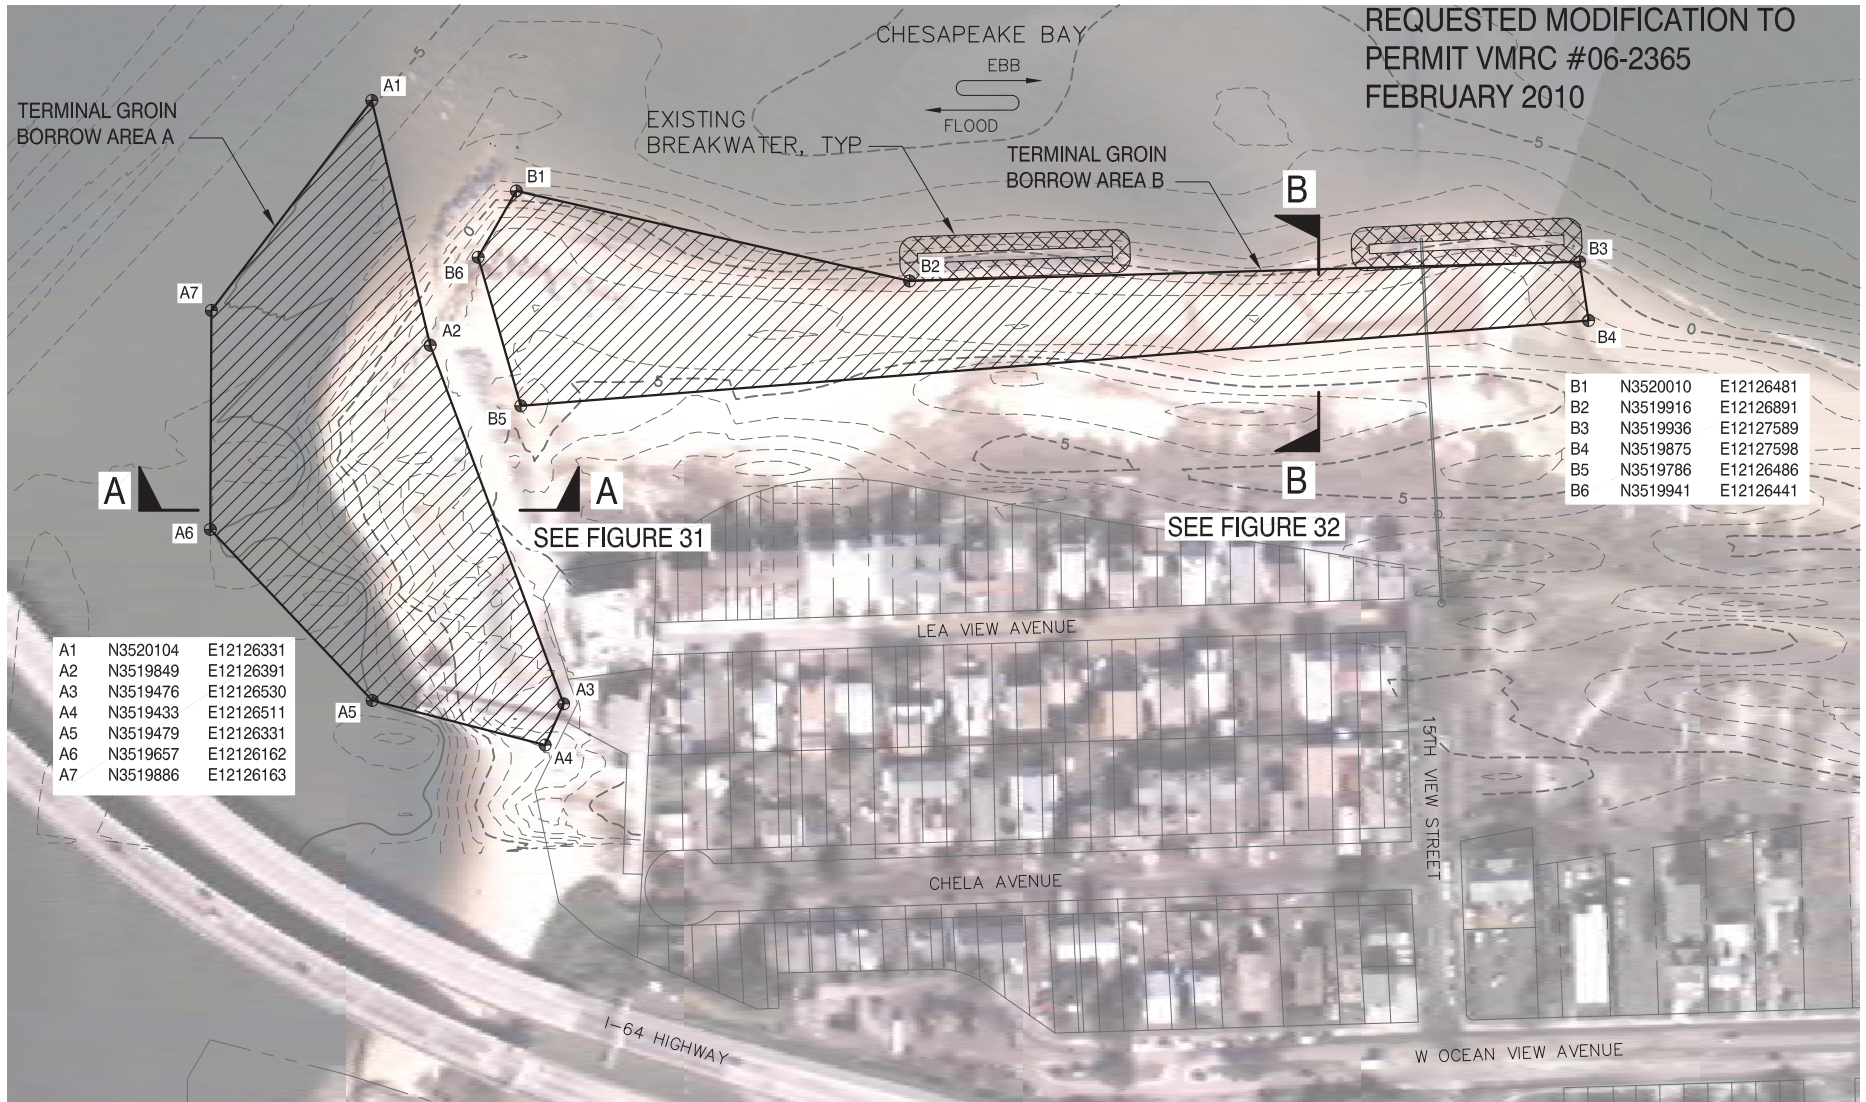
A1	N3520104	E12126331
A2	N3519849	E12126391
A3	N3519476	E12126530
A4	N3519433	E12126511
A5	N3519479	E12126331
A6	N3519657	E12126162
A7	N3519886	E12126163

B1	N3520010	E12126481
B2	N3519916	E12126891
B3	N3519936	E12127589
B4	N3519875	E12127598
B5	N3519786	E12126486
B6	N3519941	E12126441

PROPOSED BORROW AREAS

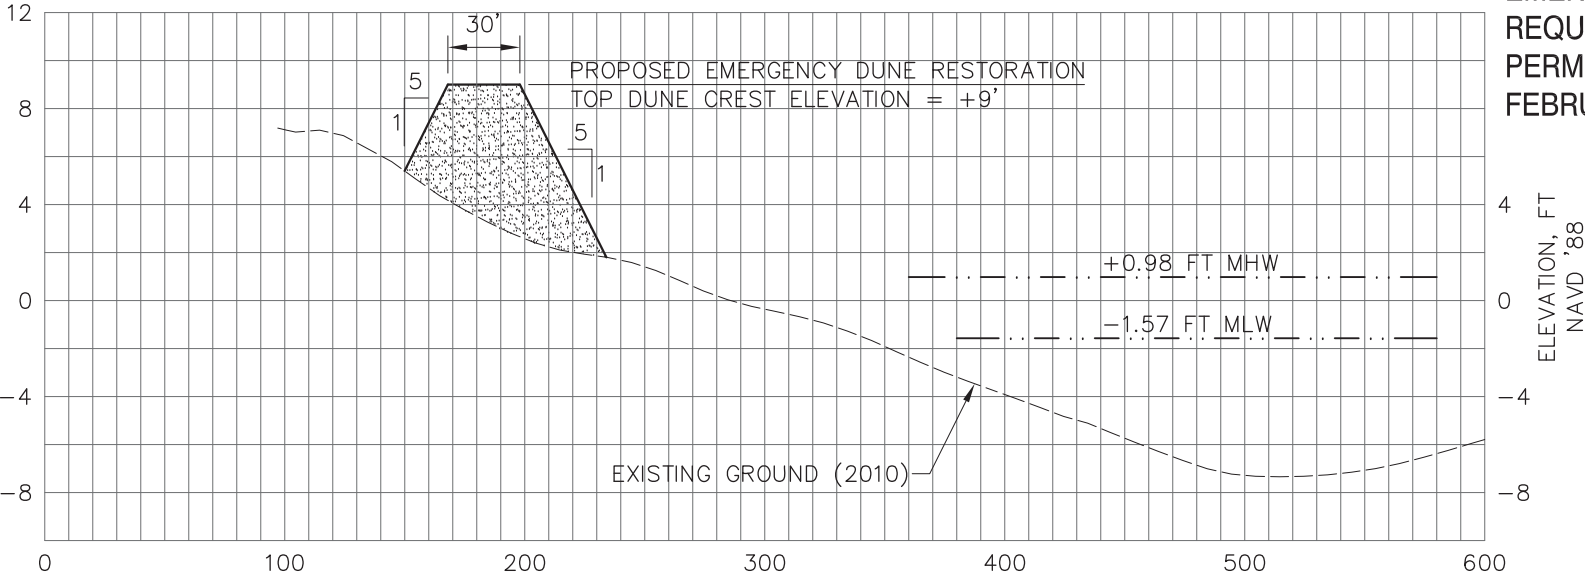
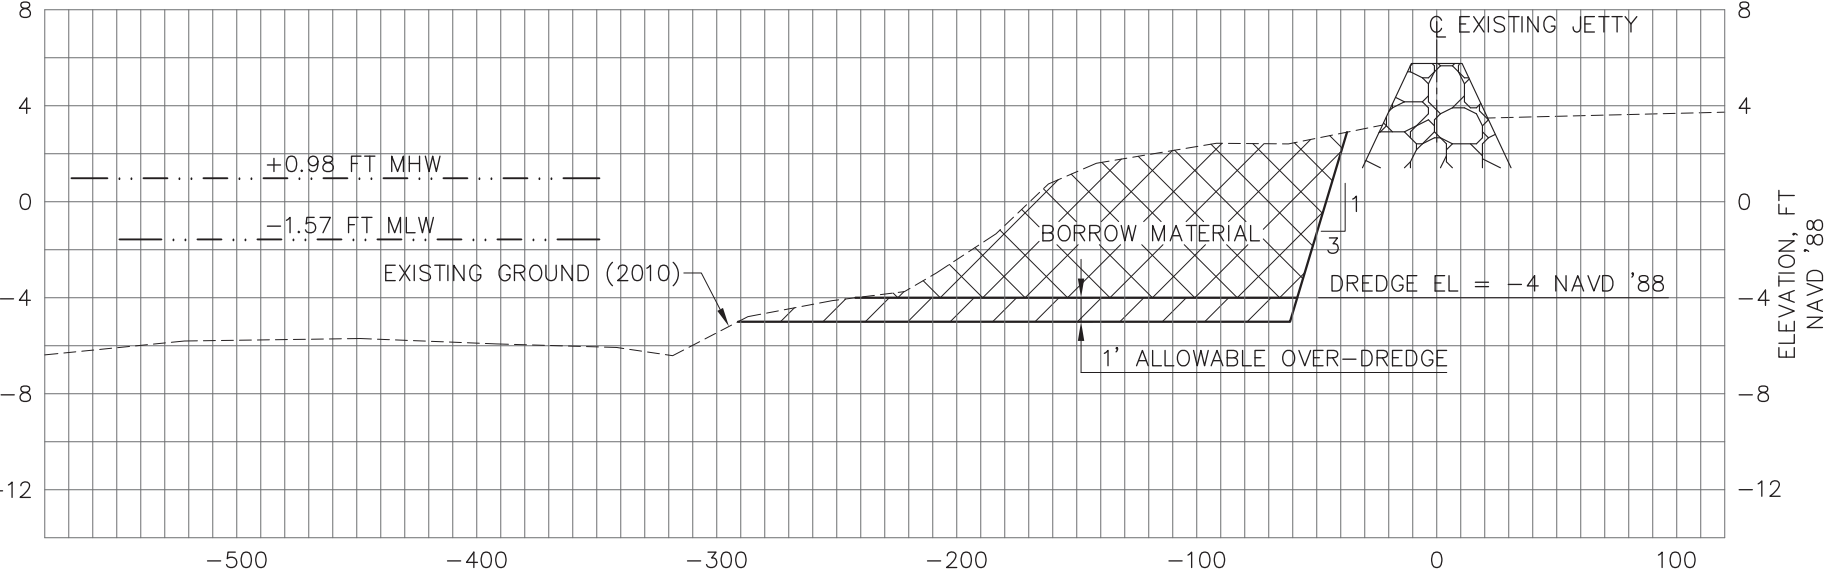
EMERGENCY DUNE RESTORATION

TERMINAL GROIN BORROW AREA A
SECTION A-A

SEE FIGURE 31

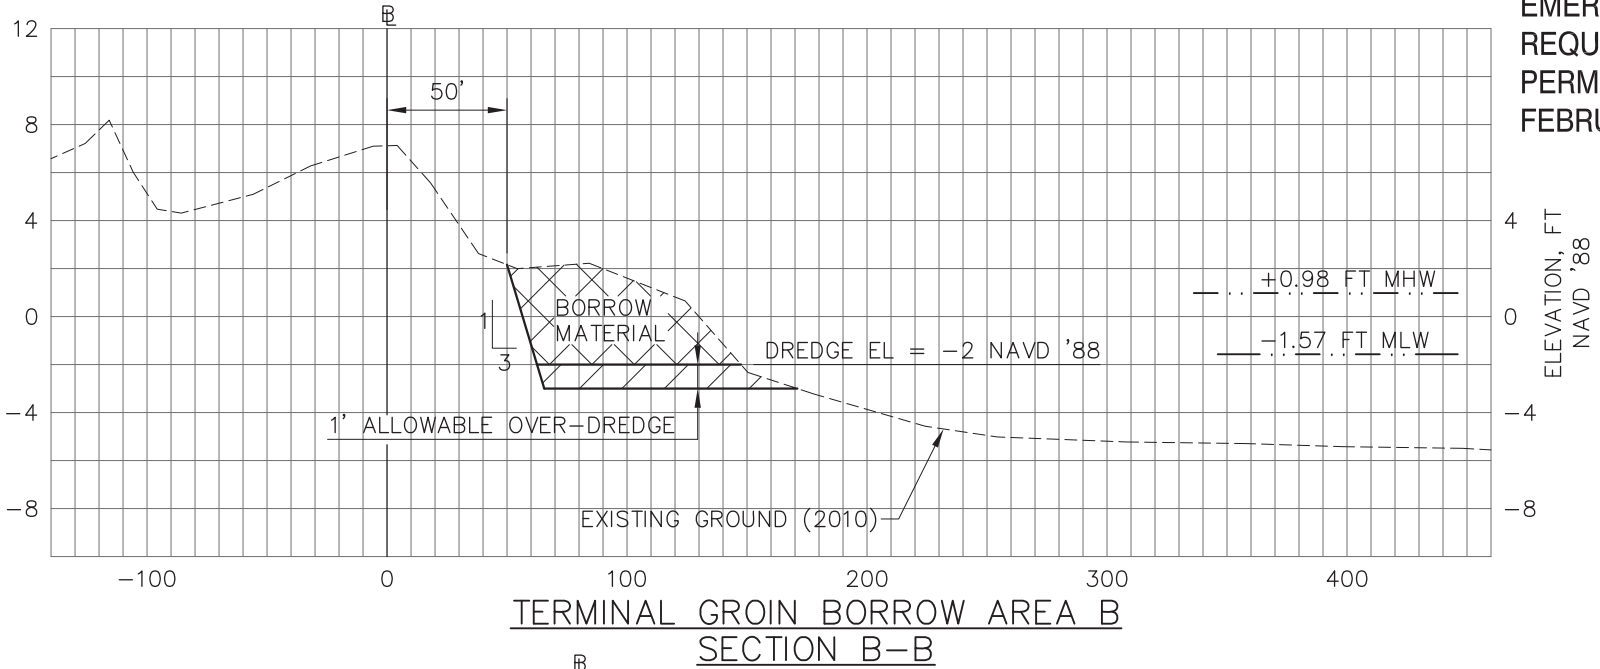
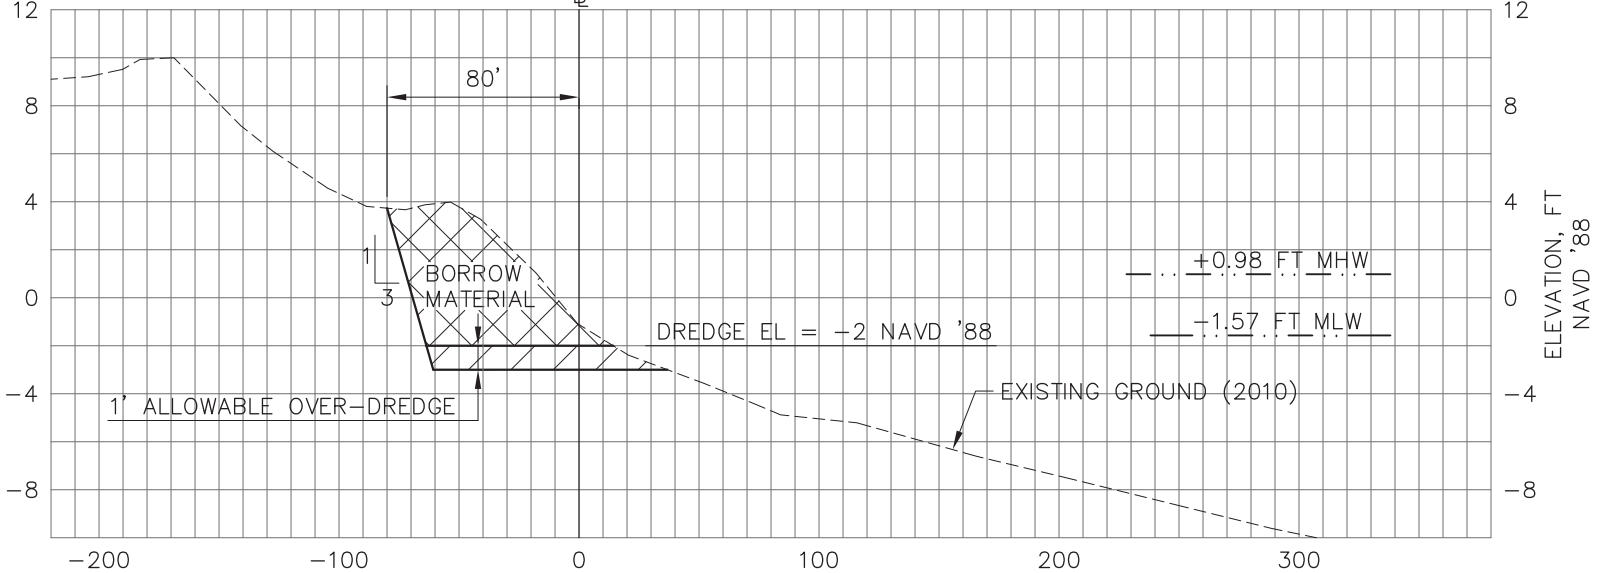
TERMINAL GROIN BORROW AREA B
 SECTION B-B

800 BLOCK BORROW AREA
 SECTION C-C

SEE FIGURE 32
