FINAL REPORT

Survey for Protected Freshwater Mussels in Fishback Run and Tributaries to the Rappahannock River Associated with a Housing Development in Culpeper County, Virginia

Braven B. Beaty & Caitlin S. Carey
Daguna Consulting, LLC
7509 Pin Oak Circle
Bristol, VA 24202

August 19th, 2024

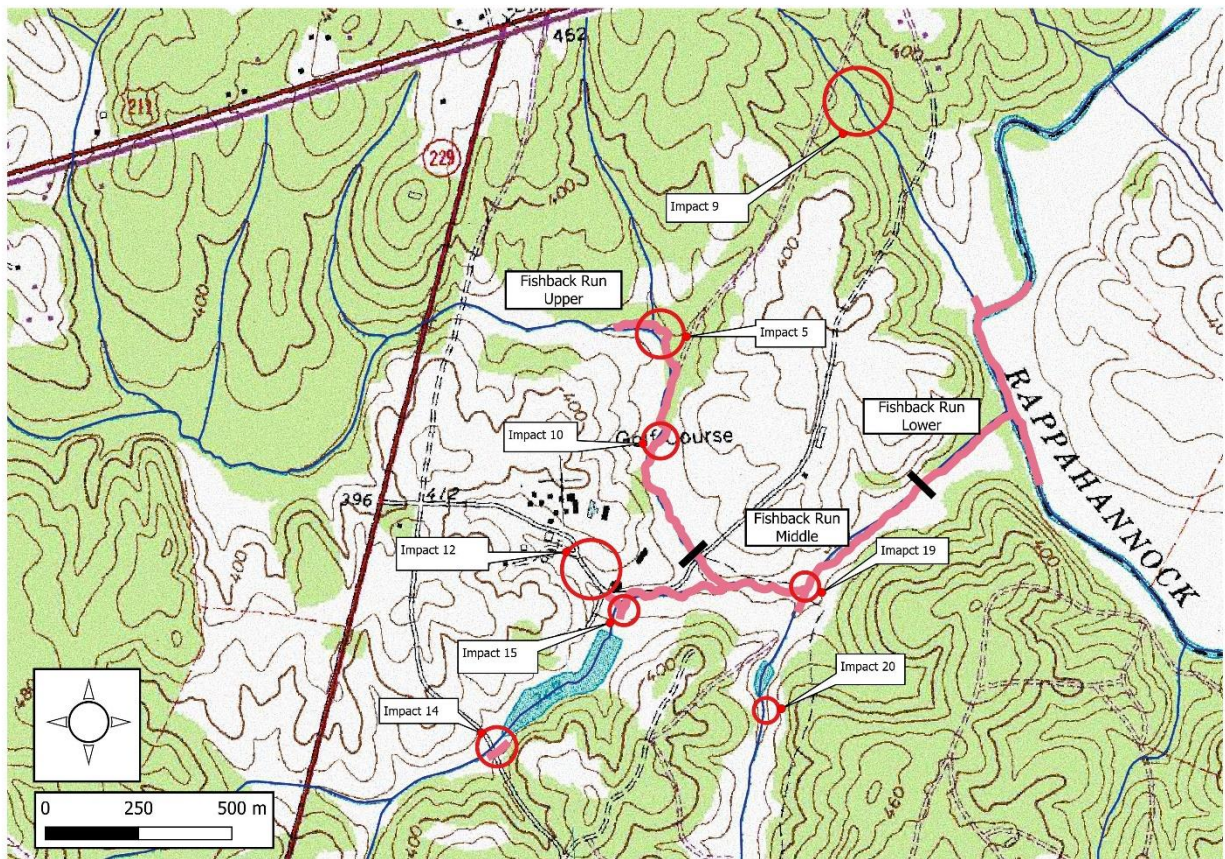
Figure 1. Topographic map showing the survey area with the searched reaches in pink and the impact areas shared by WSSI as red circles. Solid blue lines indicate streams generated by the NHD High Resolution hydrology data layer. The two black lines indicate the Fishback Run reach separations as described in the text (lower, middle, and upper).

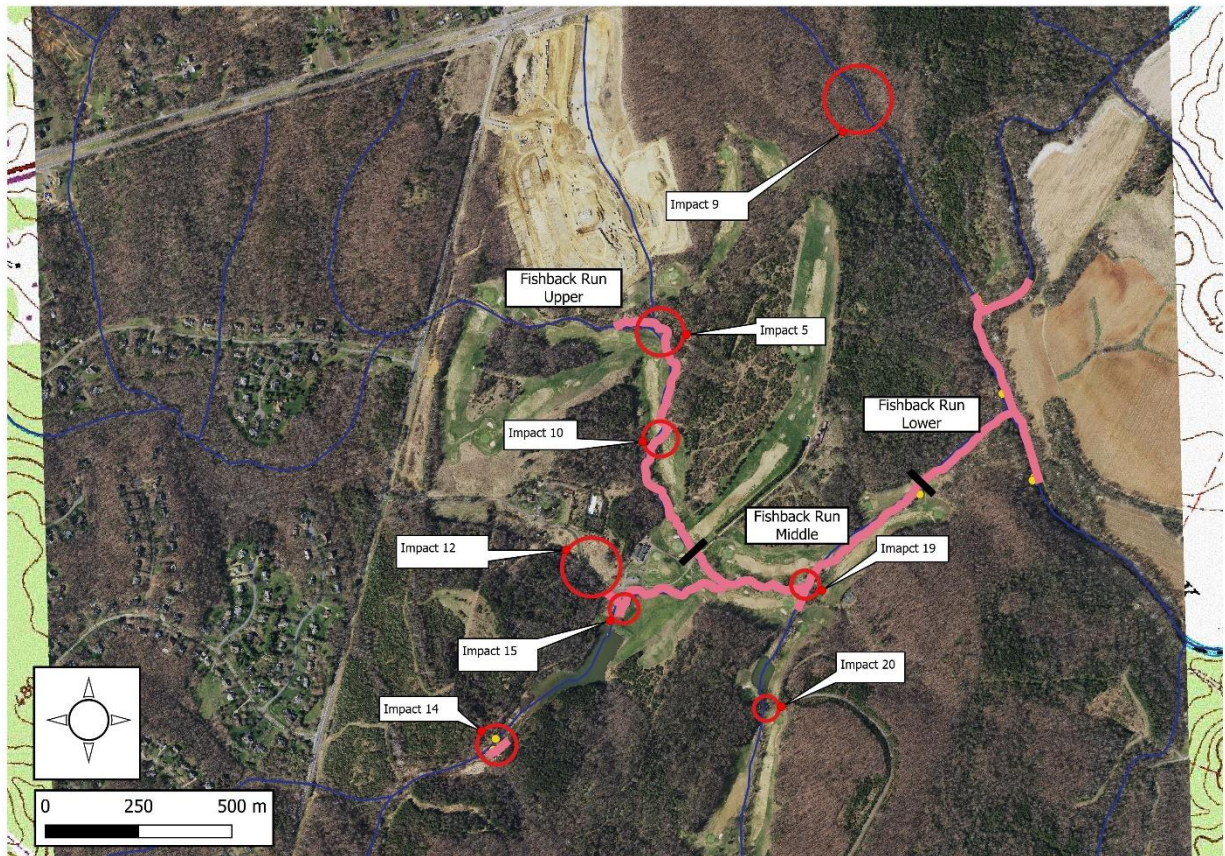
Figure 2. Aerial map showing the survey area with the searched reaches in pink and the impact areas shared by WSSI as red circles. Solid blue lines indicate streams generated by the NHD High Resolution hydrology data layer. The two black lines indicate the Fishback Run reach separations as described in the text (lower, middle, and upper).

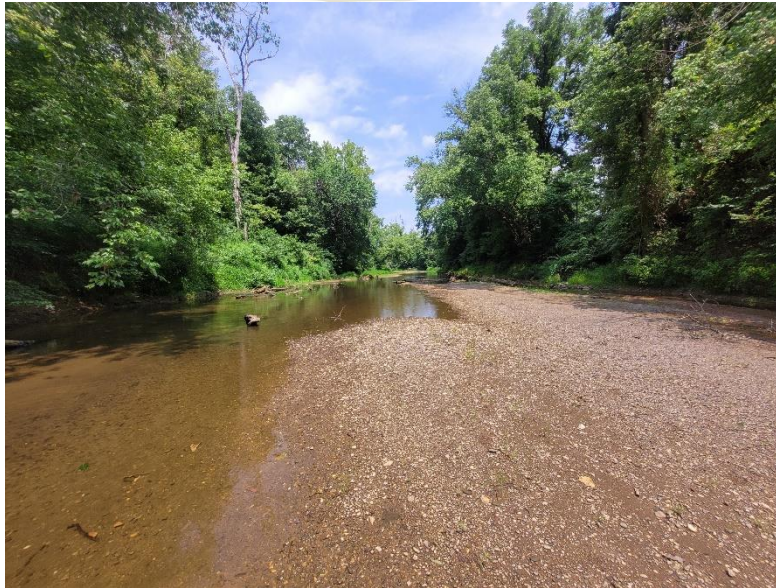
The Rappahannock River reach extending from 200 m downstream of the Fishback Run confluence to 460 m upstream of the confluence was the largest stream channel surveyed. The immediate riparian zone was primarily forested along the left-ascending bank and a thin wooded strip along the right-ascending bank ranging from 15–30 m wide with agricultural field beyond this strip (Fig. 2). The banks were steep and high, often 3–4 m above current water level (Fig. 3). Severe erosion was apparent along both banks even though trees were present along the bank tops. The channel was deeply incised. The wetted area extended the full width of the channel over approximately half the surveyed length. The remainder was characterized by sand bars with occasional boulders. The substratum was dominated by sand and silt with very little cobble/gravel substrate and only a modest amount of woody debris. The most downstream 100 m exhibited somewhat more gravel and cobble. The riverbed was unstable and moved readily underfoot while wading. Substrate composition was estimated at 80% sand, 17% silt, 2% woody debris, and less than 1% of gravel and cobble. Nutrient enrichment was evident throughout the surveyed reach with prevalent algal growth and invasive aquatic vegetation (tentatively identified as Hydrilla or Elodea) over more than 20% of the substratum (Fig. 4). However, upstream of the direct unnamed tributary the channel changed character with more gravel and cobble substrata, less algal growth, and greater sinuosity within the bank width. The channel bankfull width was uniformly

Figure 3. Rappahannock River in the surveyed reach showing the sand substratum, steep banks, and a typical sand bar.

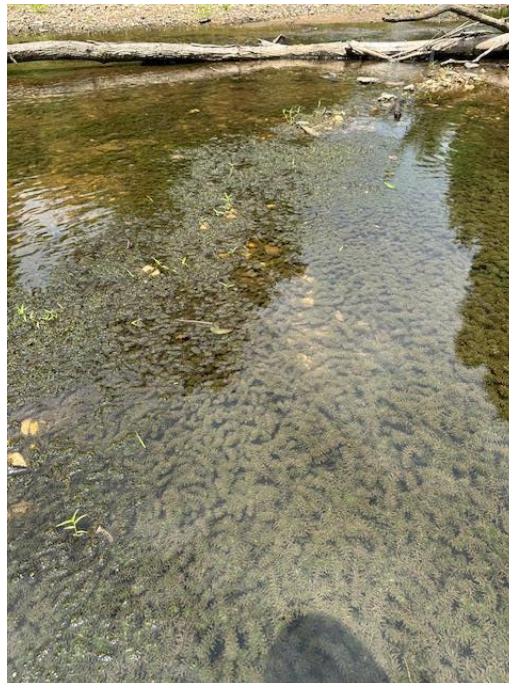
Figure 4. Dense aquatic macrophyte bed in the surveyed Rappahannock River reach. This was identified as either Hydrilla or Elodea.

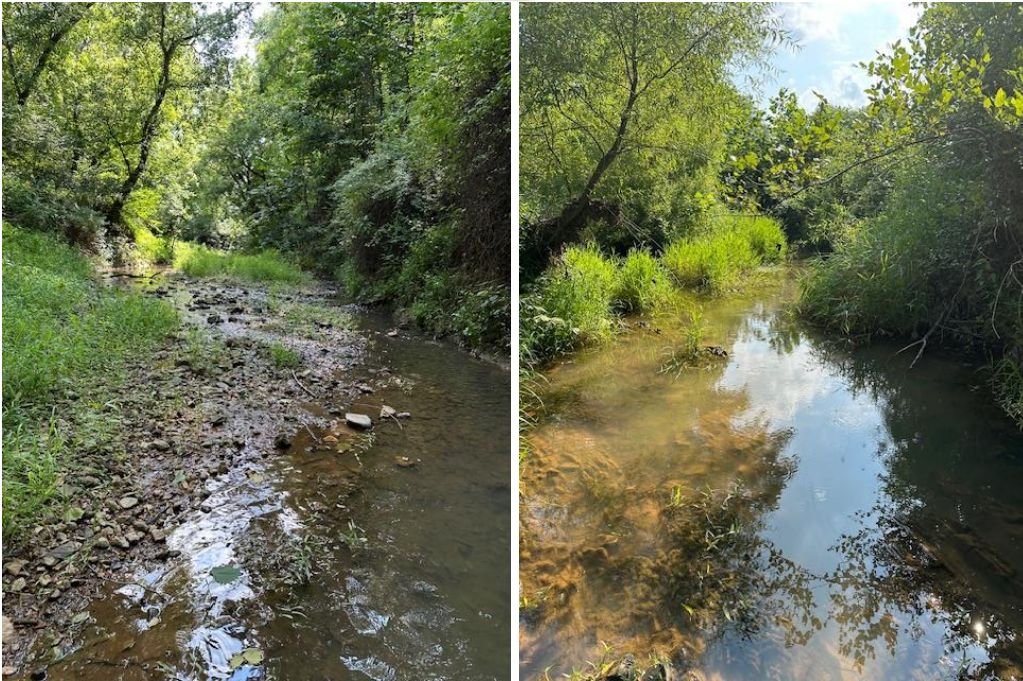
Fishback Run (lower) from its confluence with the Rappahannock River upstream to the first golf cart crossing (Fig. 5) was an approximately 290 m, 3rd-order stream through a mostly forested landscape. The mean wetted width was 4–5 m, reaching a maximum of 7 m. Bankfull width varied from 1–4 m greater than wetted widths, and was typically greater than 1.5 m. The channel was highly incised as evidenced by the (mostly) tall, steep banks and frequent erosion. Bank height was 2 m above the water level throughout most of the surveyed reach. Mean water depth was 0.3 m, reaching 0.7 m at the deepest. As mentioned above, this flow followed overnight rain so may be slightly elevated from typical baseline. The substratum was comprised of 30% bedrock, 15% gravel, 15% cobble, and 40% sand/silt with a little cobble mixed in. The riparian zone was almost entirely forested.

Figure 5. Photographs of the Fishback Run lower reach showing the varied habitats including the channel incision, invasive macrophyte beds, and the limited gravel/cobble substrate.

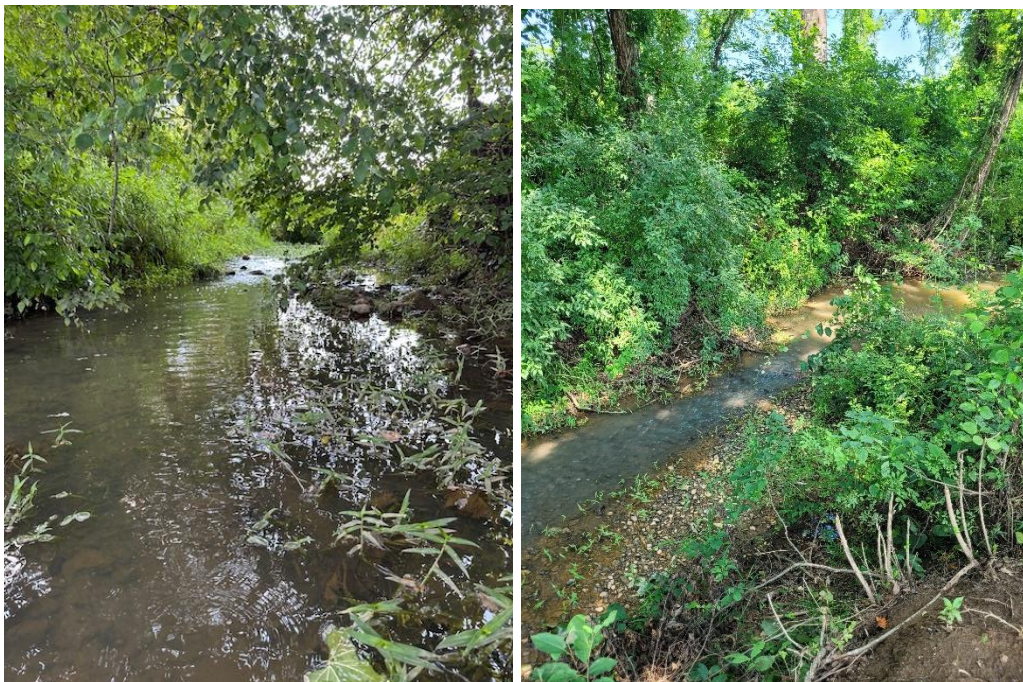
Fishback Run (middle), from the first golf cart crossing to the first impact zone and upstream of the pond drain confluence, while still third order was narrower than the previous reach. The wetted width ranged from 1–5 m with a mean of 3 m. Bankfull widths were 1–3 m greater than wetted widths. The banks were mostly steep and high, ranging from 1–2 m above the water level. The channel exhibited some sinuosity within the channel confinement, focused in higher velocity areas where the wetted width was narrower. The substratum composition remained 30% bedrock, 15% gravel, 10% cobble, and 45% sand/silt (Fig. 6). However, approximately 30% of the substrate was occupied by aquatic macrophytes including water willow and hydrilla or elodea, particularly densely concentrated in slow velocity areas. Further nutrient enrichment evidence included extensive surface algae growth even though little filamentous algae was present. Golf balls were numerous in the stream channels within the golf course footprint. The stream was entirely encompassed by the golf course with a thin riparian buffer strip of trees and shrubs. Golf course managers had cut the riparian shrubby cover throughout approximately half of the surveyed length. Much of this cut material was pushed into the stream channel creating further bank instability and increased presence of instream woody debris.

Figure 6. Habitats within the middle Fishback Run surveyed reach.

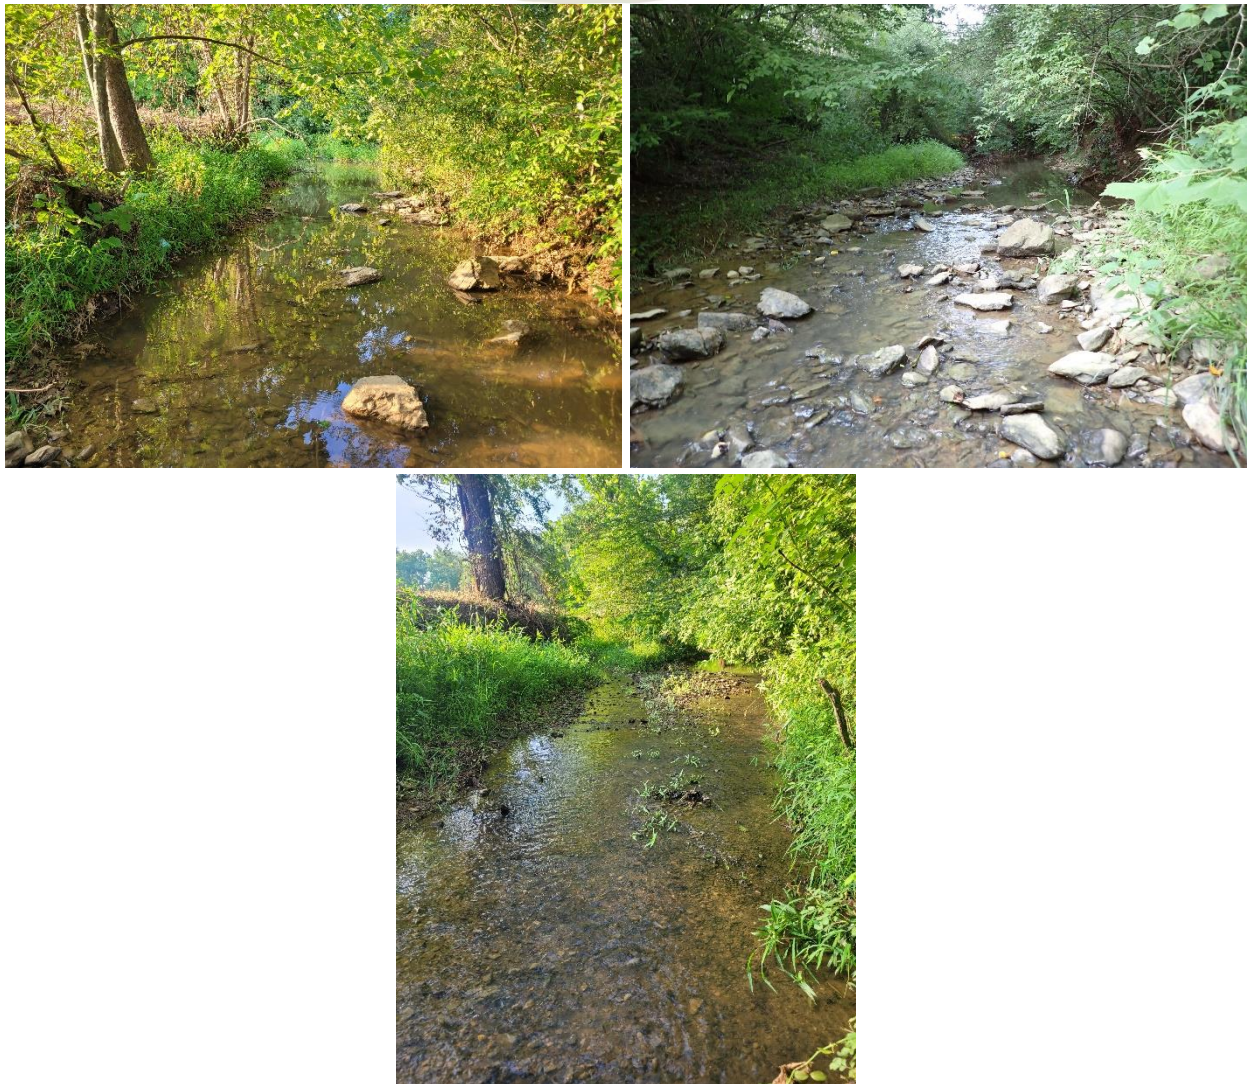
of sand/silt and substrates, and others dominated by boulder and cobble substrates, as well as a few shallow pools (Fig. 7). Depth ranged from 0.1–0.5 m, averaging approximately 0.2 m. The banks remained approximately 1 m high and sloped, creating a bankfull width approximately 6 m greater than the wetted width, which was 3–4 m. The small tributary entering Fishback Run from the right-ascending bank near the third impact zone was too small to provide suitable mussel habitat.

Figure 7. Photographs of the varied habitats in the upper Fishback Run surveyed reach. Note the greater amount of cobble and boulder than Fishback Run reaches farther downstream.

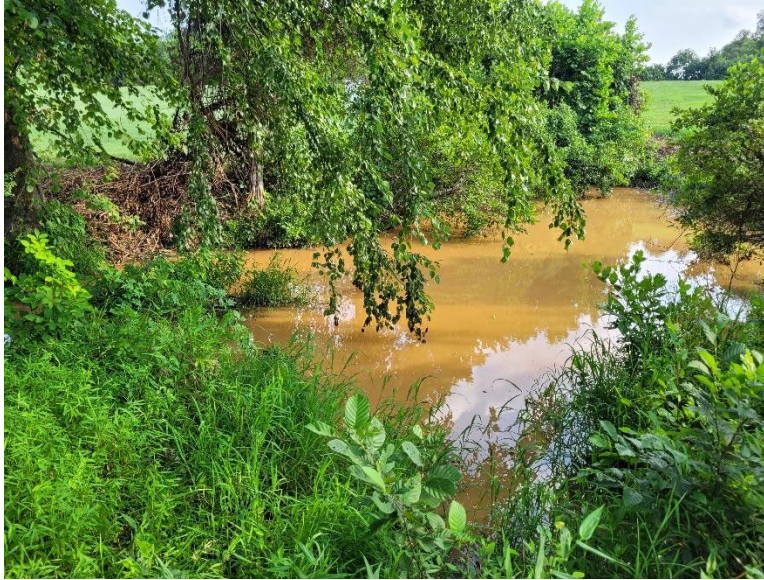
The tributary draining the pond contained marginal habitat for native mussels. There were 3 large stagnant pools (Fig. 8) between Fishback Run and the outflow of the pond dam, one near the confluence with Fishback Run, one near the middle of the reach, and one a little downstream of the dam. The remainder of the channel appeared modified and channelized. Some of the banks were armored with large rocks, a man-made installation, in an attempt to stabilize them (Fig. 9). The banks were generally less than 1 m high and sloped. None of the banks were wooded although a few scattered trees occurred in the immediate riparian zone (Fig. 10). Due to high turbidity in pools, water depth in the pools was indeterminate. Water depth in the remainder of the reach was approximately 0.1–0.3 m. The substratum in flowing parts of this reach was dominated by cobble. Some invasive aquatic vegetation was observed, creating ‘monocultures’. The tributary entering this reach from the right-ascending bank just downstream of impact zone 3 was too small, less than 0.5 m wide, to support native mussels and was deemed unsuitable habitat.

Figure 8. Stagnant pool in the tributary draining the pond. The turbidity of the water prevented estimating depth and searching for mussels.

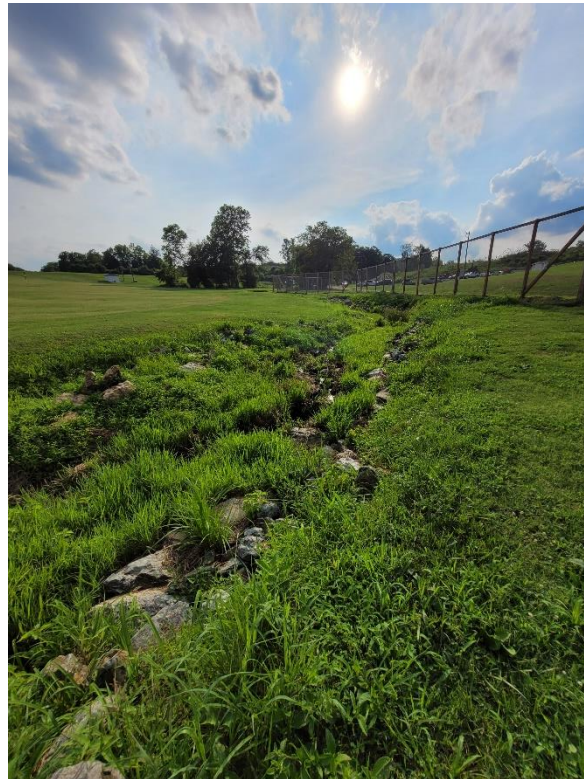
Figure 9. Photograph showing bank armoring with large rocks along the tributary draining the pond.

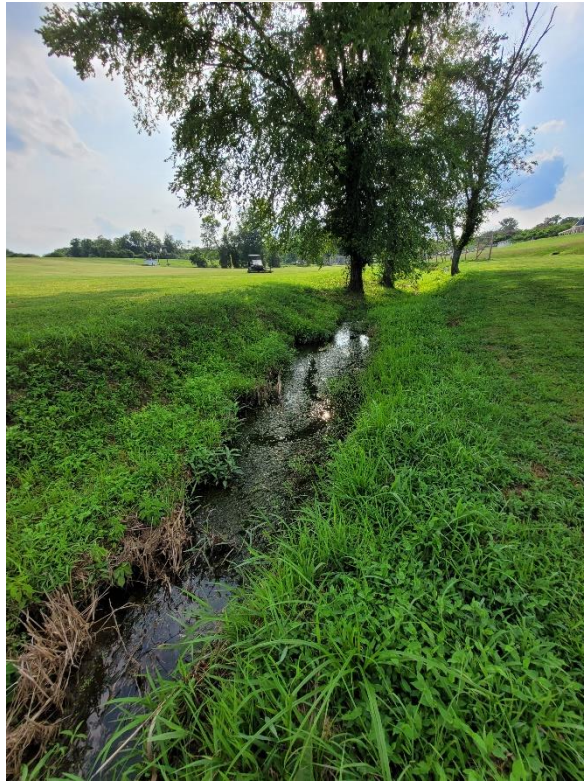
Figure 10. The tributary draining the pond was channelized with gradually sloped and grass covered banks.

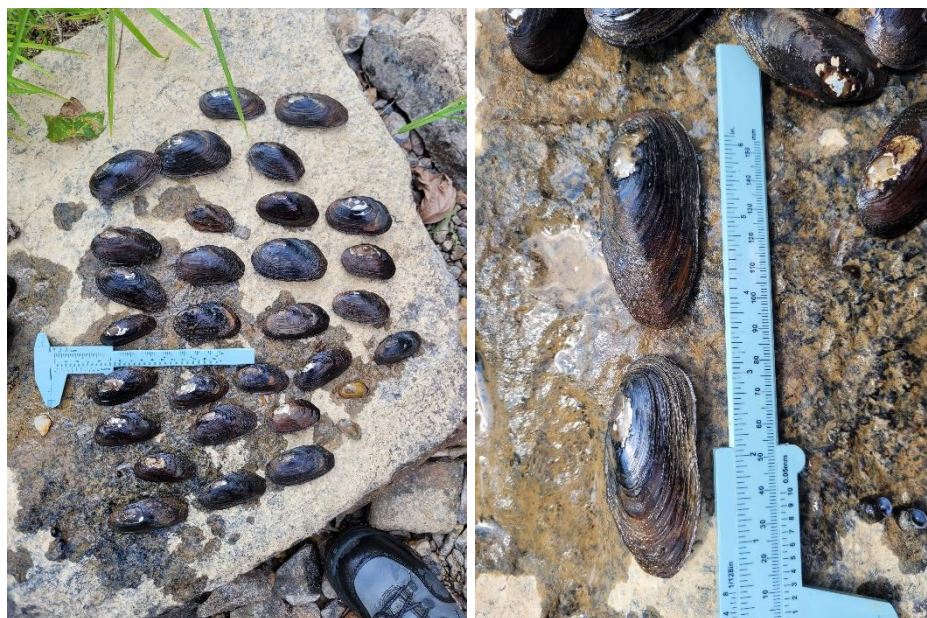
The survey yielded evidence of two mussel species. We observed 47 live Eastern Elliptio (*Elliptio complanata*) and 2 live Northern Lance (*Elliptio fisheriana*) in the Rappahannock River mainstem

Figure 11. Live Eastern Elliptio (*Elliptio complanata*) on left and Northern Lance (*Elliptio fisheriana*) on right observed in the Rappahannock River surveyed reach.

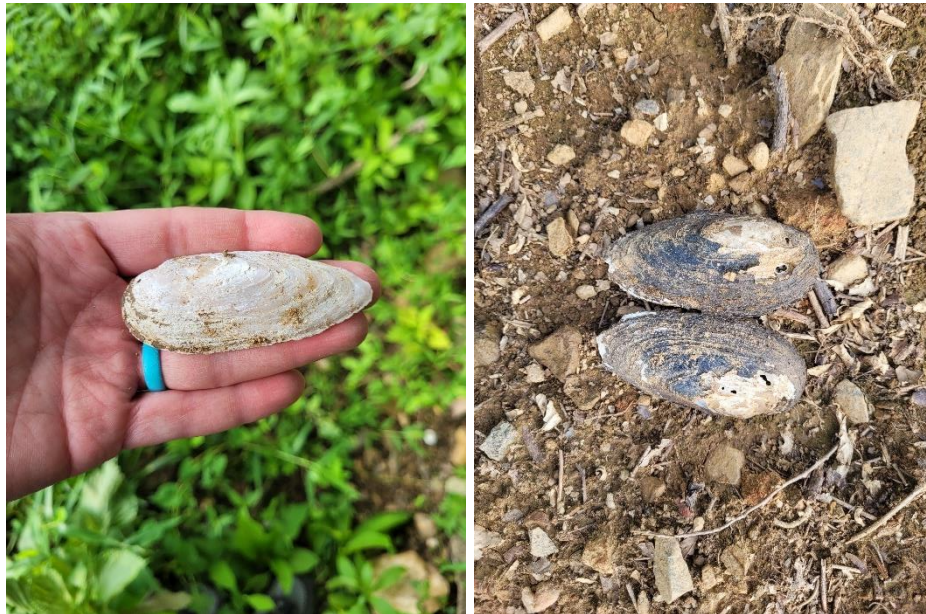
(Fig. 11). The only other location where native mussels were observed was immediately below the outflow of the pond in the unnamed tributary draining the pond where several relic Eastern Floater and Northern Lance shells were detected (Fig. 12). No live mussels were encountered in any of the streams besides the Rappahannock River mainstem. Asian Clams (*Corbicula fluminea*) were present in Fishback Run but were not abundant. Sandy substrates that were disturbed to expose subsurface bivalves did not yield many live Asian Clams.

Figure 12. Relic shells observed in the tributary draining the pond.
