MISCELLANEOUS PAPER GL-87-4

PERIMETER DIKE STABILITY ANALYSES CRANEY ISLAND DISPOSAL AREA, NORFOLK DISTRICT, NORFOLK, VIRGINIA

Geotechnical Laboratory

This publication describes the slope stability analyses and recommended designs for the raised perimeter dikes at the Craney Island disposal area in Norfolk, Virginia.

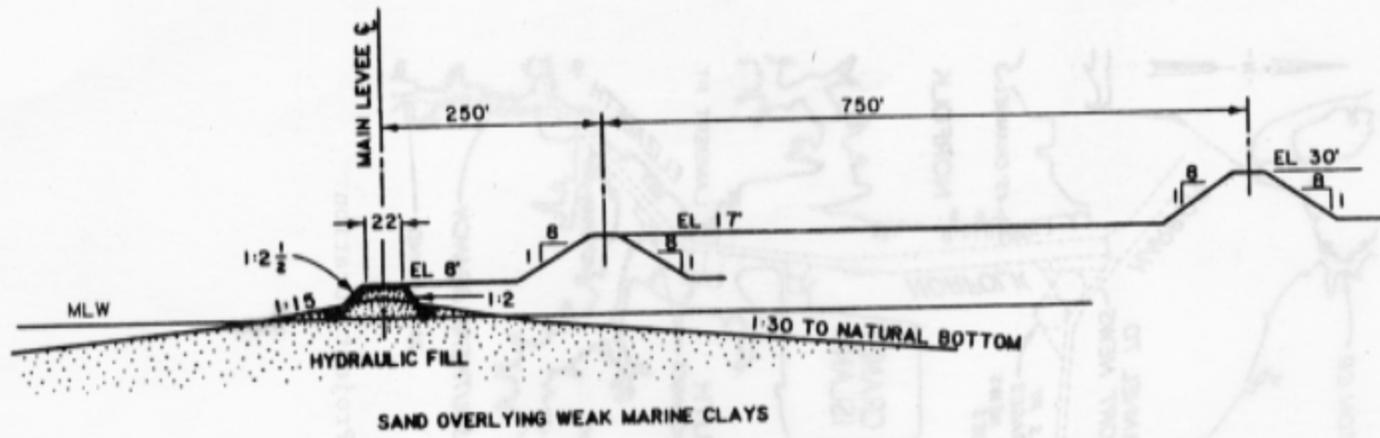
TYPICAL SECTION THROUGH LEVEE
(NOT TO SCALE)

Figure 2. Proposed benched cross-section for west perimeter dike by Norfolk District

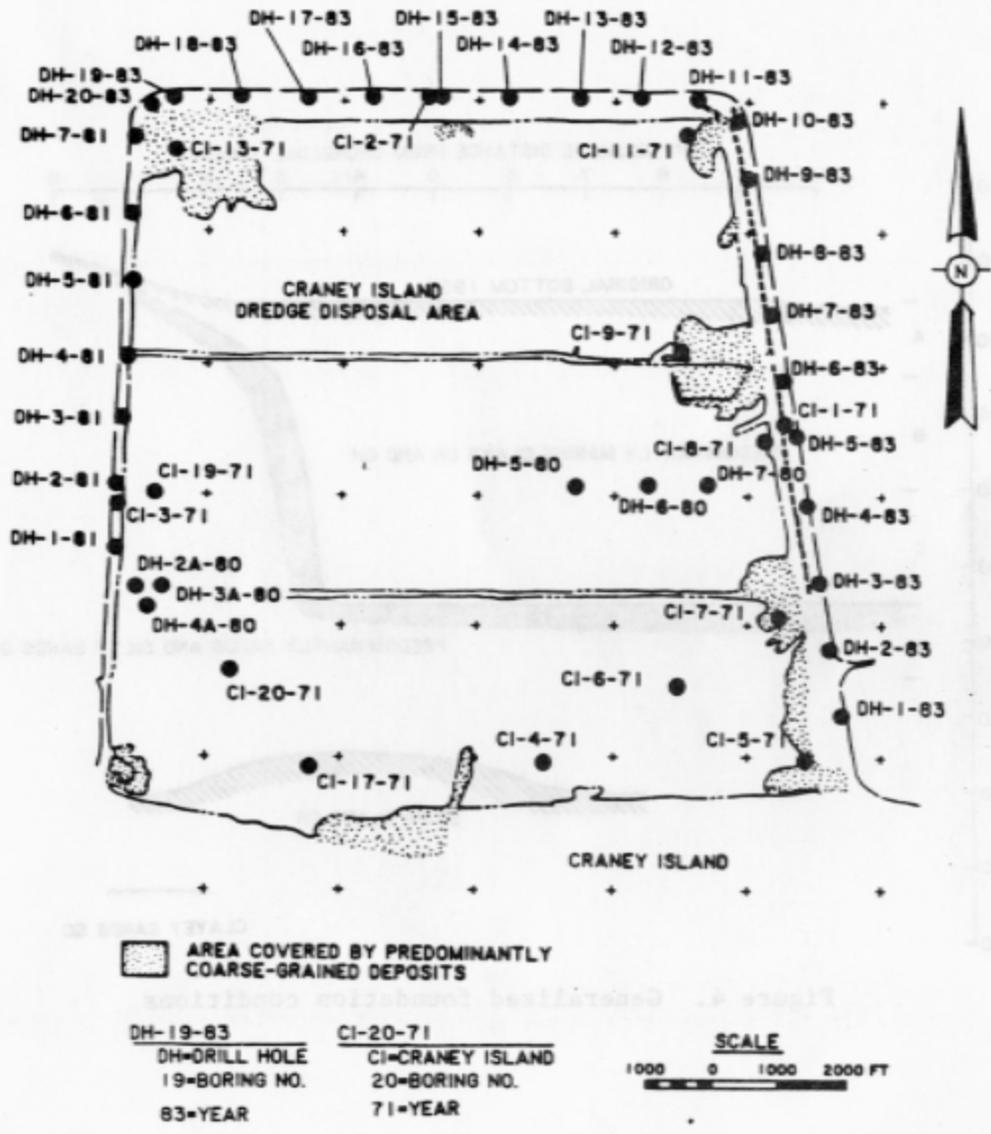
Figure 3. Boring plan and coarse grain material at inflow points

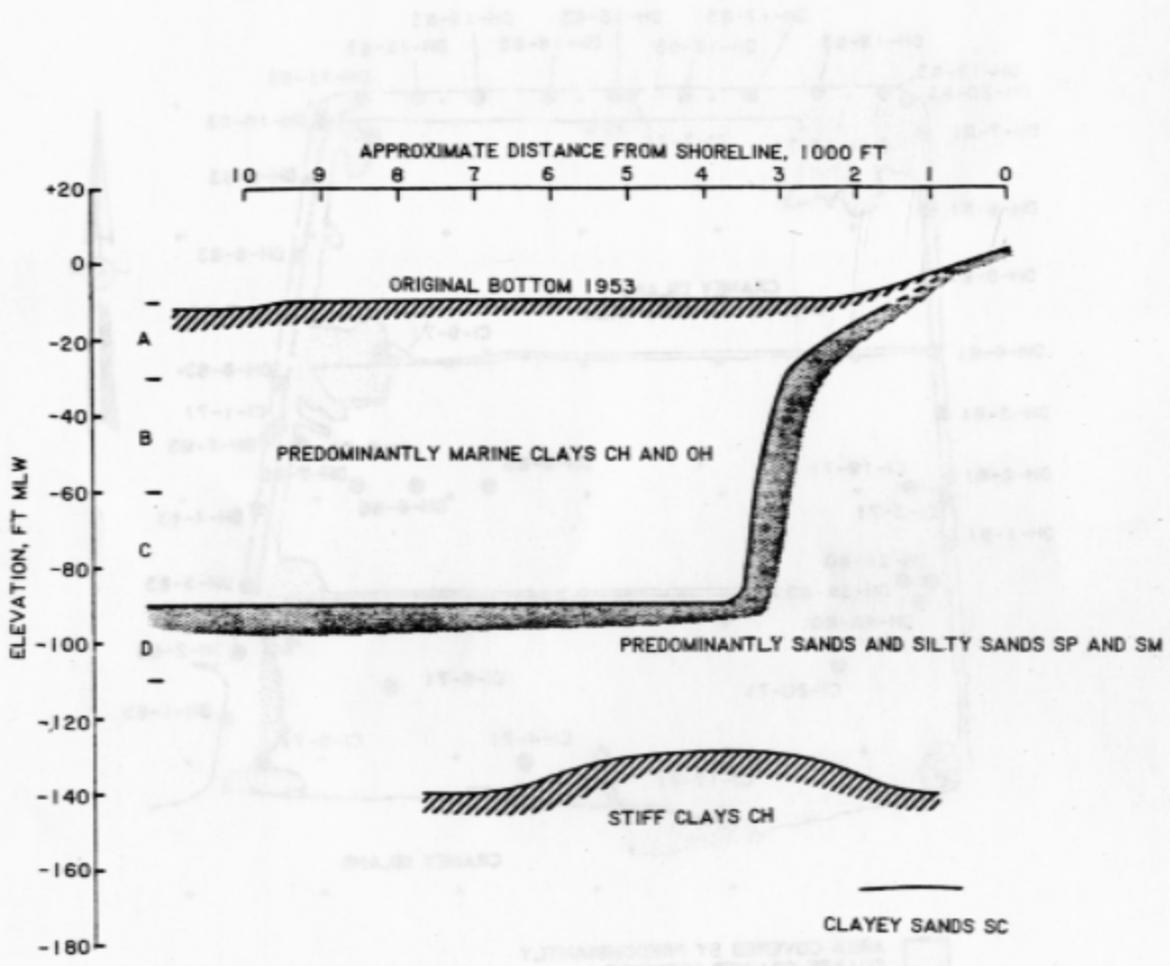
Figure 4. Generalized foundation conditions

26. A generalized plot of the major foundation soil zones is shown in Figure 4 and tabulated in Table 1. Field vane shear strength tests and

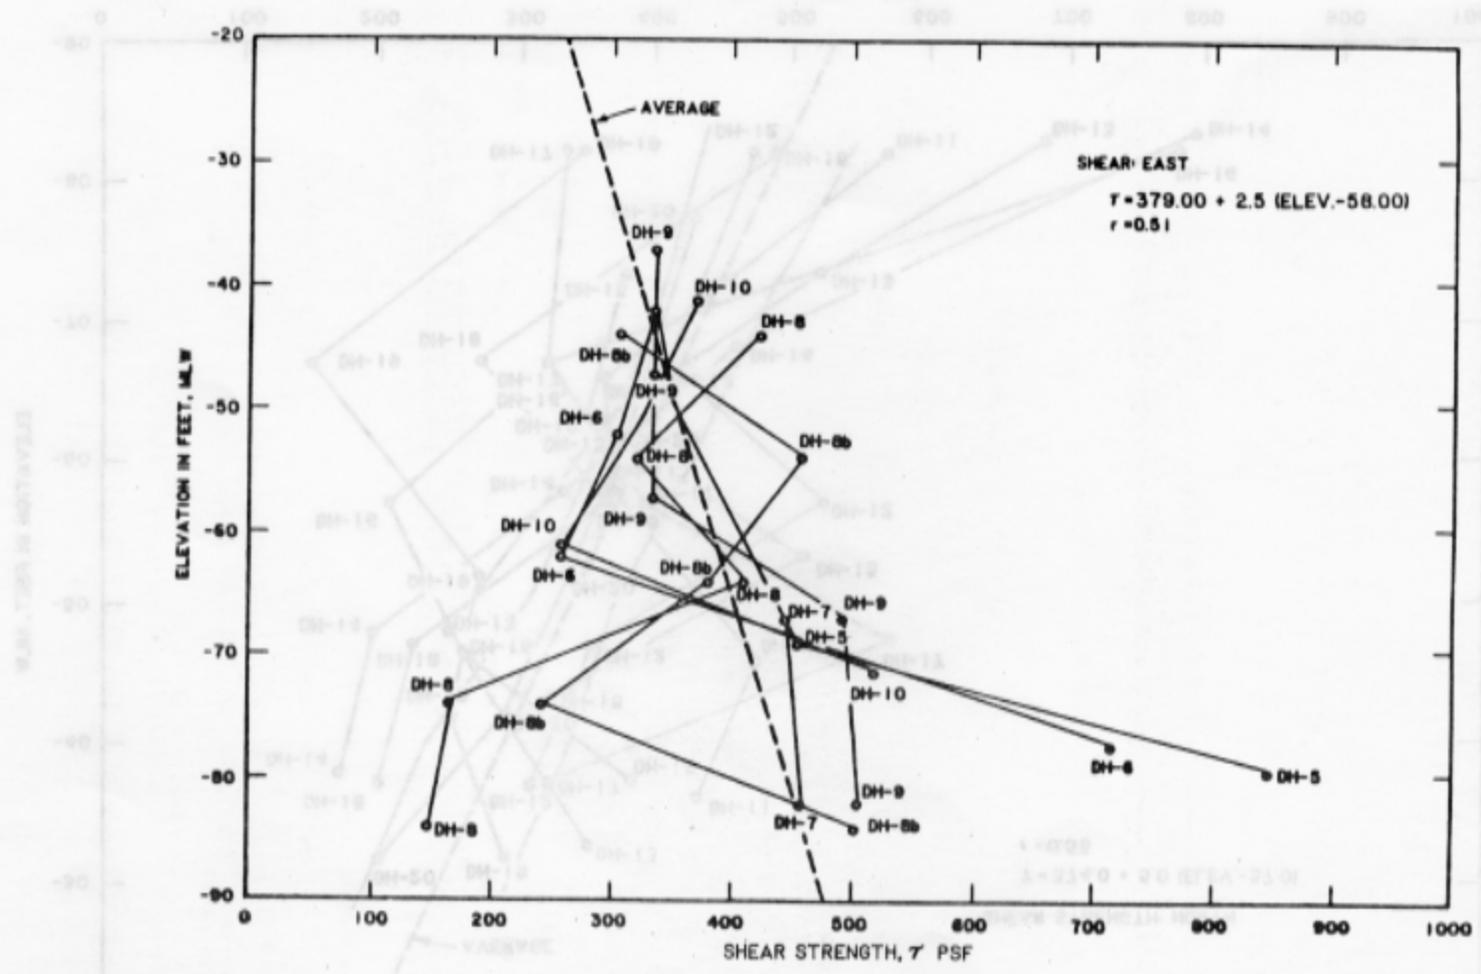
Figure 5. Shear strength versus depth-East

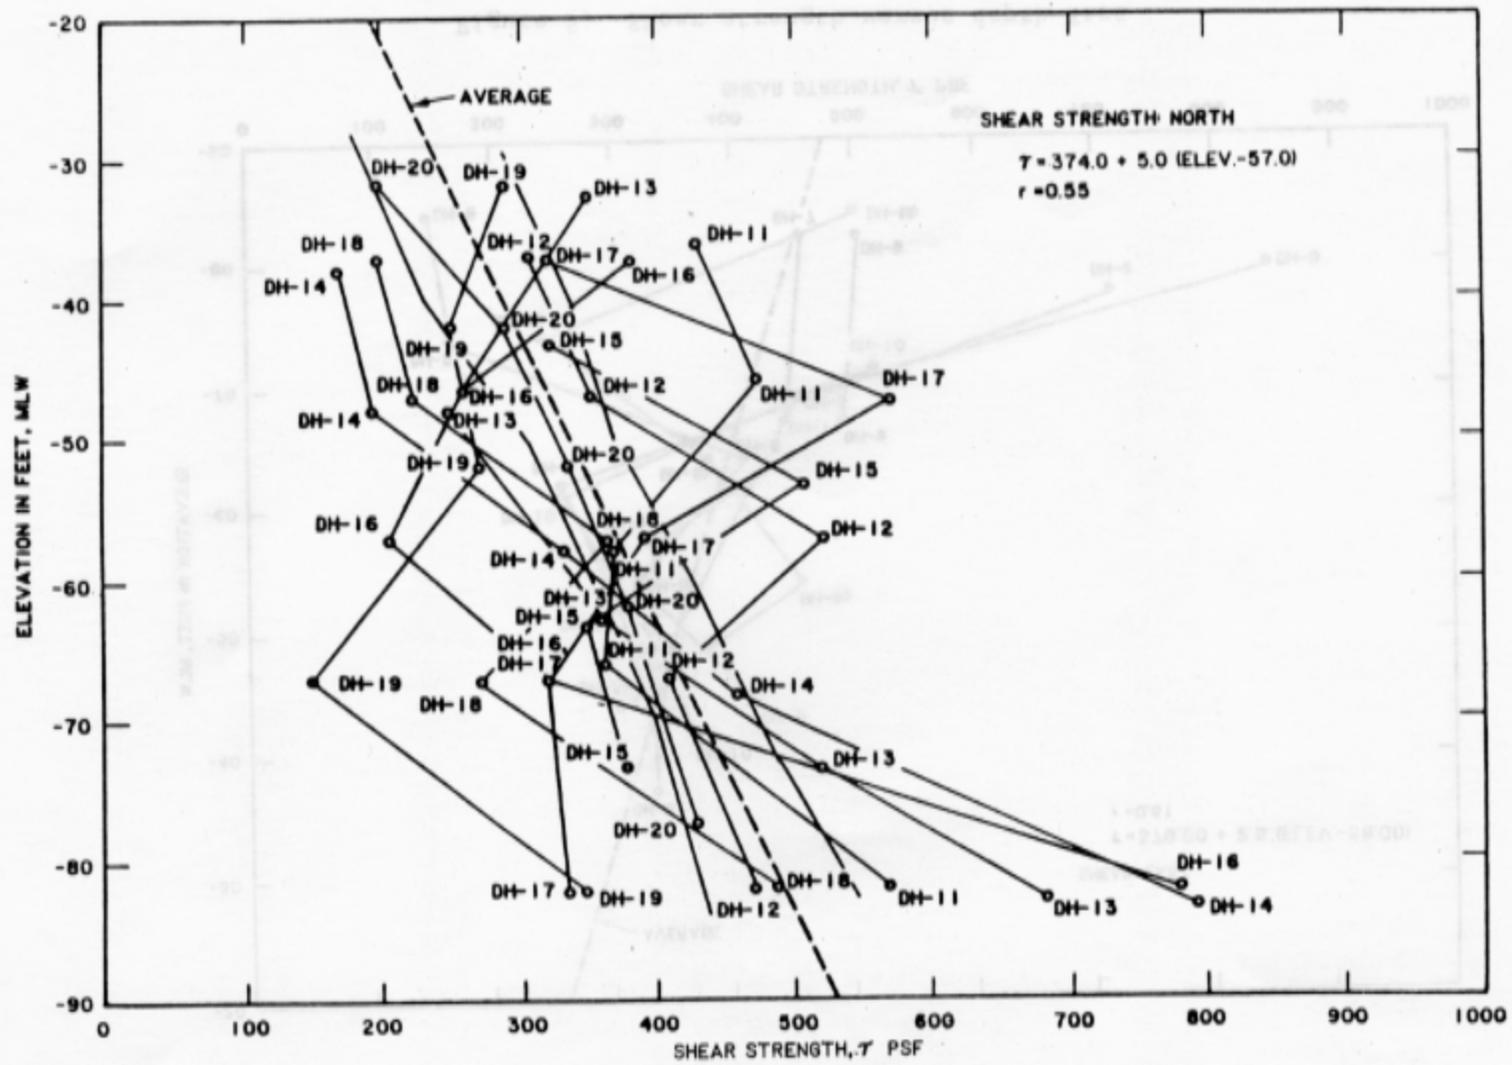
Figure 6. Shear strength versus depth-North

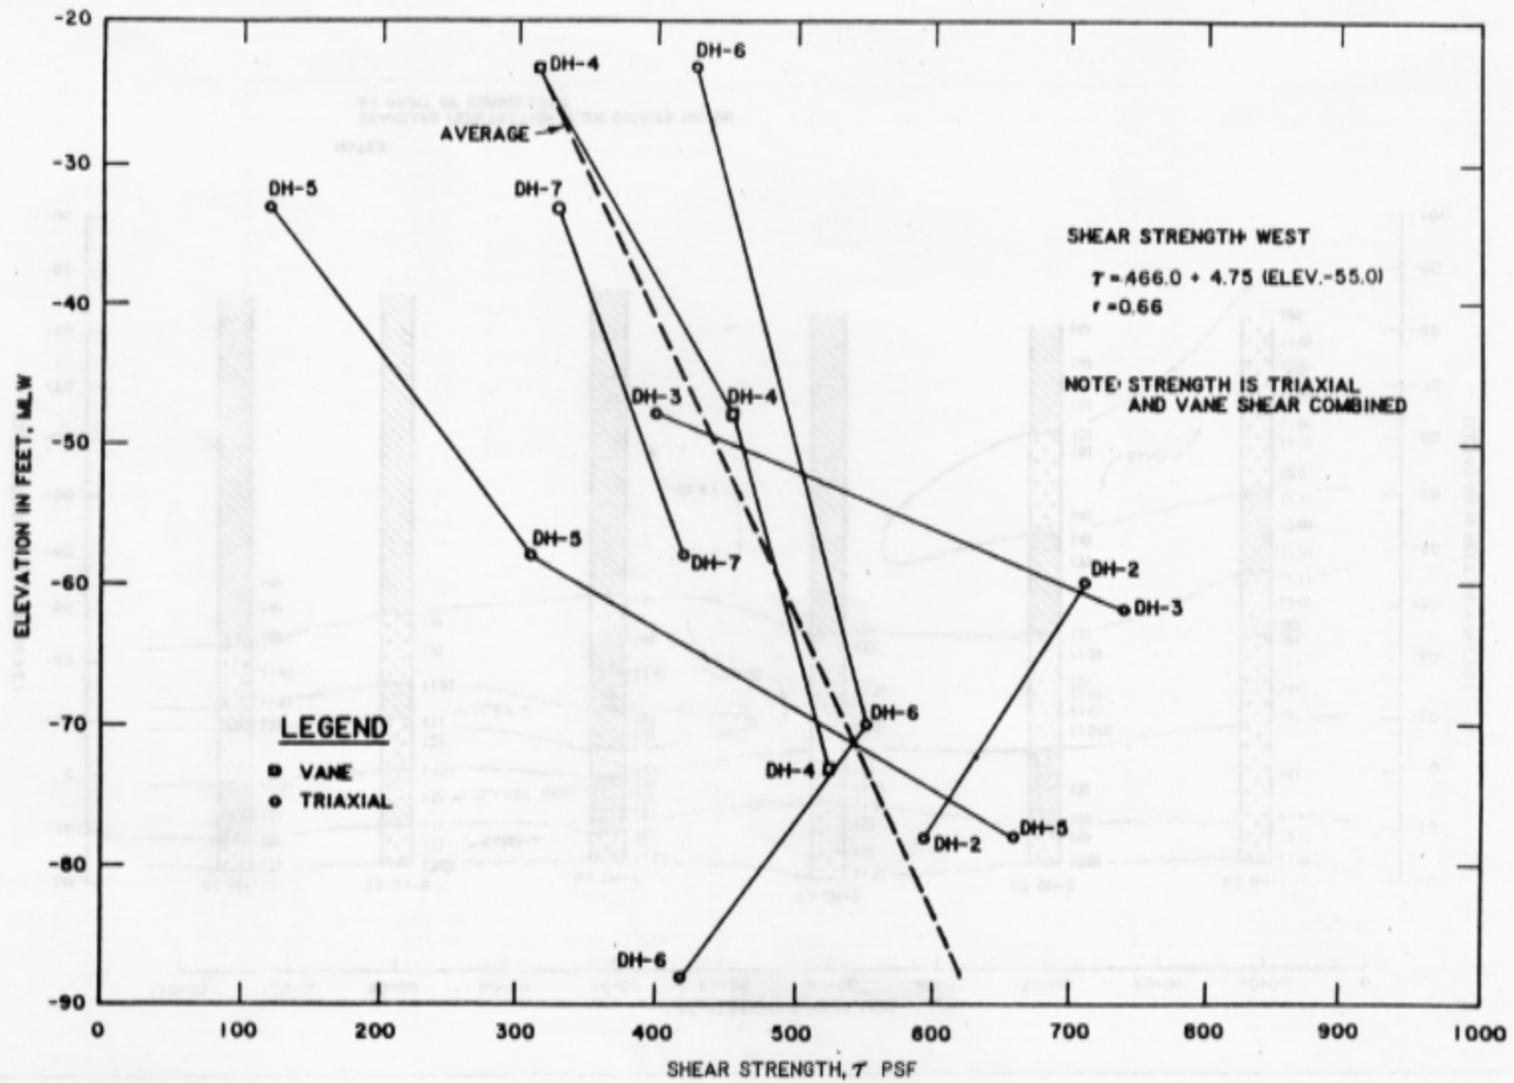
Figure 7. Shear strength versus depth-West

39. The shear strength of the foundation clay was selected based on numerous tests (see Figure 7). There is a large degree of scatter in the data. To evaluate the sensitivity of the selected shear strength, values plus and minus 10 psf, 25 psf, and 50 psf of the selected cohesion parameter were used in the analysis of the recommended design. The cohesion value is assigned to the profile describing the top of the clay. All analyses used the same rate of increase for the cohesion. Figure 29 illustrates the relationship between cohesion and the safety factor.

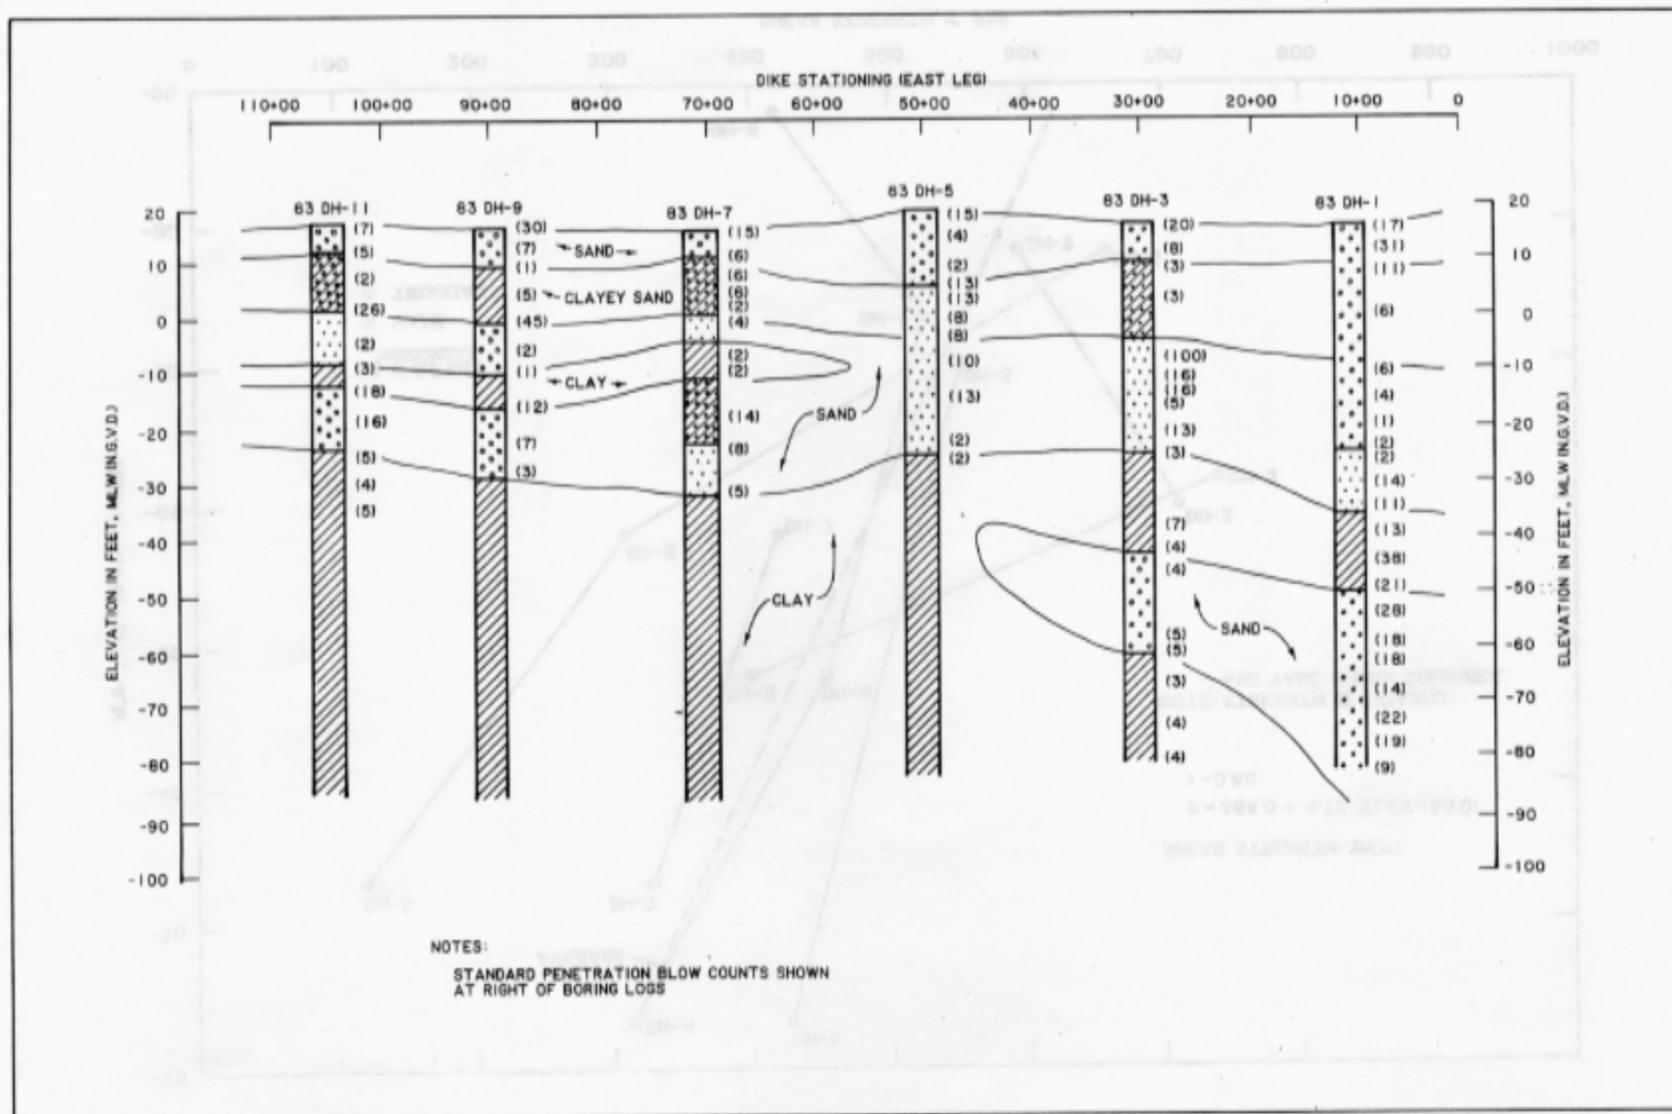
Figure 8. Subsurface profile A-A-east leg

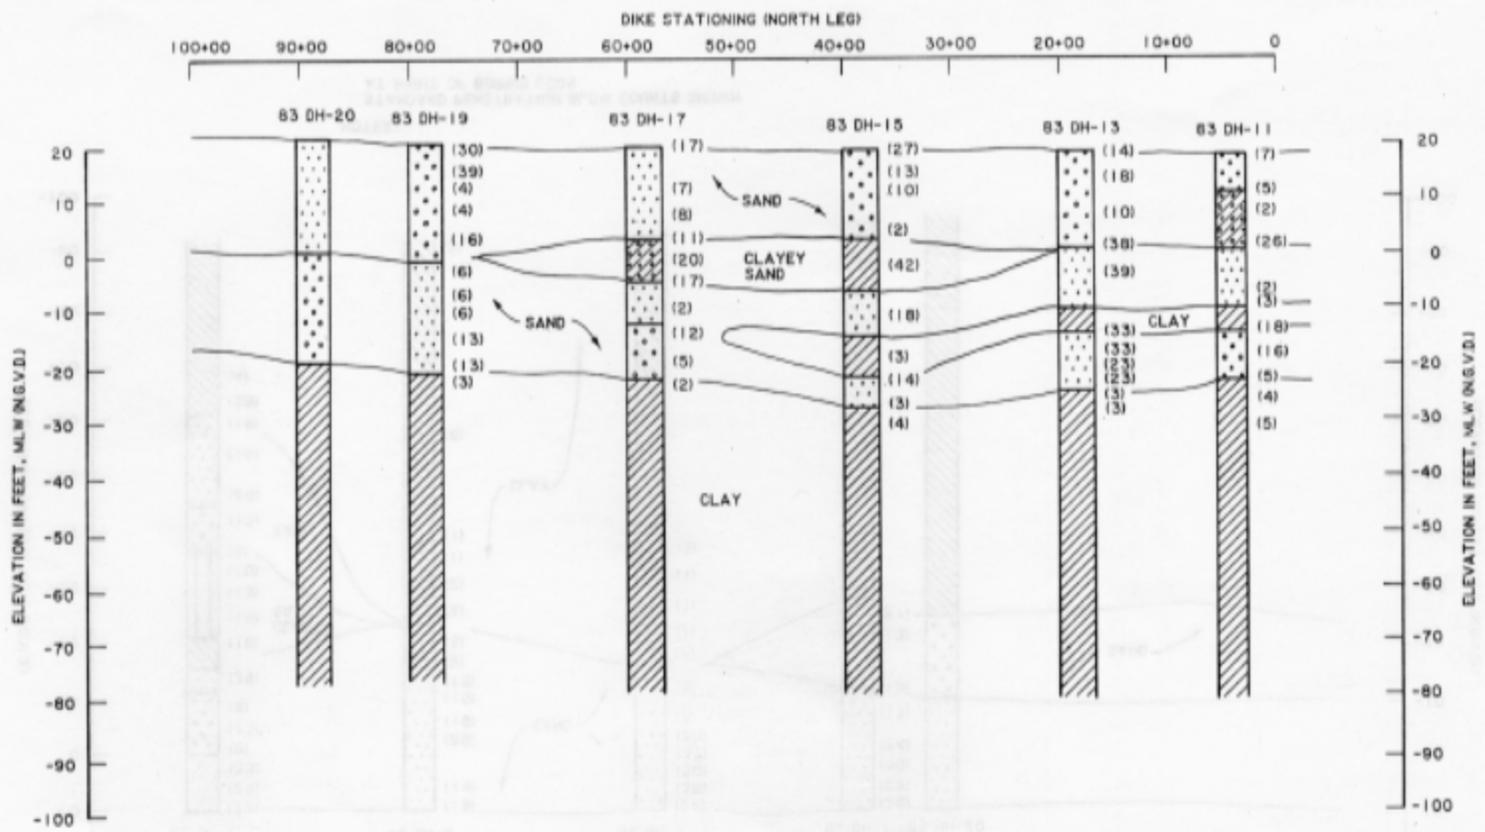
NOTES:
 STANDARD PENETRATION BLOW COUNTS SHOWN
 AT RIGHT OF BORING LOGS

Figure 9. Subsurface profile B-B-north leg

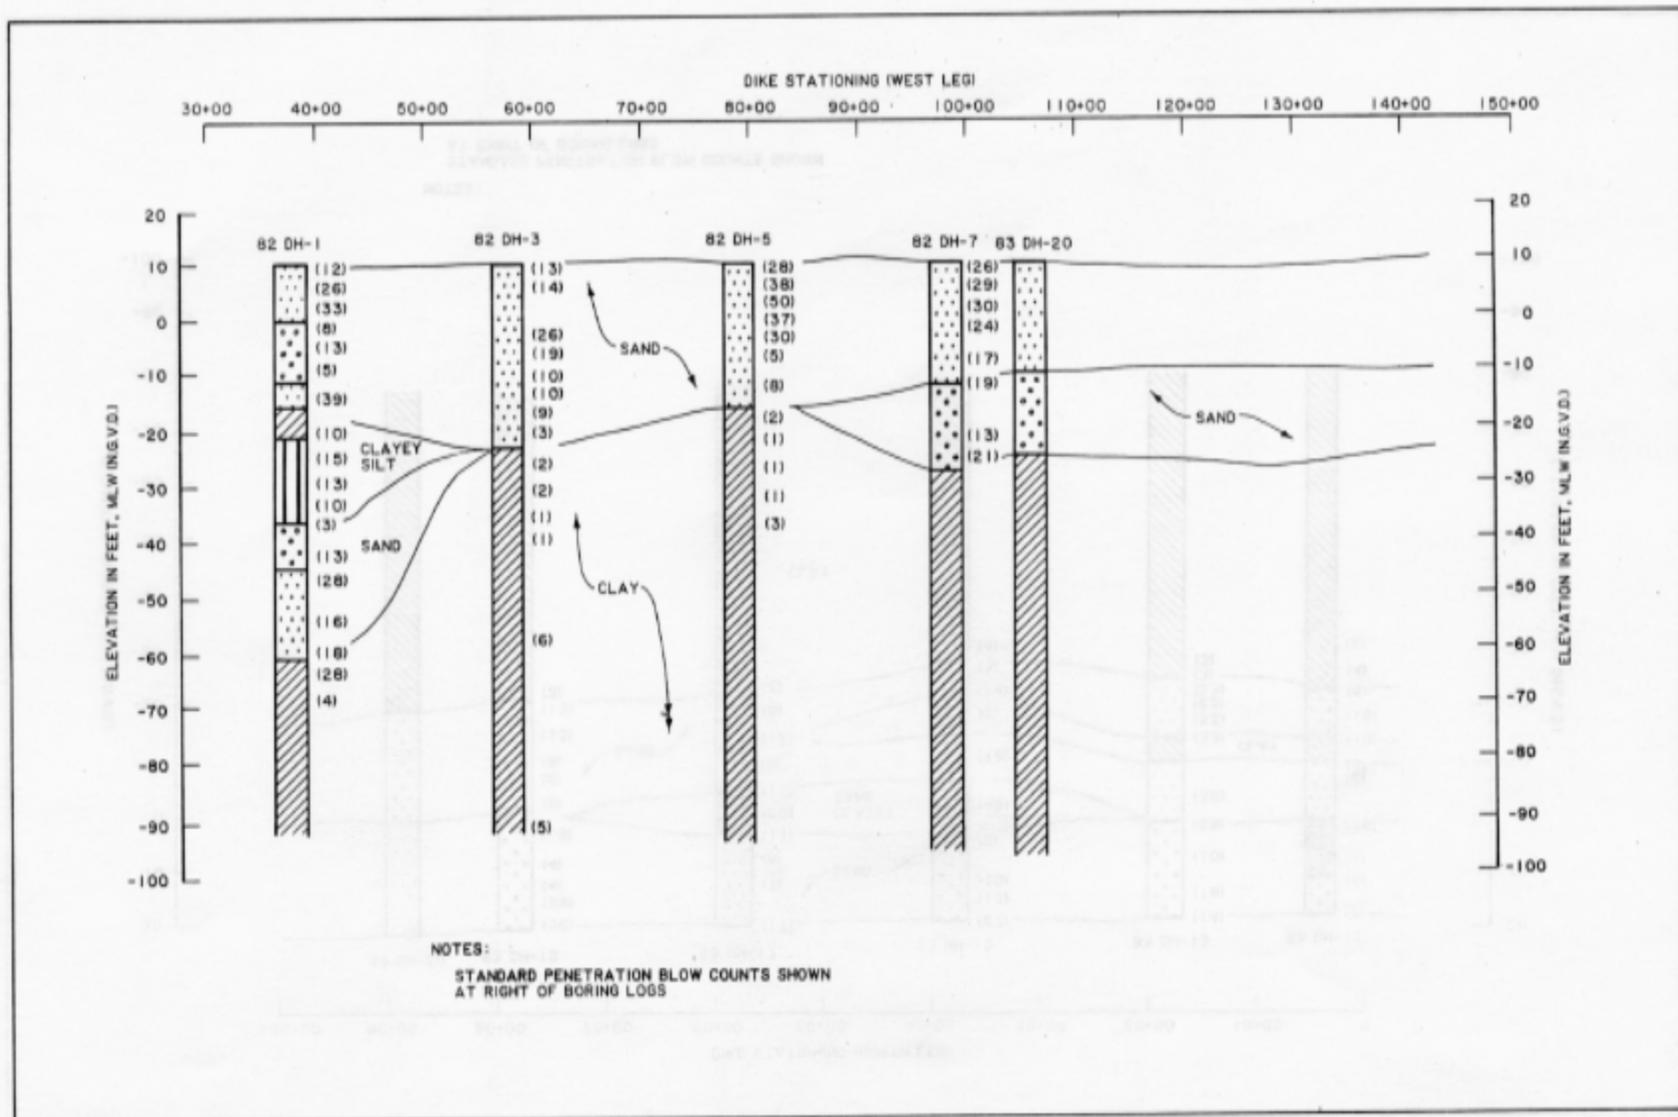
Figure 10. Subsurface profile C-C-west leg

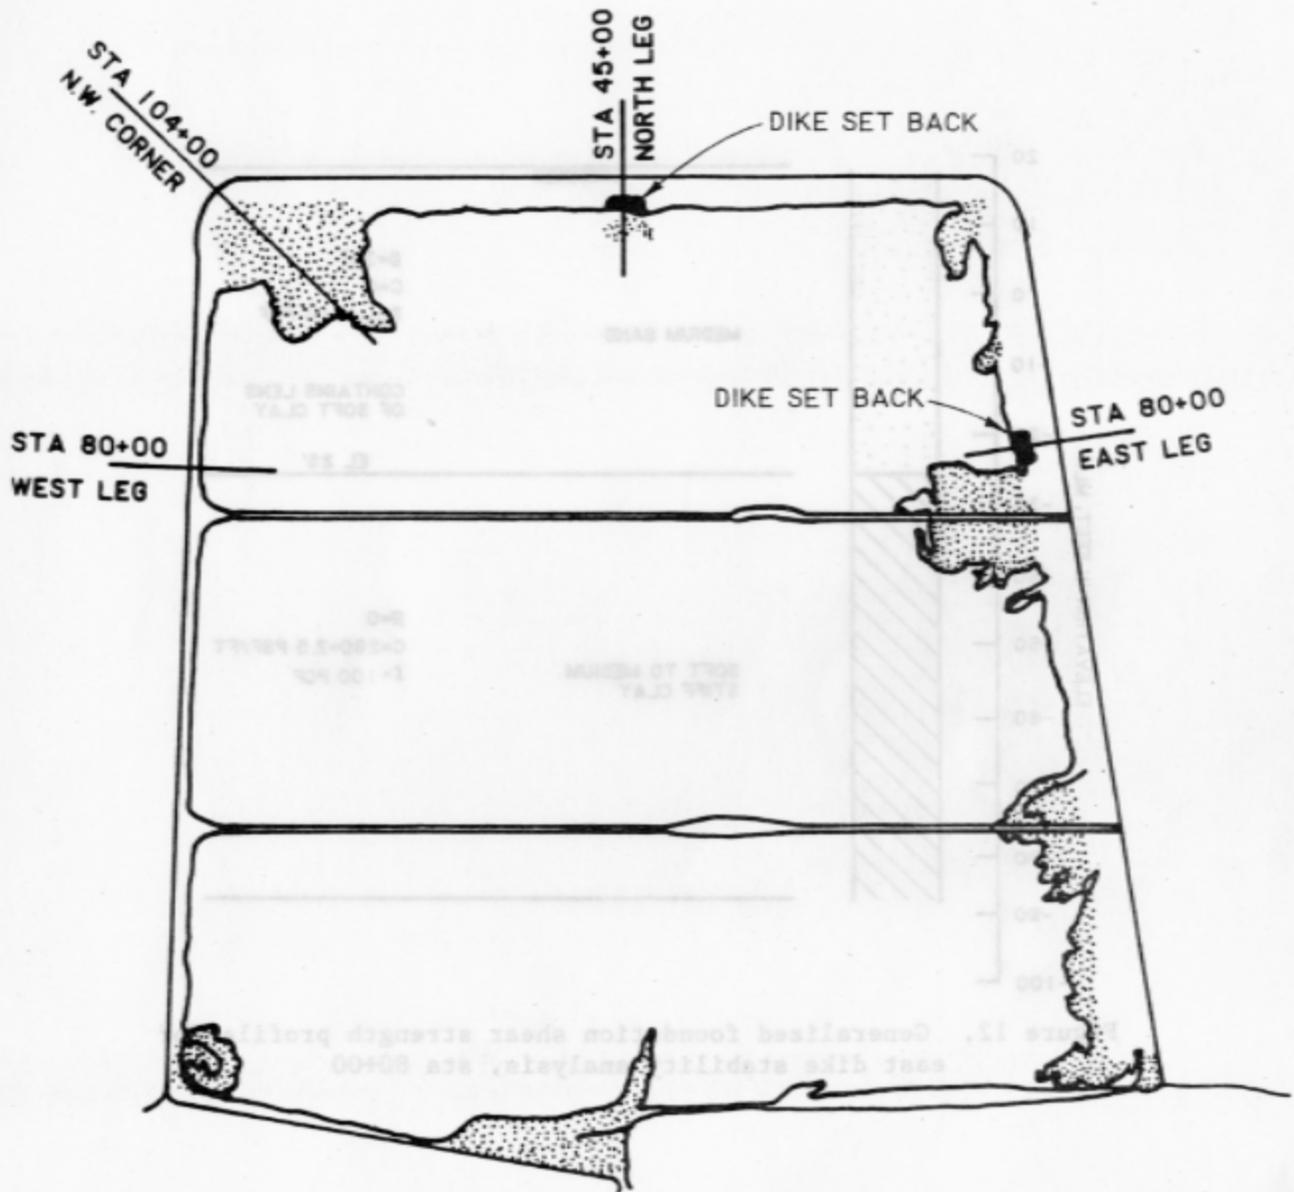
Figure 11. Location of cross section investigated during dike stability analysis

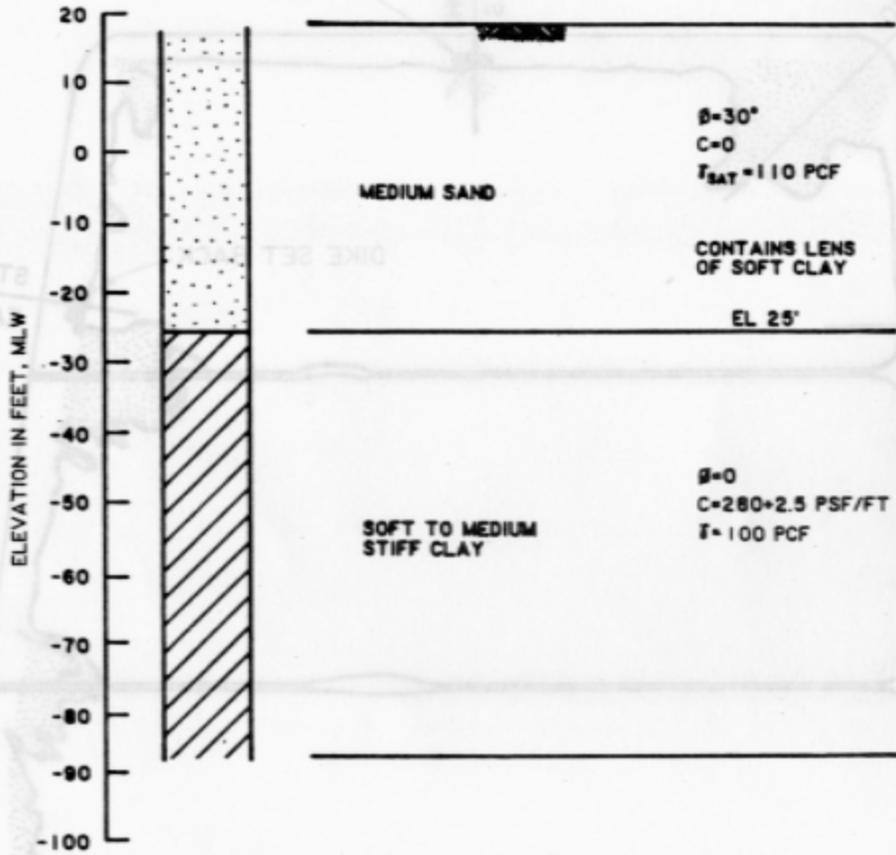
Figure 12. Generalized foundation shear strength profile for east dike stability analysis, sta 80+00

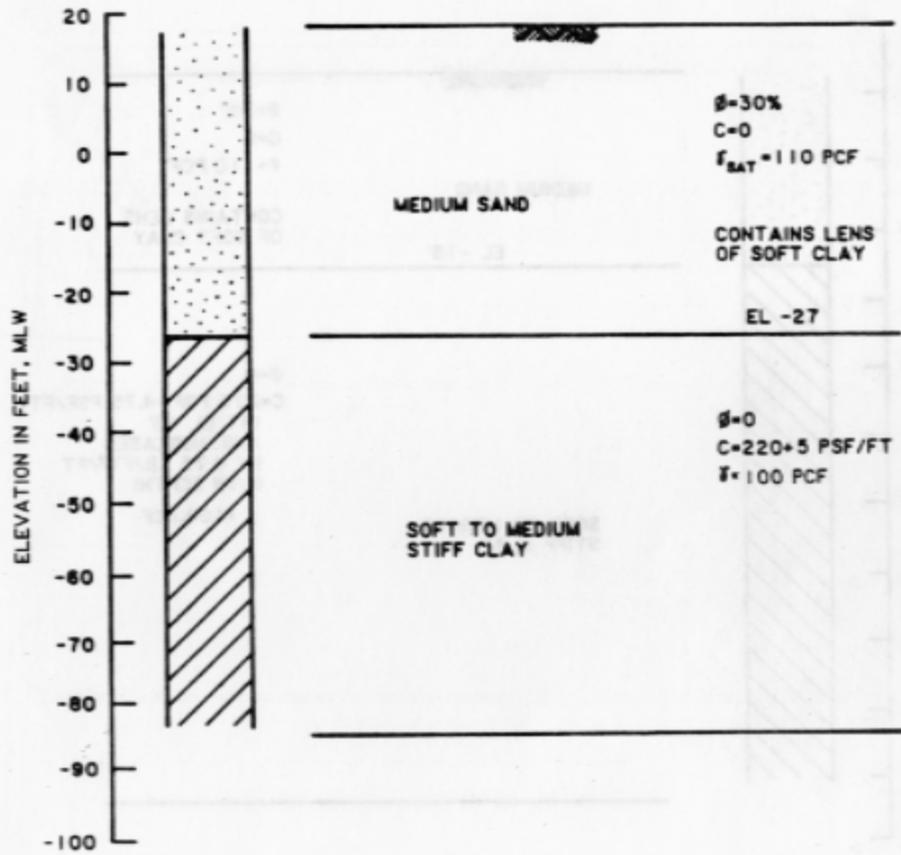
Figure 13. Generalized foundation shear strength profile for north dike stability analysis, north sta 45+00

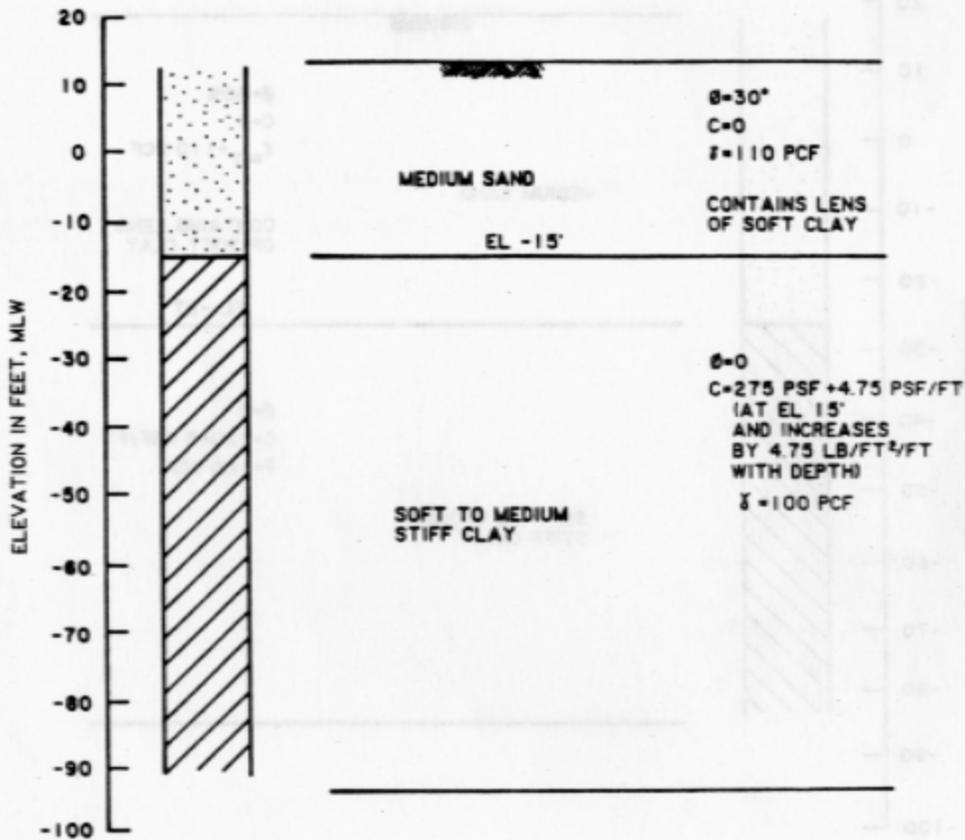
Figure 14. Generalized foundation shear strength profile for west dikes stability analysis, northwest corner sta 80+00

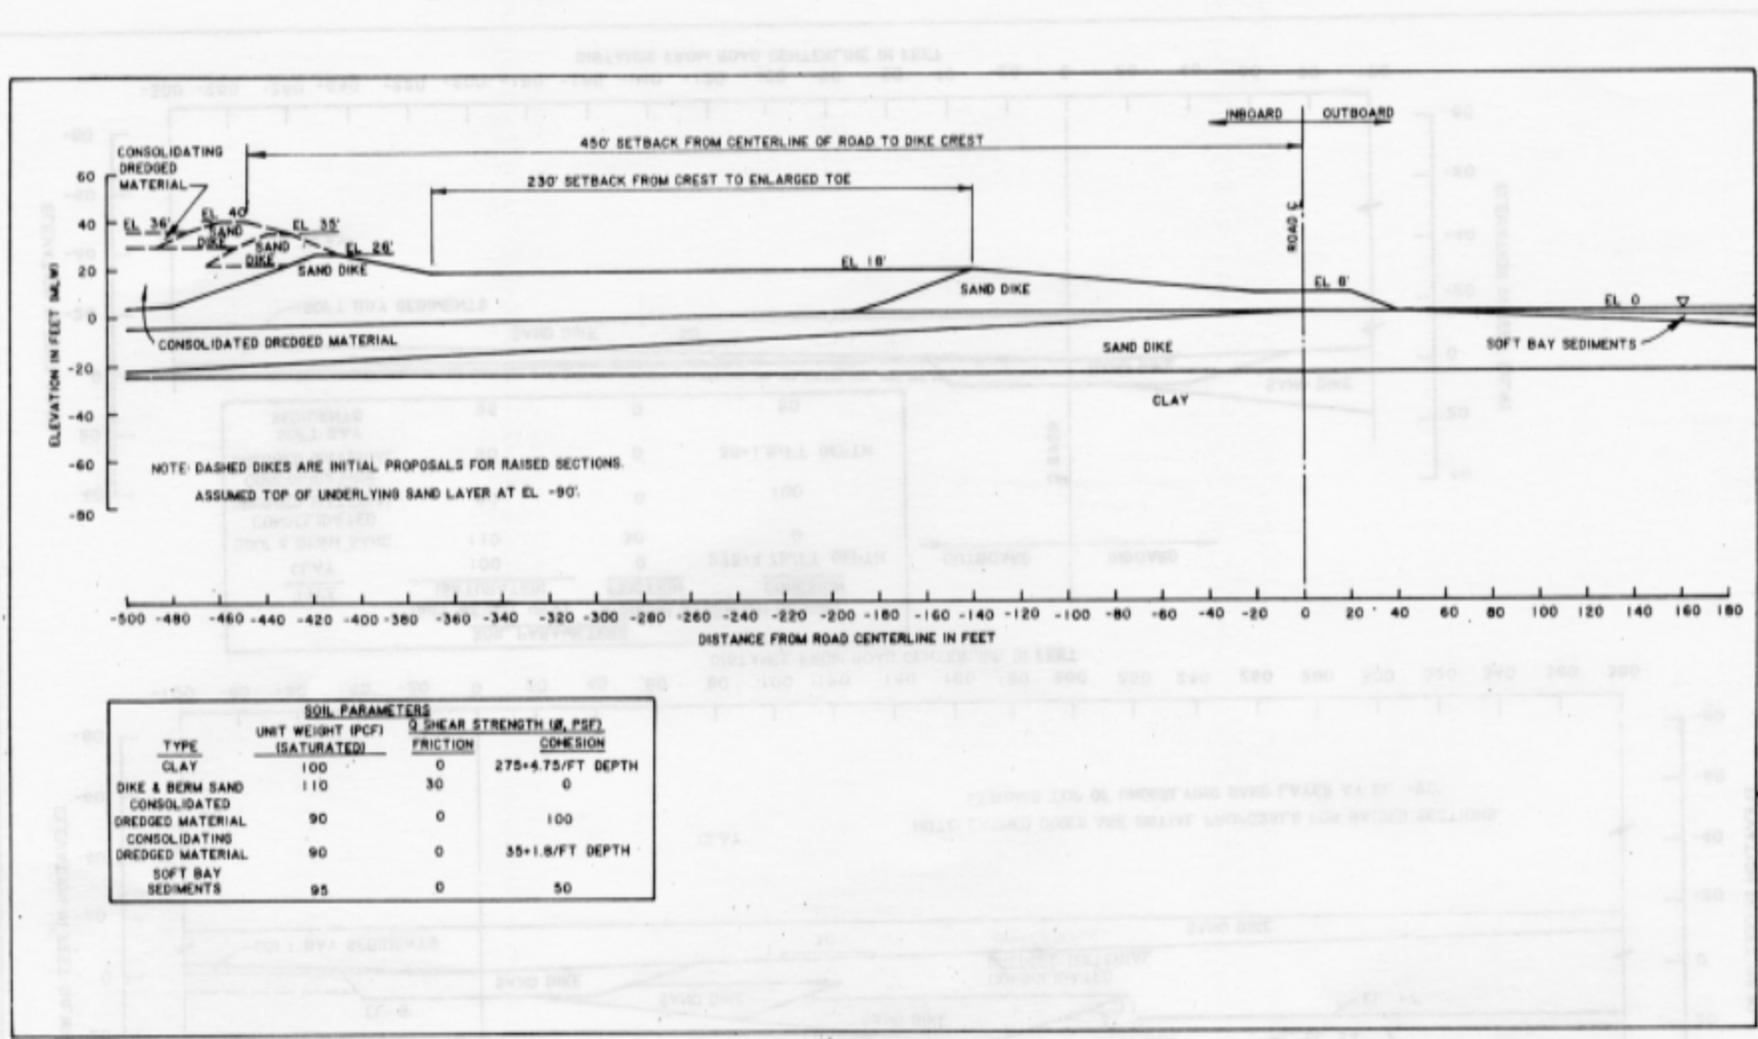
Figure 16. Generalized cross-section, east perimeter dike

30. The dike cross sections used for analysis were selected based on the largest thickness of the soft foundation clay shown on the soil profiles developed in the geotechnical investigation section of this report. Four cross sections were identified with one in the northwest corner and one each on the west, north, and east dikes as shown in Figure 11. The stations of the cross sections identified were 104+00, 80+00, 45+00, and 80+00 for the northwest corner, west, north, and east dikes, respectively. The shear strength of the soft foundation clay at these cross sections are shown in Figures 12-14. The geometry of the cross sections shown in Figures 15-18 was obtained from survey results and foundation investigations.

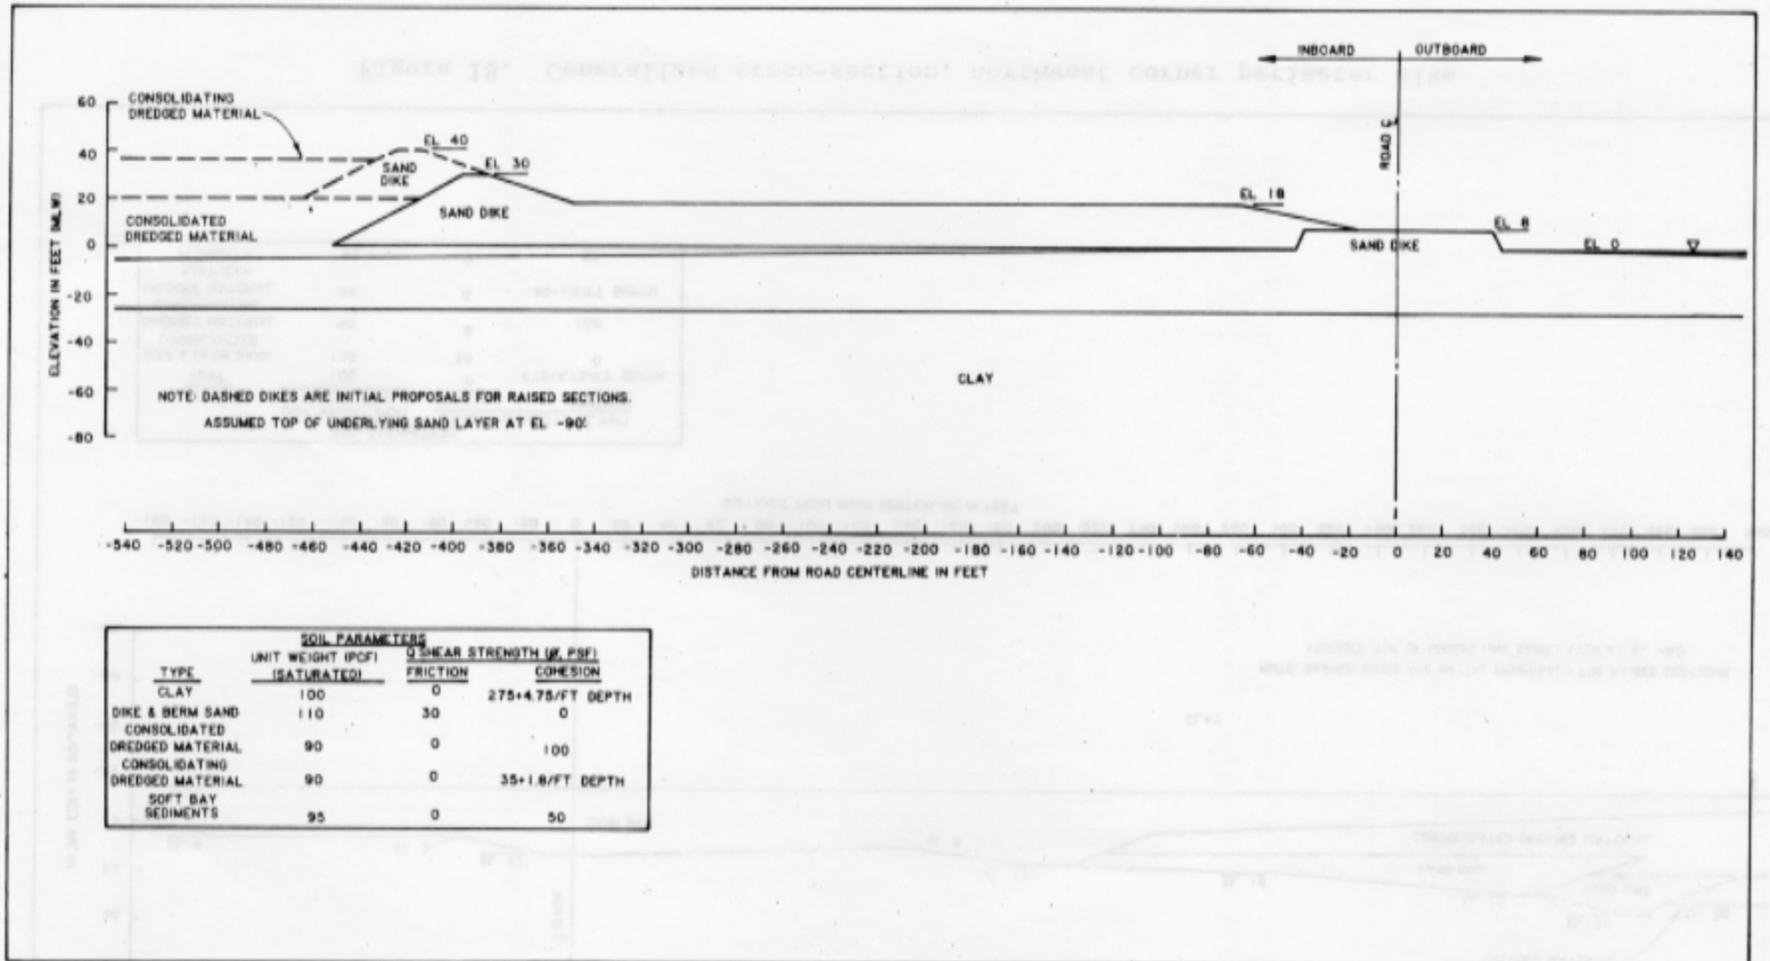
Figure 17. Generalized cross-section, north perimeter dike

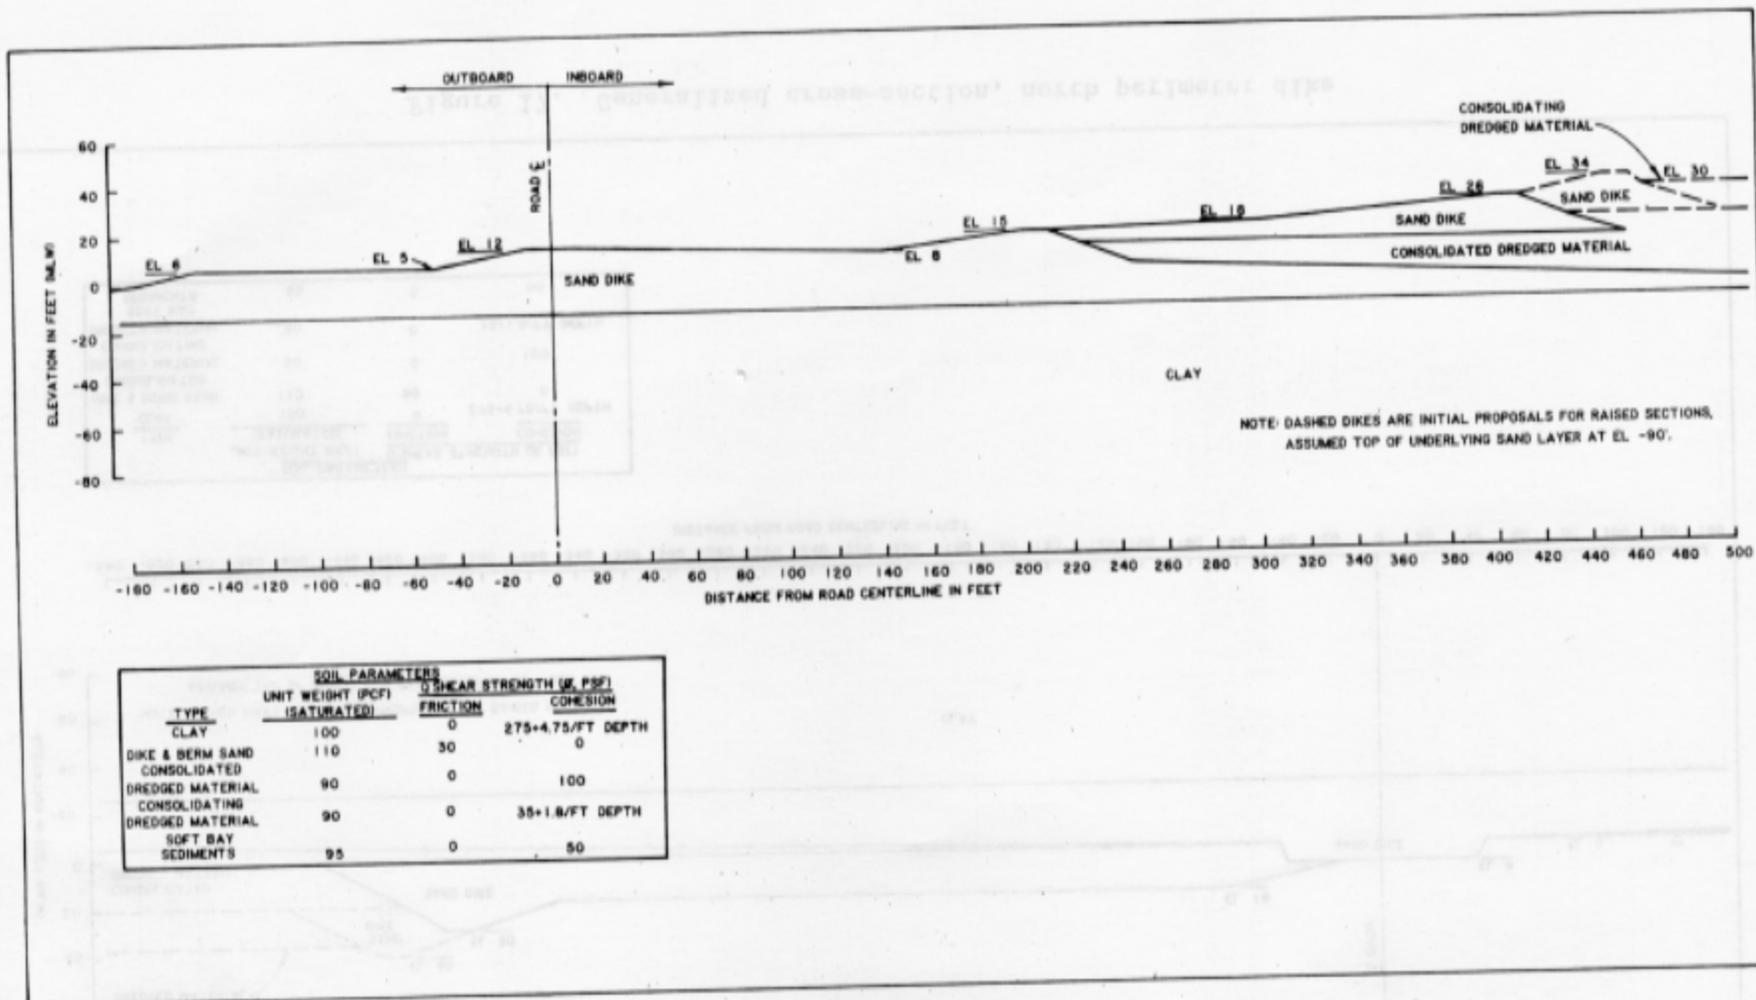
Figure 18. Generalized cross-section, northwest corner perimeter dike
