MISCELLANEOUS PAPER GL-87-4

PERIMETER DIKE STABILITY ANALYSES CRANEY ISLAND DISPOSAL AREA, NORFOLK DISTRICT, NORFOLK, VIRGINIA

Geotechnical Laboratory

This publication describes the slope stability analyses and recommended designs for the raised perimeter dikes at the Craney Island disposal area in Norfolk, Virginia.

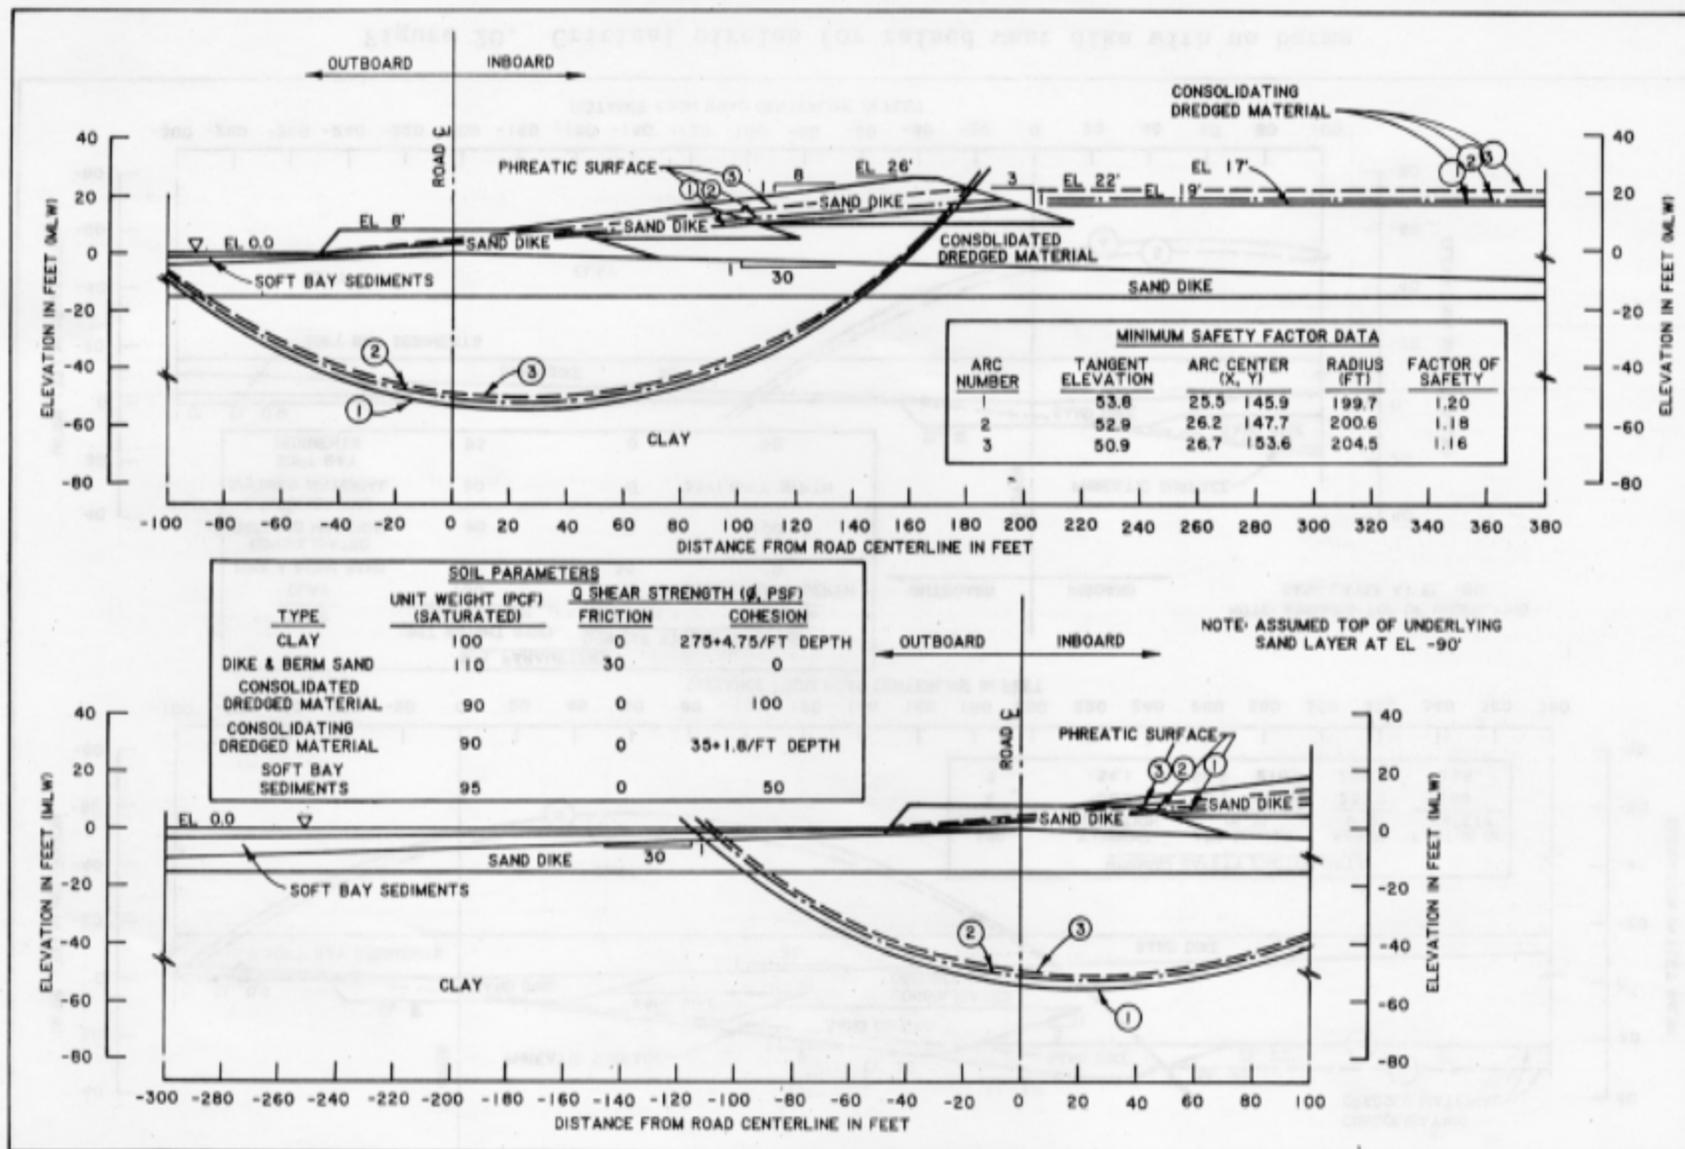
Figure 19. Critical circles for various dredged material elevations using existing west dike configuration

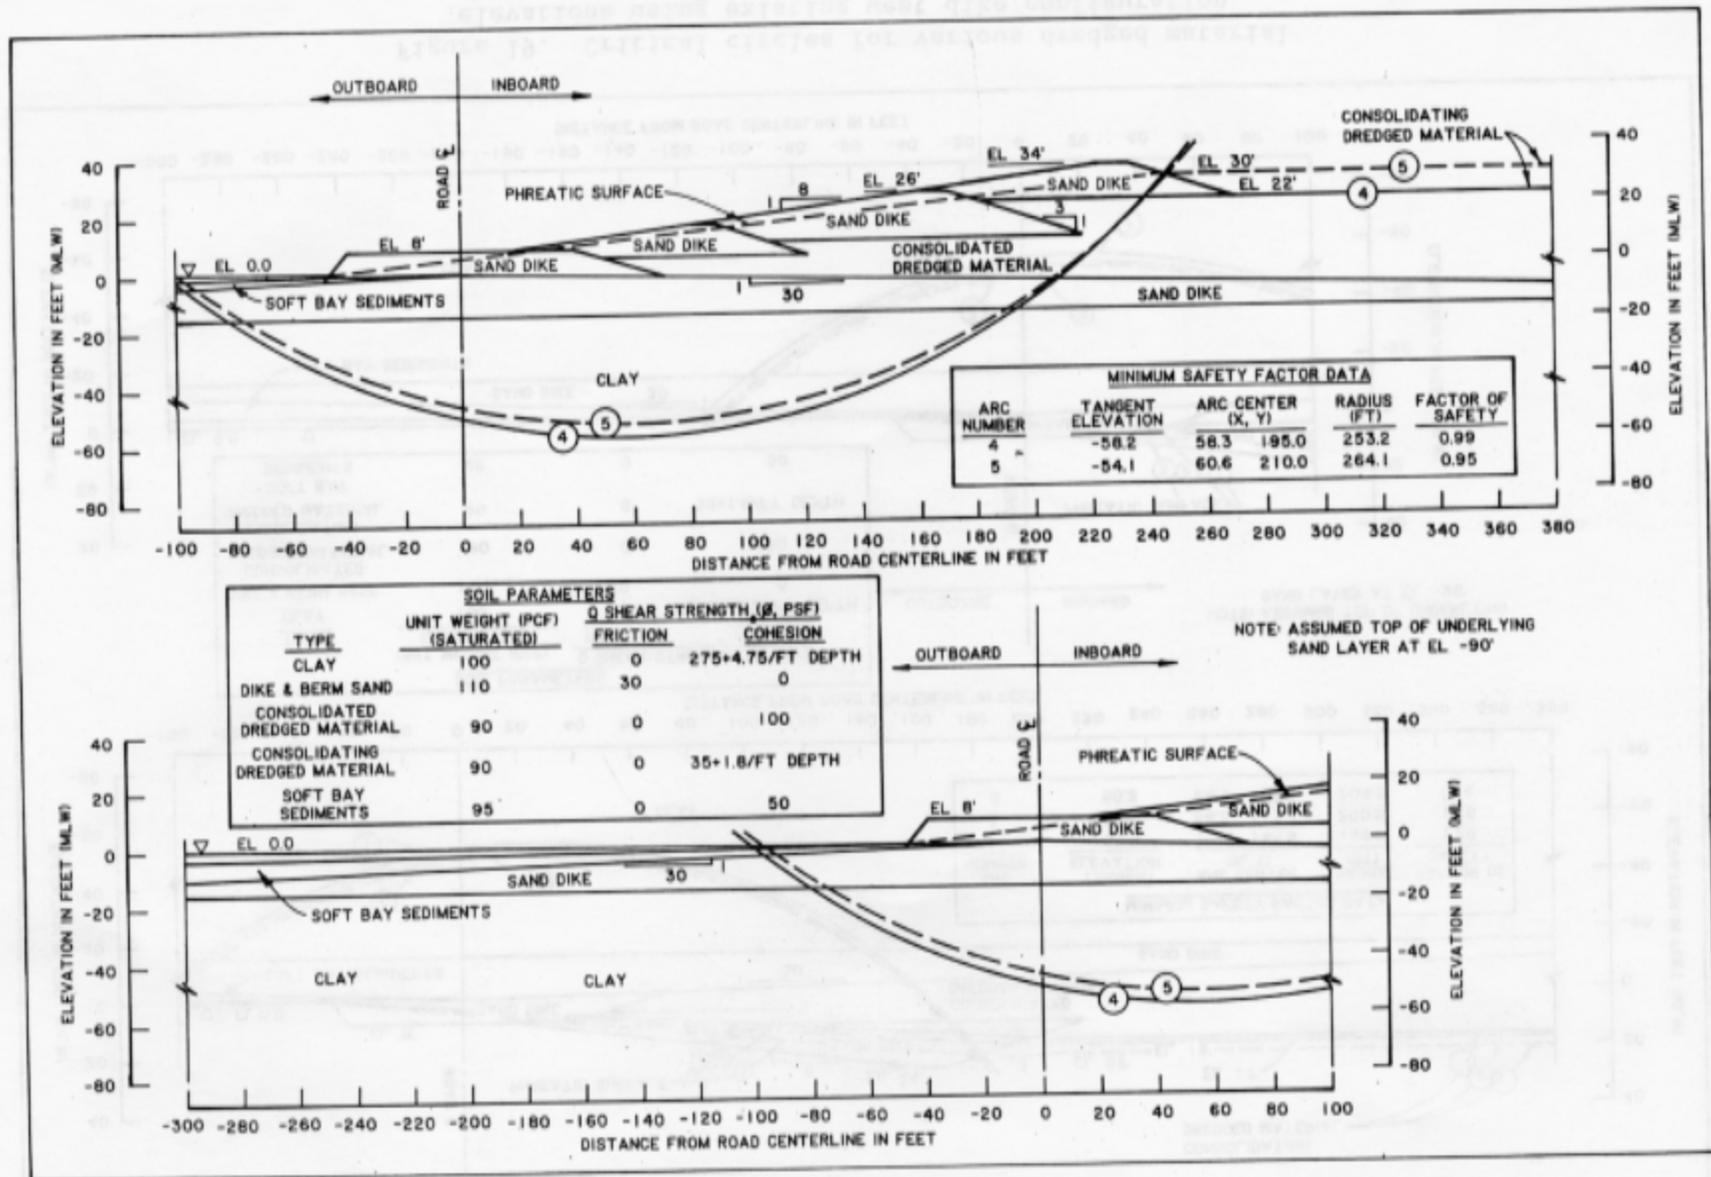
Figure 20. Critical circles for raised west dike with no berms

32. The next scenarios considered raising the containment dike to el +34 with the dredge material at two elevations. The first case involving the raised dike considered the dredged material at el +22. The resulting safety factor is below 1.0 with a value of 0.99. This result indicates that some or part of the berms necessary for stability when the dredge material is increased to el +30 should be in place before the dike is raised. When the analysis was performed with the dredged material up to el +30, the safety factor dropped to 0.95. The results of these calculations are shown in Table 2 as runs 4 and 5. The critical circles are shown in Figure 20.

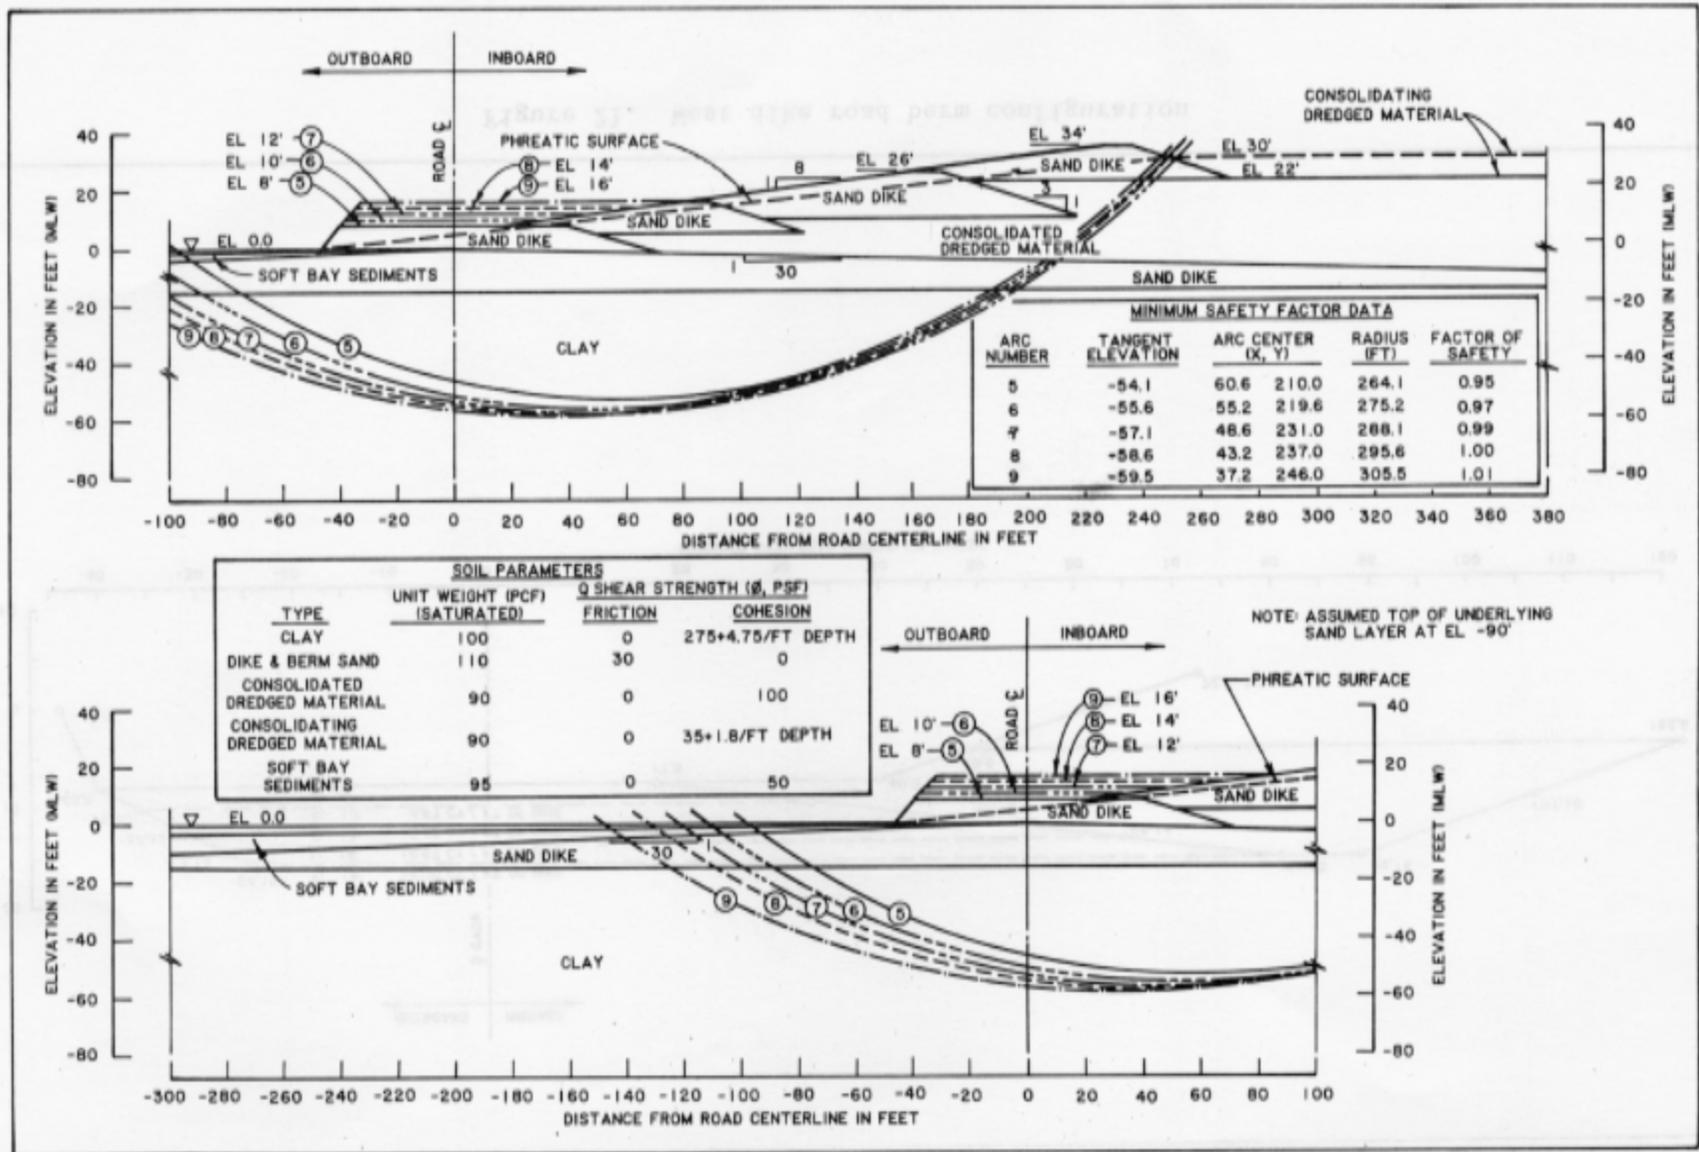
Figure 22. Critical circles for raised west dike with road berms

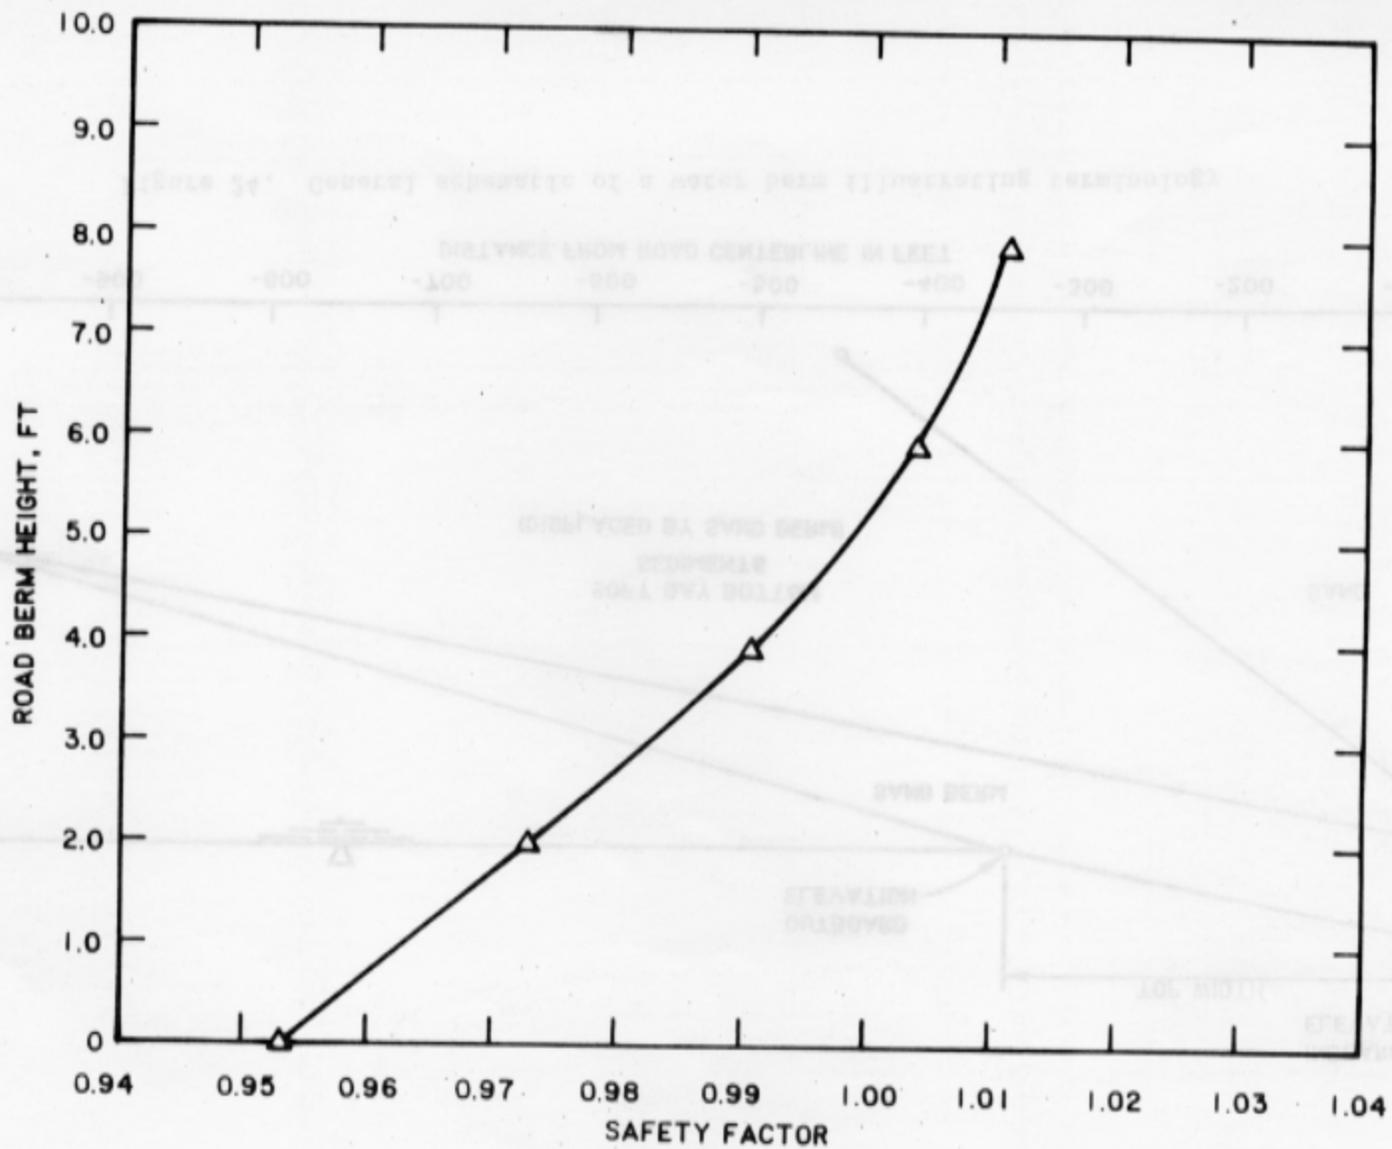
Figure 23. West dike road berm height versus safety factor

34. The existing roadway at el +8 is about 58 ft wide. The road berm consists of a mass of sandy material that increases the road elevation. A slope of 2H:1V was used for the outboard or west side of the berm. The effectiveness of the road berm was evaluated by increasing the berm elevation in 2-ft increments. Figure 21 illustrates how the berms fit in the current configuration and indicates the volume of material contained in each berm. The safety factors increase from 0.95 for the current roadway to 1.01 for an 8-ft berm (top of berm at el +16). The results are listed in Table 3 with the critical circles shown in Figure 22. A plot of safety factor versus berm elevation is shown in Figure 23. The safety factor increased as the berm elevation increased with a change in the rate of increase at +12. The center coordinates for the critical shear surfaces moved outward (lower X value) and upward (larger Y value). This movement tends to counter balance the additional resisting forces generated by the berm.

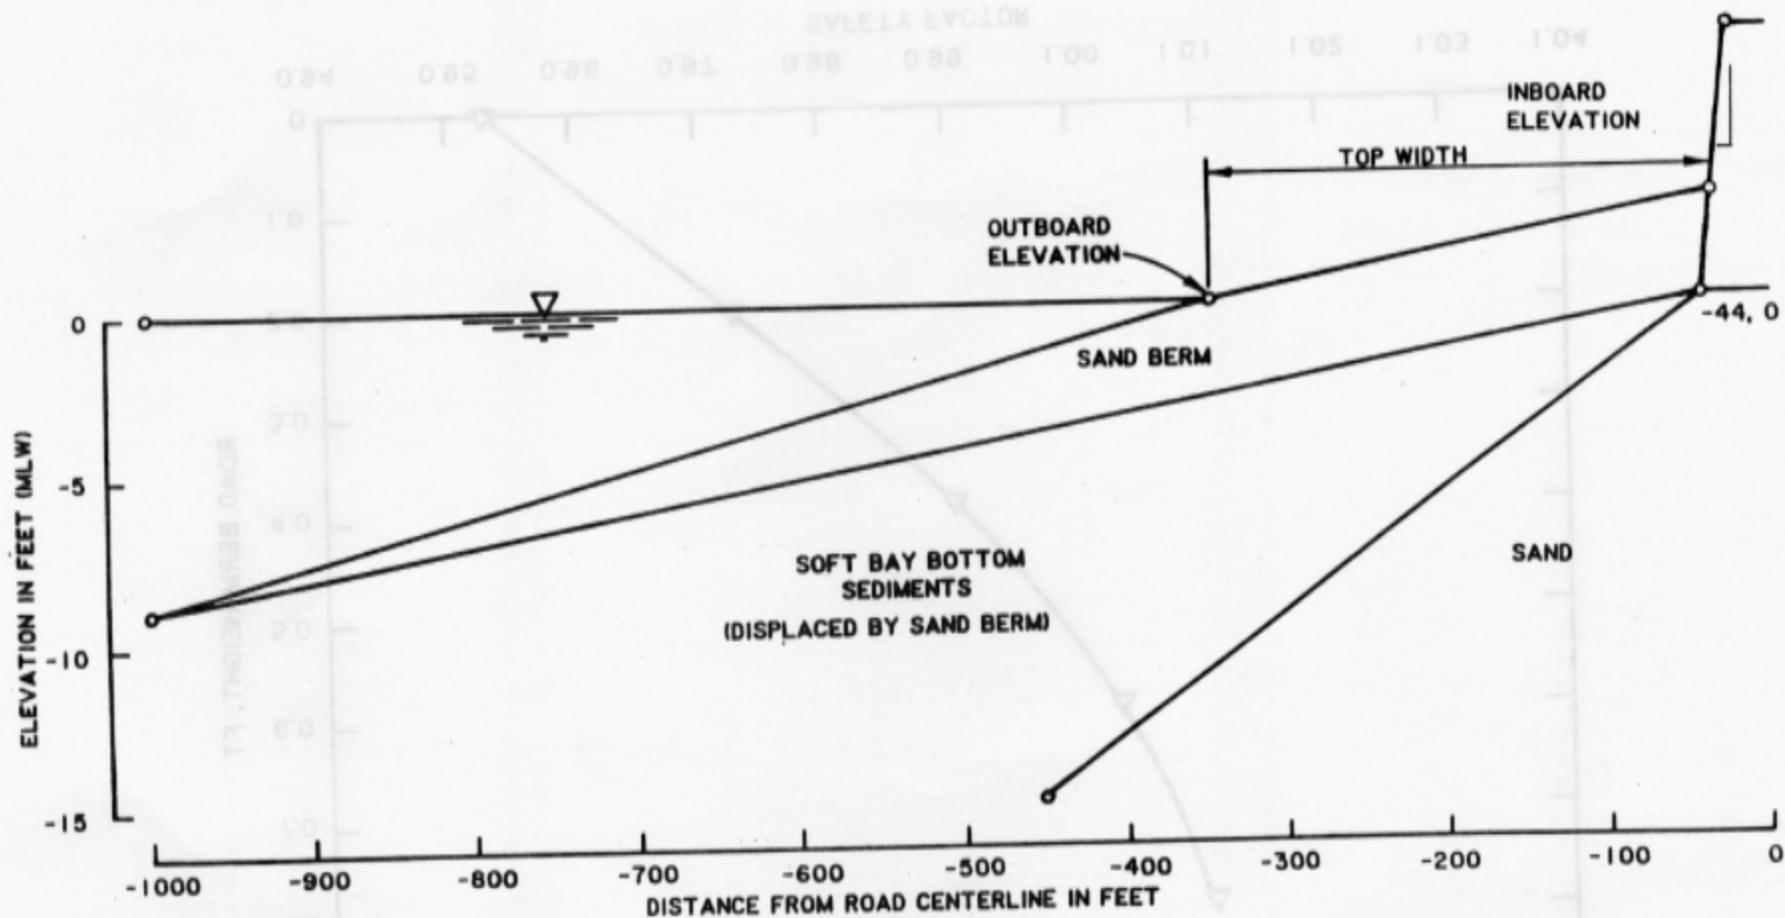
Figure 24. General schematic of a water berm illustrating terminology

terminology is shown in Figure 24. The three variables are the inboard elevation, outboard elevation, and the top width. Three combinations of elevations were used. They are el 0 for both the inboard and outboard values, el 0 for the outboard and el +3 for the inboard value, and el +3 for the outboard and el +6 for the inboard value. For each combination of elevations, three top widths of 100, 300, and 500 ft were evaluated. The results of these computations are shown in Table 4. The critical circles for the berms with el +3 to +6 are shown in Figure 25. There is a significant increase in safety factor when the top width increased to 100 ft. A small increase occurs with an increase from 100 to 300 ft. However, no increase occurs when the berm width is increased to 500 ft. Figure 25 shows that a minimum width of 100 to 150 ft is needed. However, a berm top width of 300 ft was selected for further study

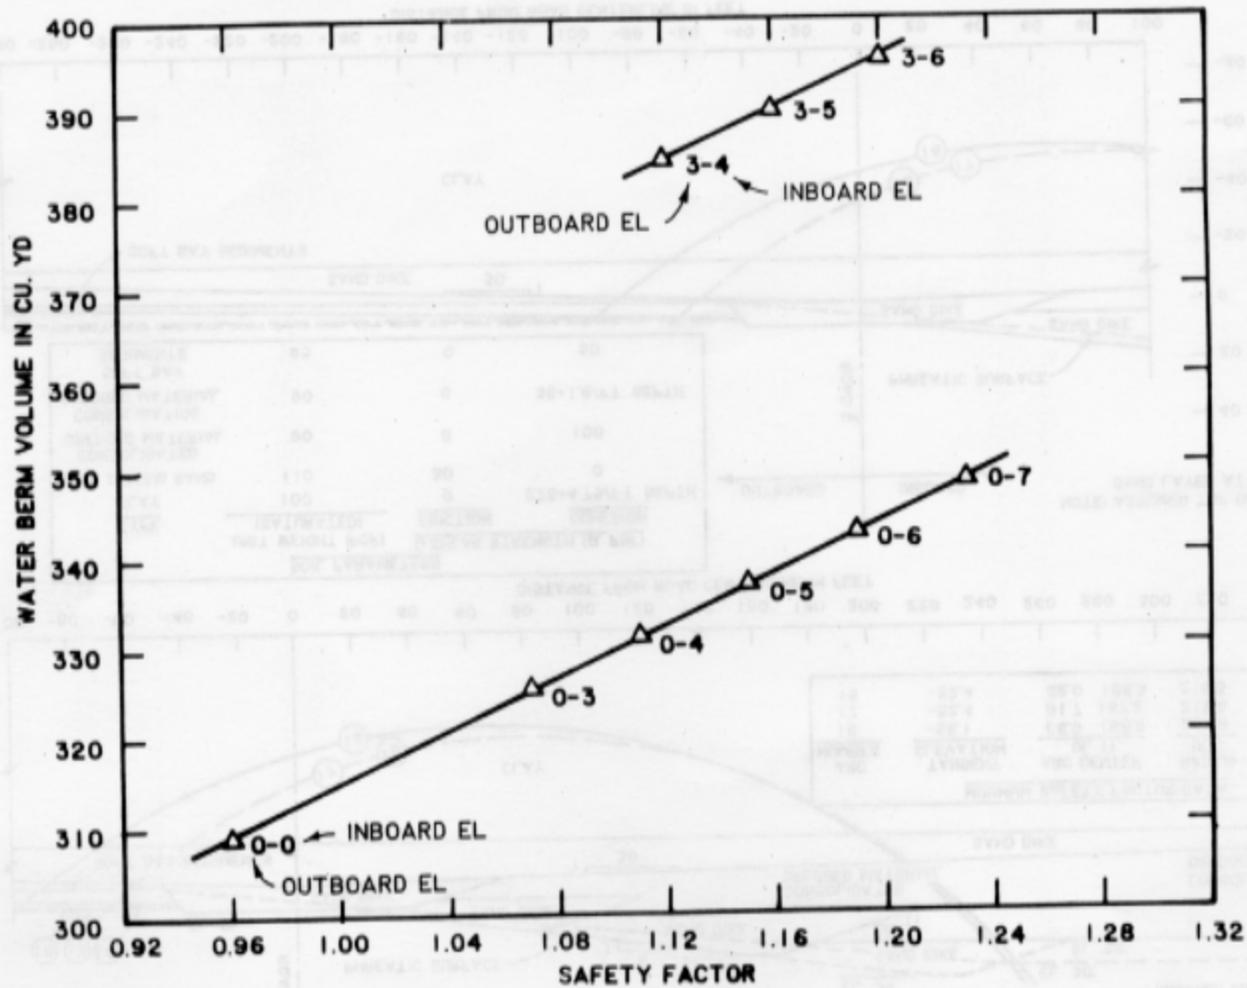
Figure 26. West dike water berm volume versus safety factor

so that a margin against erosion of the berm is provided. Several additional elevation pairs were evaluated for 300-ft-wide berms. These results are also shown in Table 4. The volume of the various berms are listed in Table 5. The safety factor increased more for the water berm than for the road berm, but the volume of material in the water berm is 16 to 70 times larger than the road berm. A plot of the water berm volume versus safety factor is shown in Figure 26. This plot shows that the safety factor is dependent upon the inboard elevation and not the outboard elevation.

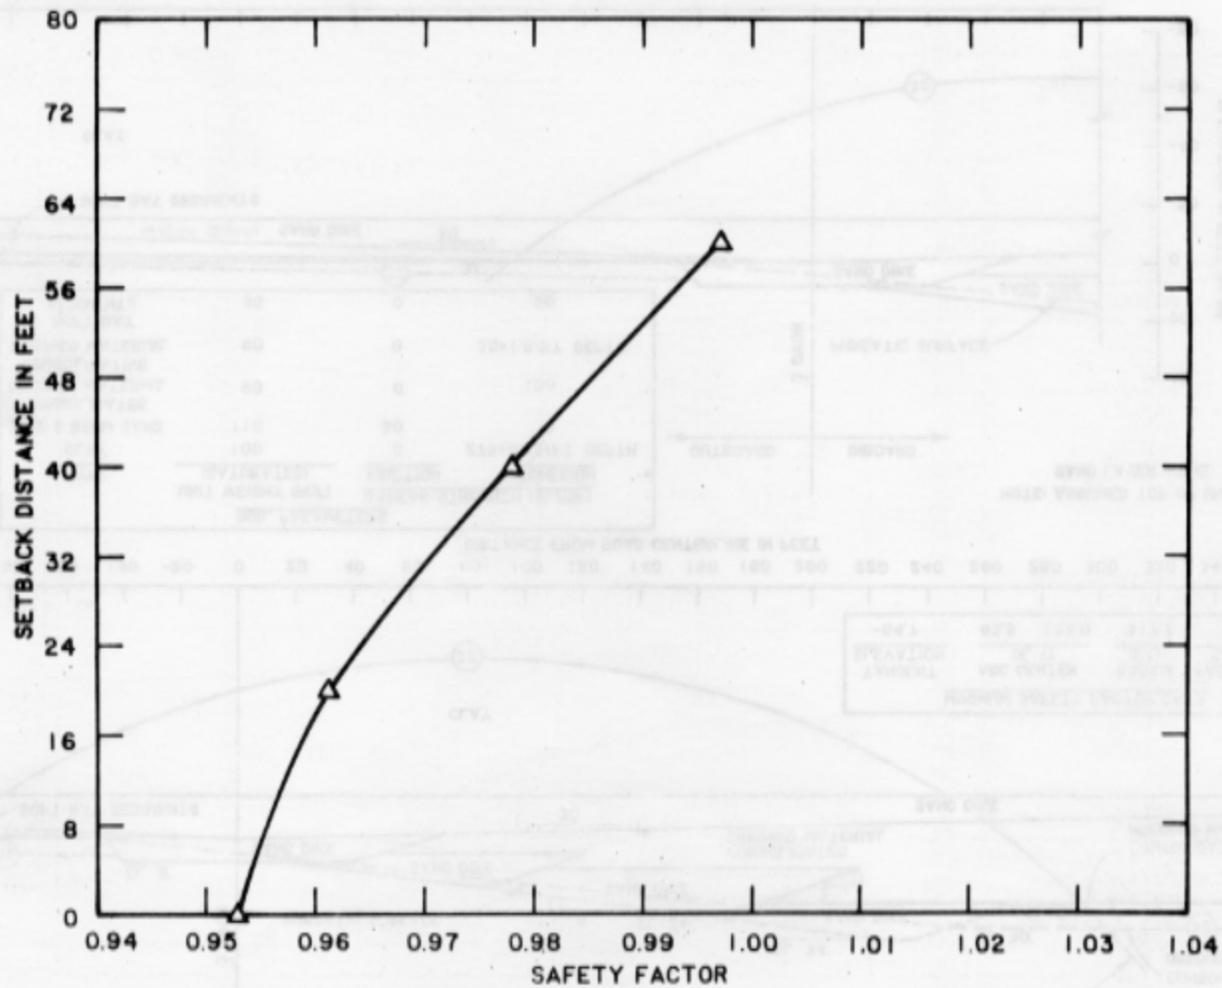
Figure 27. West dike setback versus safety factor

36. A setback distance is the horizontal distance from the outboard crest of the el +26 dike to the outboard toe of the el +34 dike. This setback was varied from 0 to 60 ft in intervals of 20 ft. The results are shown in Table 6. A plot of safety factor versus setback distance is shown in Figure 27. Only small increase in safety factor occurs when the dike is setback.

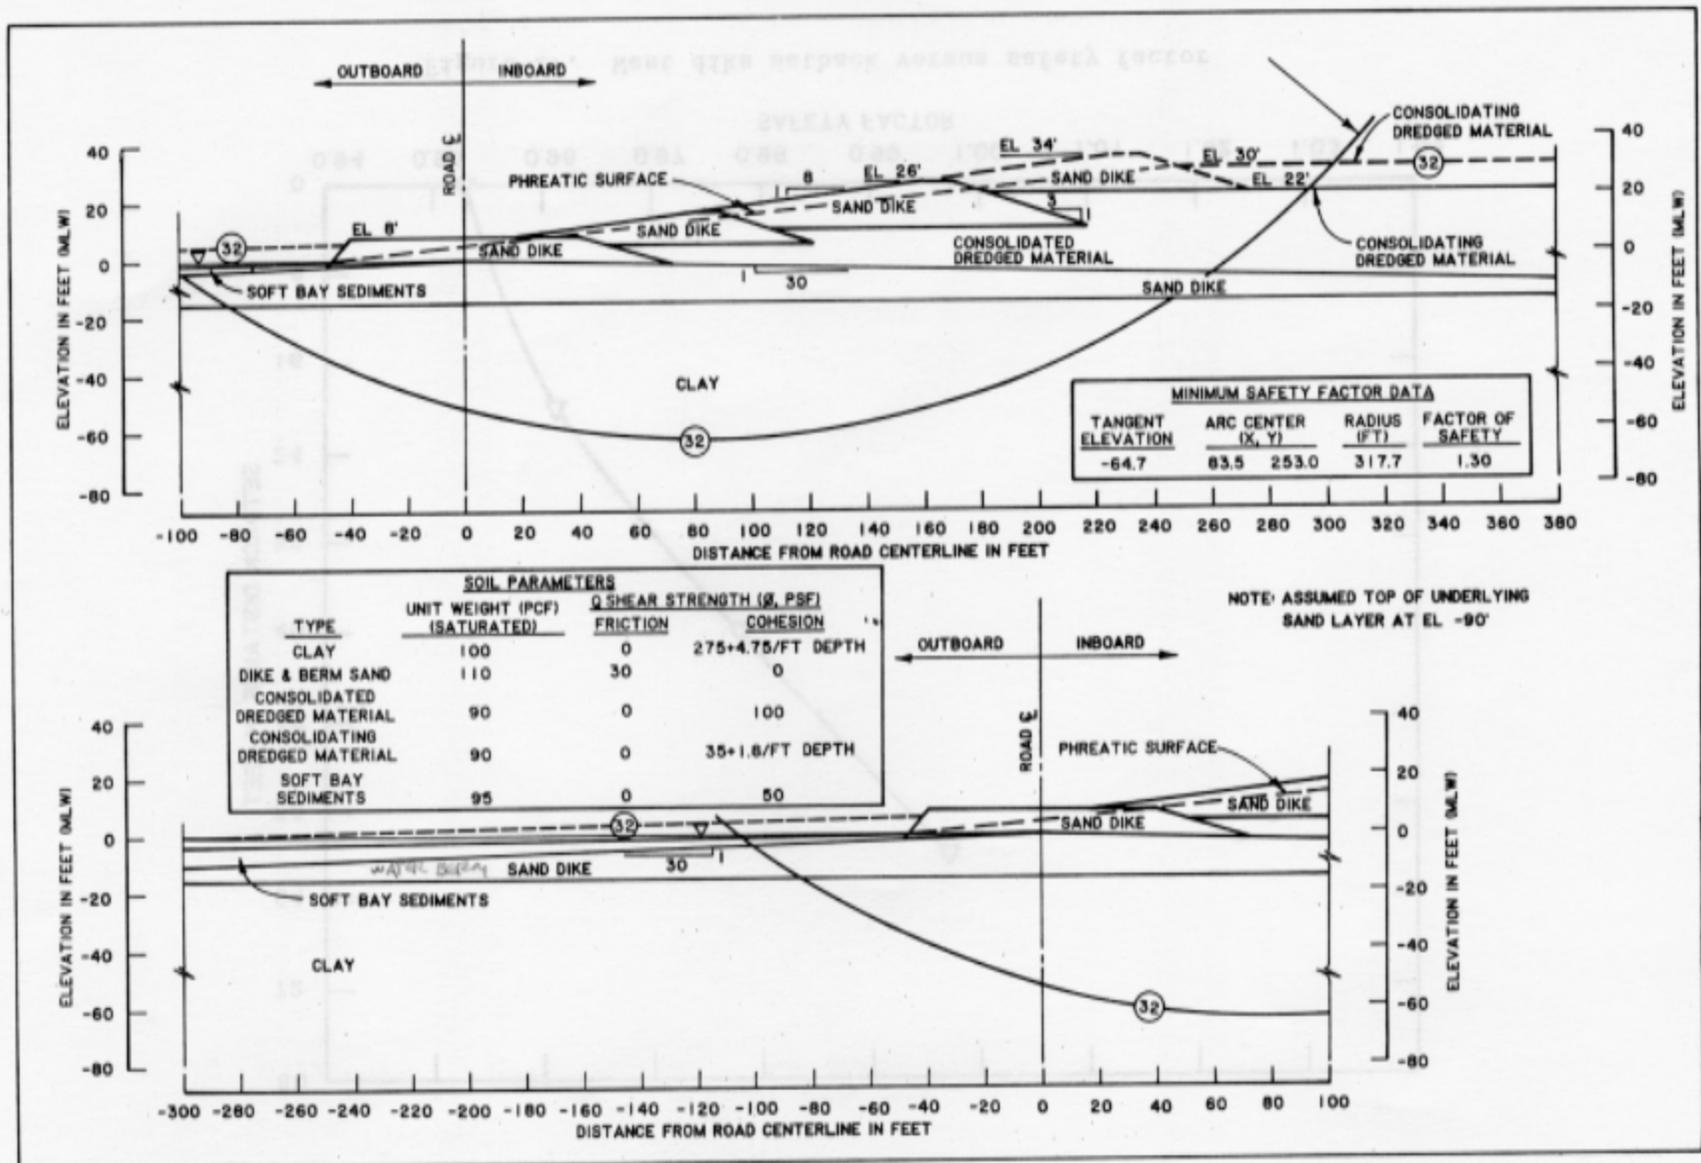
Figure 28. Recommended raised dike cross-section for the west perimeter dike

considered. When combining these three potential solutions it must be noted that there is not a unique solution. The recommended design will be closest to a safety factor of 1.3 and minimize the material in the various berms. The first combination consisted of a water berm 300 ft wide with el +3 to +6 ft and a road berm. The road berm varied from el +16 to el +12. The safety factor for the el +16 berm was 1.34 reducing to 1.29 for the el +12 berm. Notice that the changes in the safety factor calculated individually for each the three solutions can only serve as a guide and can not be added together. Water berms were then combined with a setback distance of 60 ft. The safety factor for a water berm from el +3 to +6 and 300 ft wide was 1.24. When a water berm with el 0 to +3 was considered, the safety factor decreased to 1.19. Because of other constraints such as weirs and reductions in size, setbacks larger than 60 ft were not considered. The optimum design was then a matter of selecting the best water berm and road berm. Four additional combinations were considered. The recommended design consists of a water berm 300 ft wide with el 0 to +7 ft and a road berm to el +10 ft. The safety factor for this combination is 1.30. The results and total volumes for all combinations considered are shown in Table 7. Figure 28 shows the recommended section and the critical circle.

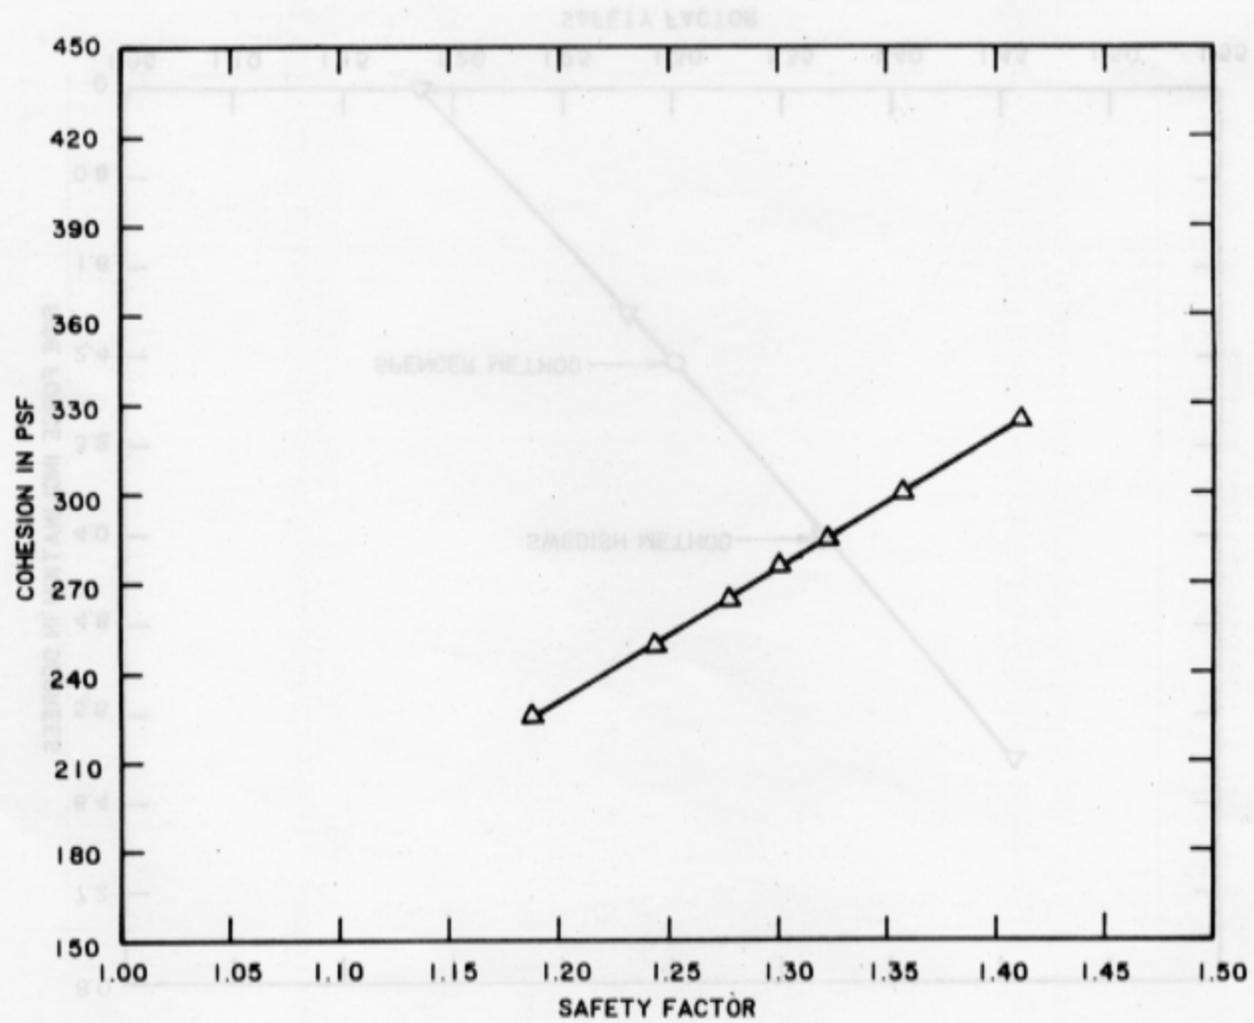
Figure 29. Cohesion of foundation clay under west dike versus safety factor

39. The shear strength of the foundation clay was selected based on numerous tests (see Figure 7). There is a large degree of scatter in the data. To evaluate the sensitivity of the selected shear strength, values plus and minus 10 psf, 25 psf, and 50 psf of the selected cohesion parameter were used in the analysis of the recommended design. The cohesion value is assigned to the profile describing the top of the clay. All analyses used the same rate of increase for the cohesion. Figure 29 illustrates the relationship between cohesion and the safety factor.

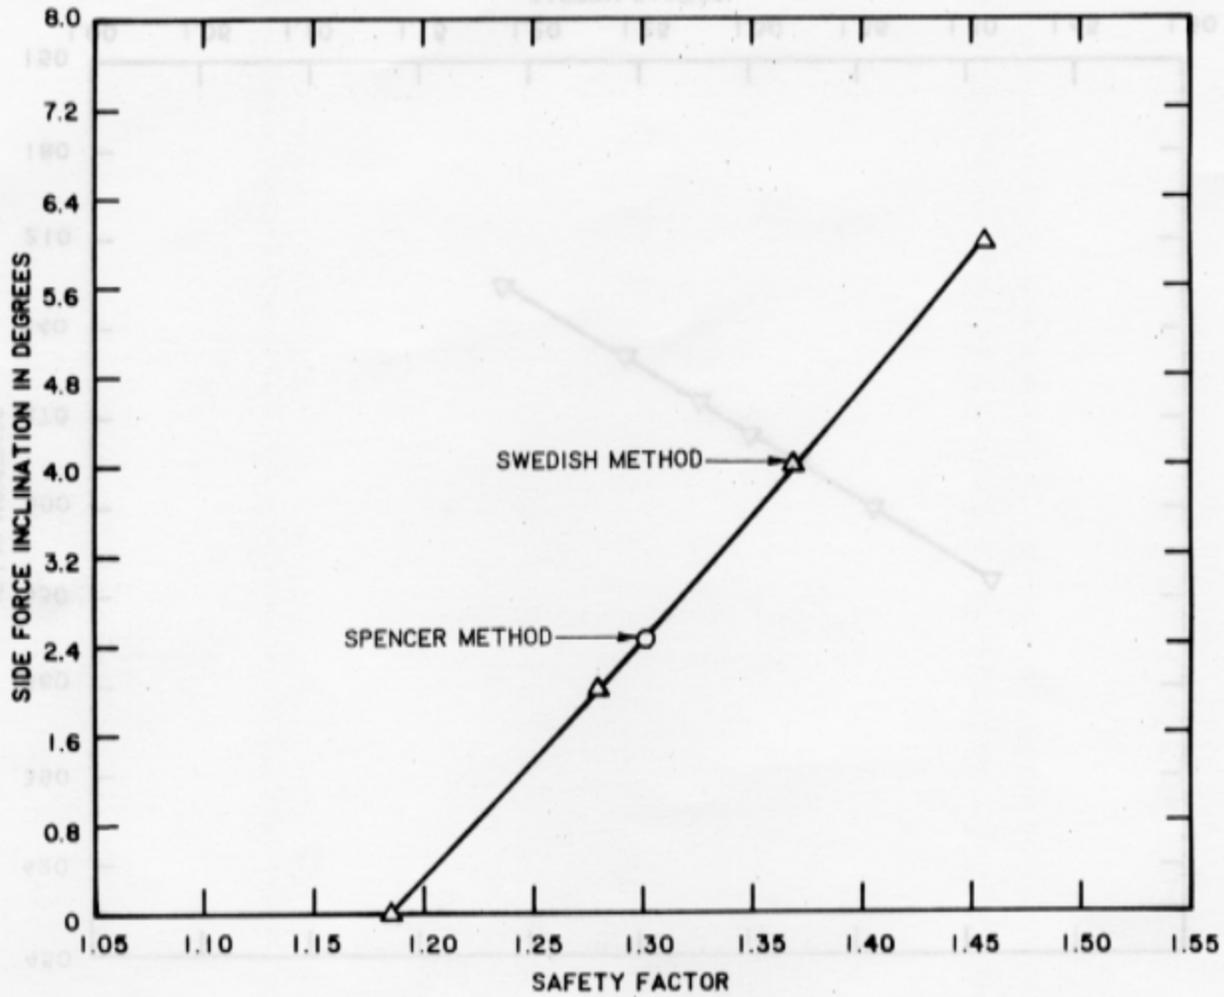
Figure 30. Side force inclination for recommended west dike section versus safety factor

Swedish method where different side force inclinations were specified was used to show the influence of the side force inclination. A plot of the results is shown in Figure 30. The side force inclination in the Modified Swedish procedure must be specified by the user. With the surface geometry broken up into many slopes, the proper side force inclination is difficult to determine. Thus, since Spencer's procedure calculates the side force inclination, this method should be used. The side force inclination from Spencer's method can then be used in the Modified Swedish procedure to perform a hand check.

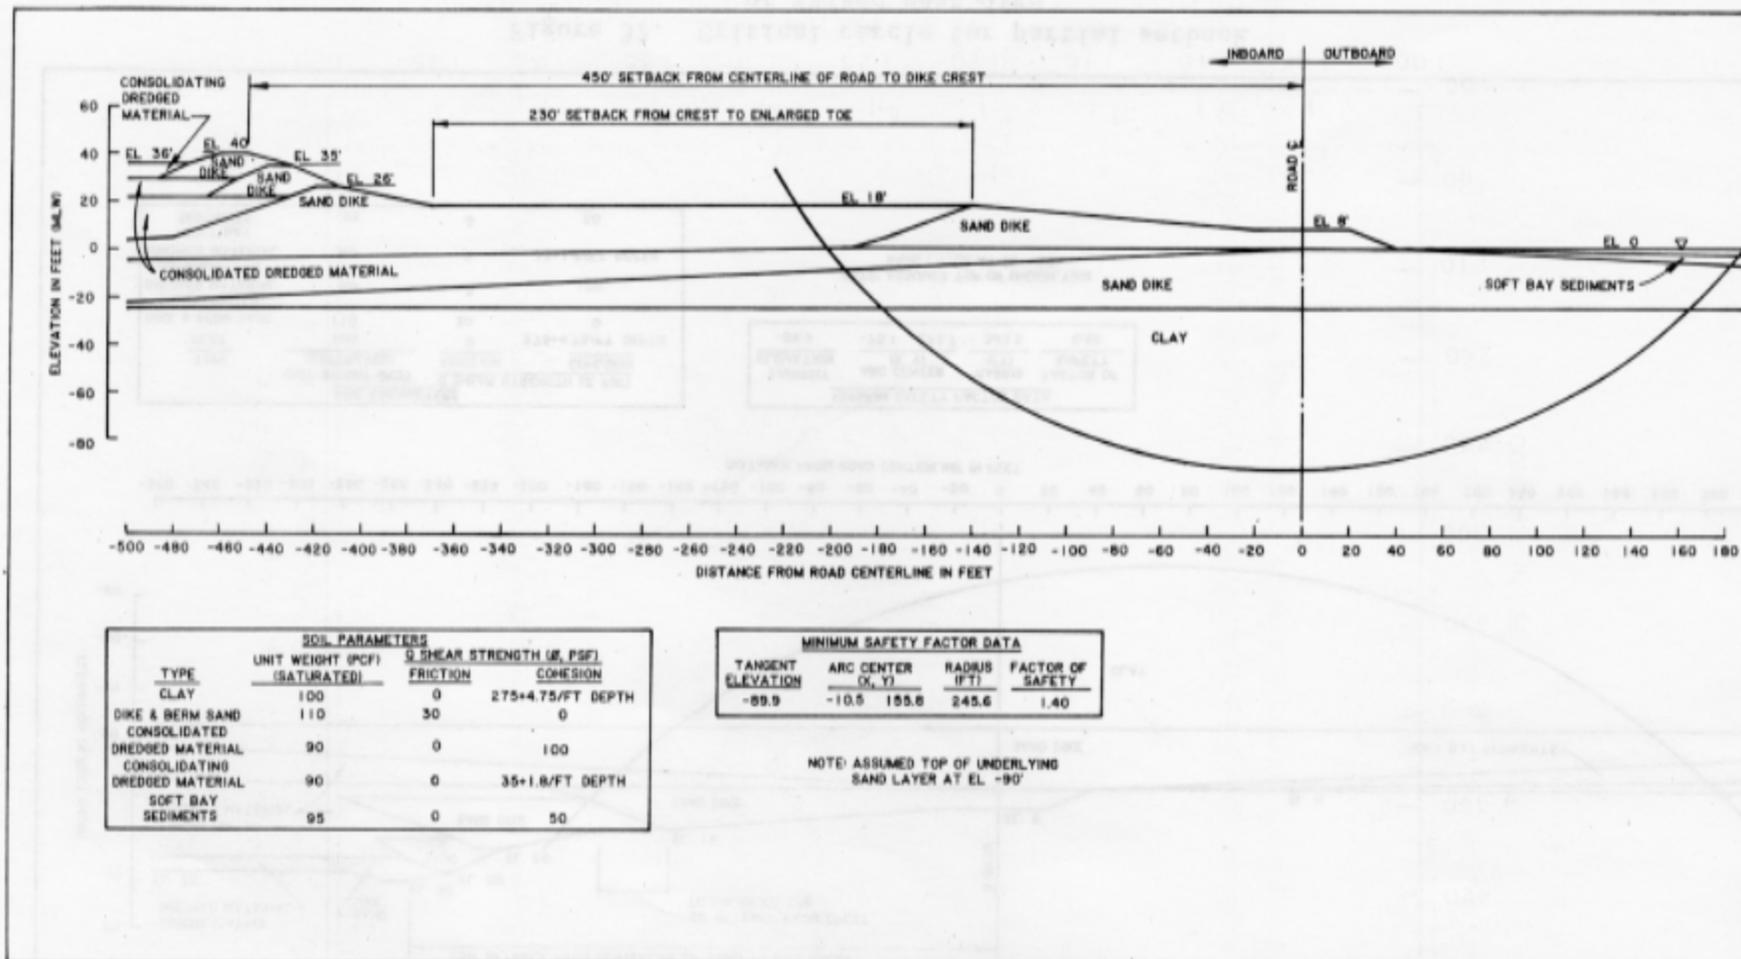
Figure 31. Recommended section for full setback of raised east dike

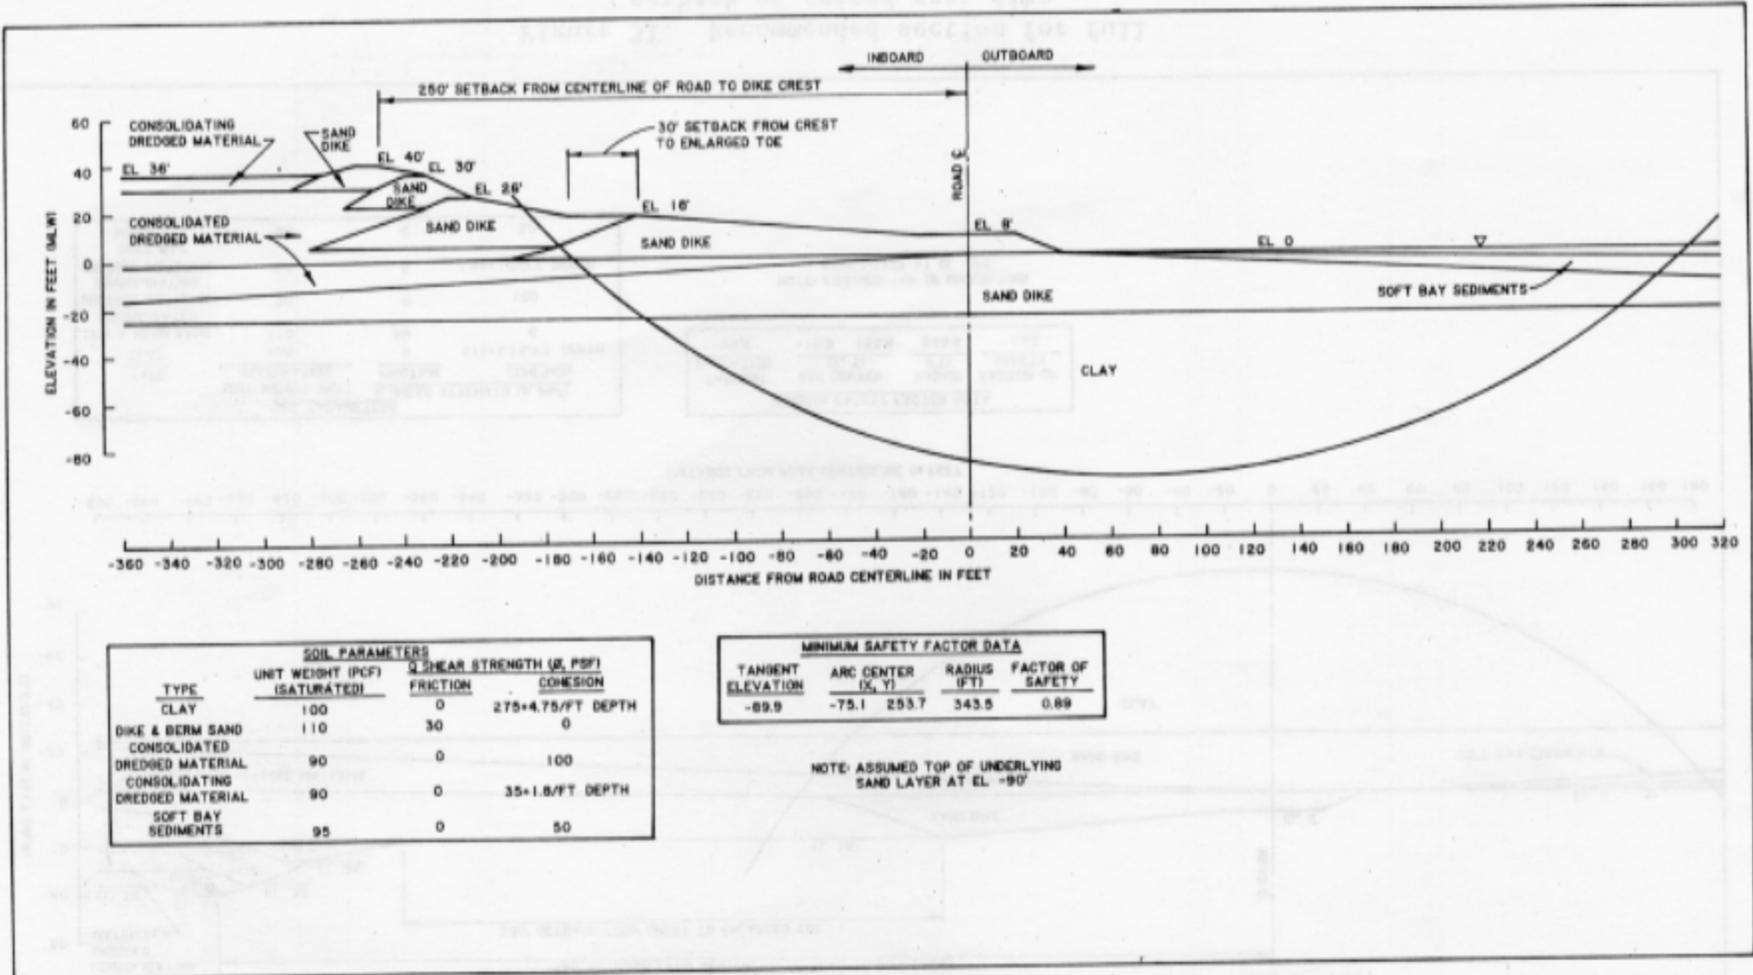
SOIL PARAMETERS			
TYPE	UNIT WEIGHT (PCF) (SATURATED)	SHEAR STRENGTH (PSF)	
		FRICTION	COHESION
CLAY	100	0	275+4.75/FT DEPTH
DIKE & BERM SAND	110	30	0
CONSOLIDATED DREDGED MATERIAL	90	0	100
CONSOLIDATING DREDGED MATERIAL	90	0	35+1.8/FT DEPTH
SOFT BAY SEDIMENTS	95	0	50

MINIMUM SAFETY FACTOR DATA			
TANGENT ELEVATION	ARC CENTER (X, Y)	RADIUS (FT)	FACTOR OF SAFETY
-69.9	-75.1 253.7	343.5	0.89

NOTE: ASSUMED TOP OF UNDERLYING SAND LAYER AT EL -90'

Figure 32. Critical circle for partial setback of raised east dike

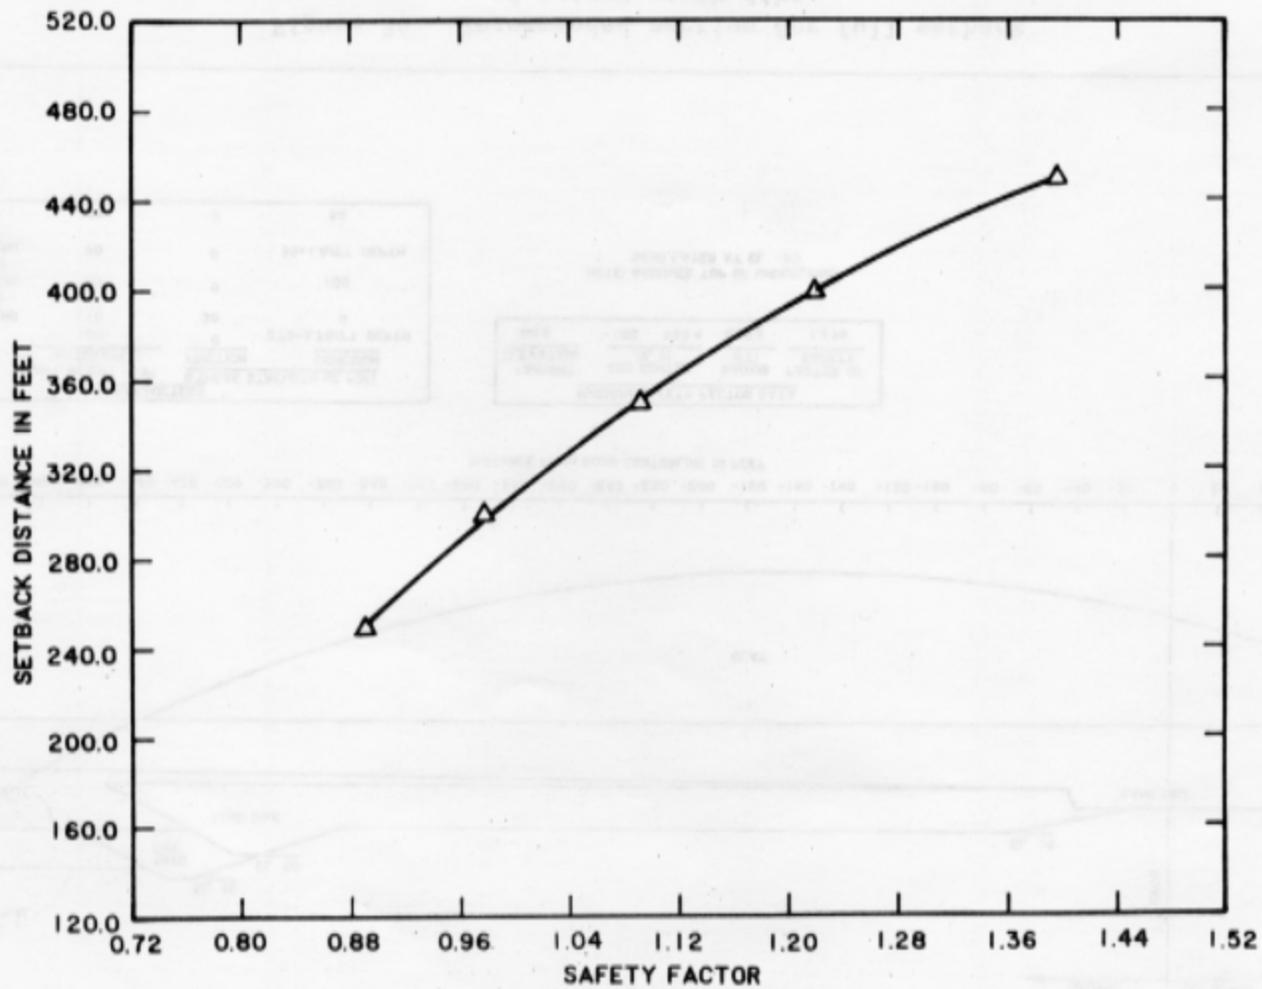
Figure 33. East dike setback distance versus safety factor
