MISCELLANEOUS PAPER GL-87-4

PERIMETER DIKE STABILITY ANALYSES CRANEY ISLAND DISPOSAL AREA, NORFOLK DISTRICT, NORFOLK, VIRGINIA

Geotechnical Laboratory

This publication describes the slope stability analyses and recommended designs for the raised perimeter dikes at the Craney Island disposal area in Norfolk, Virginia.

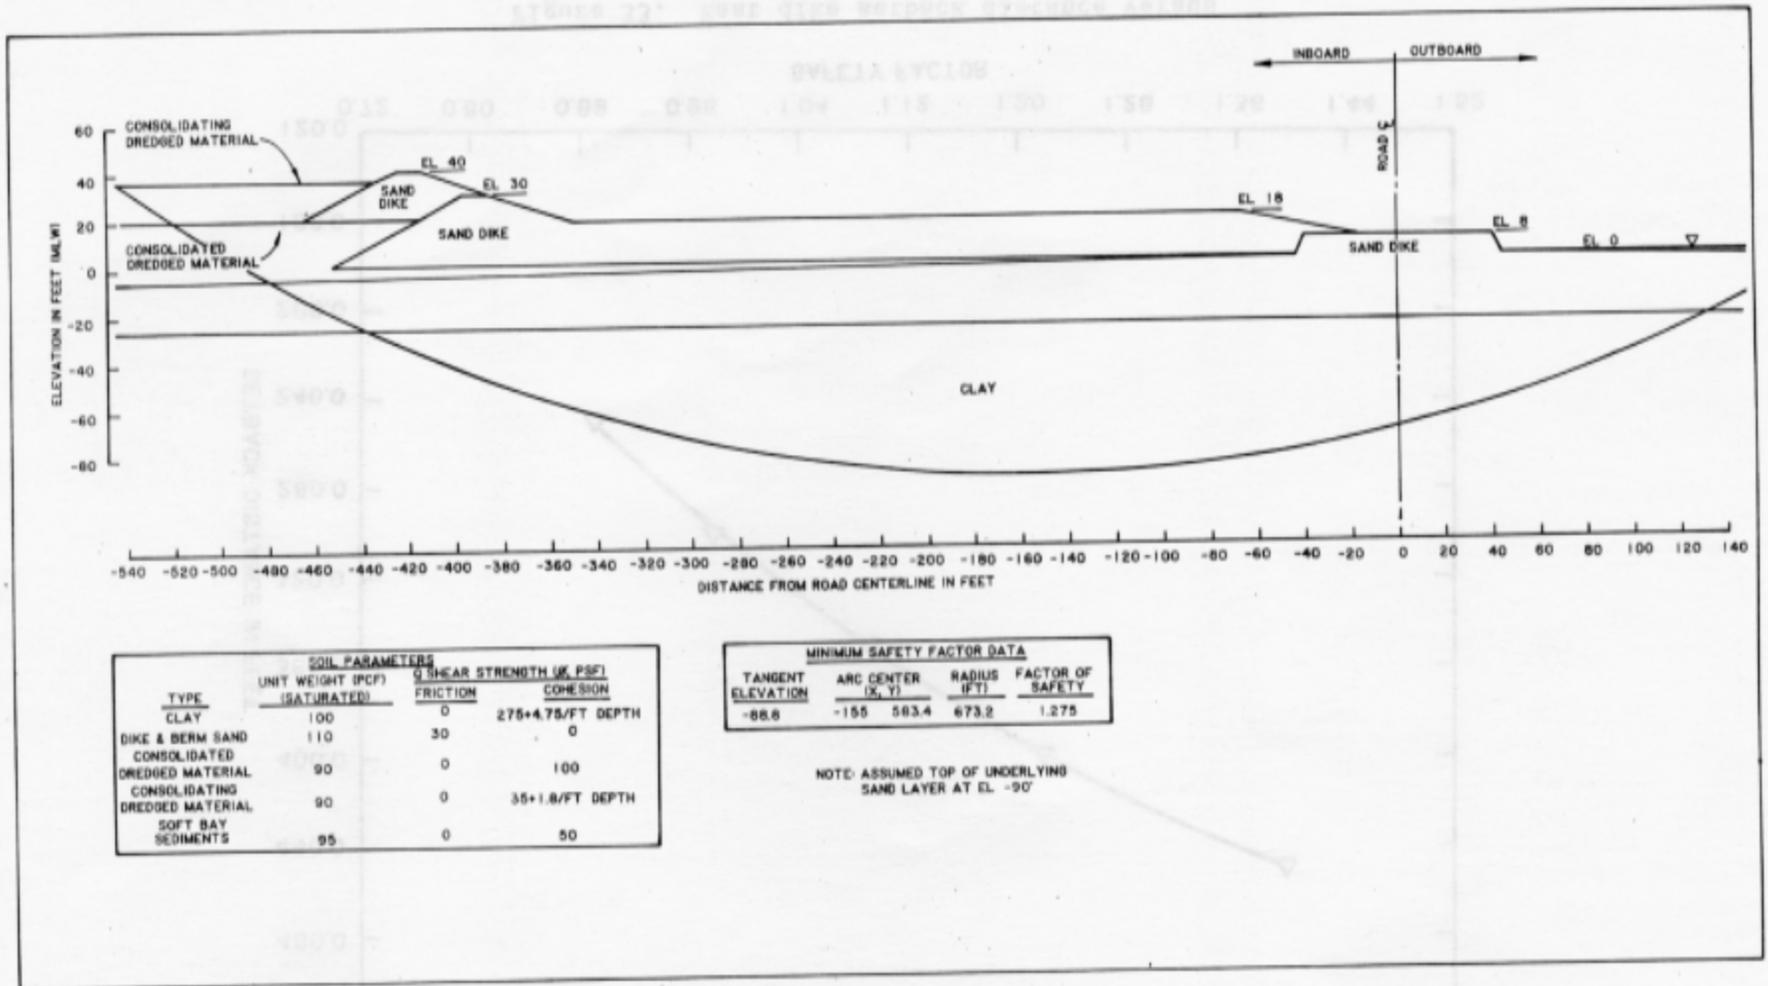
Figure 34. Recommended section for full setback of raised north dike

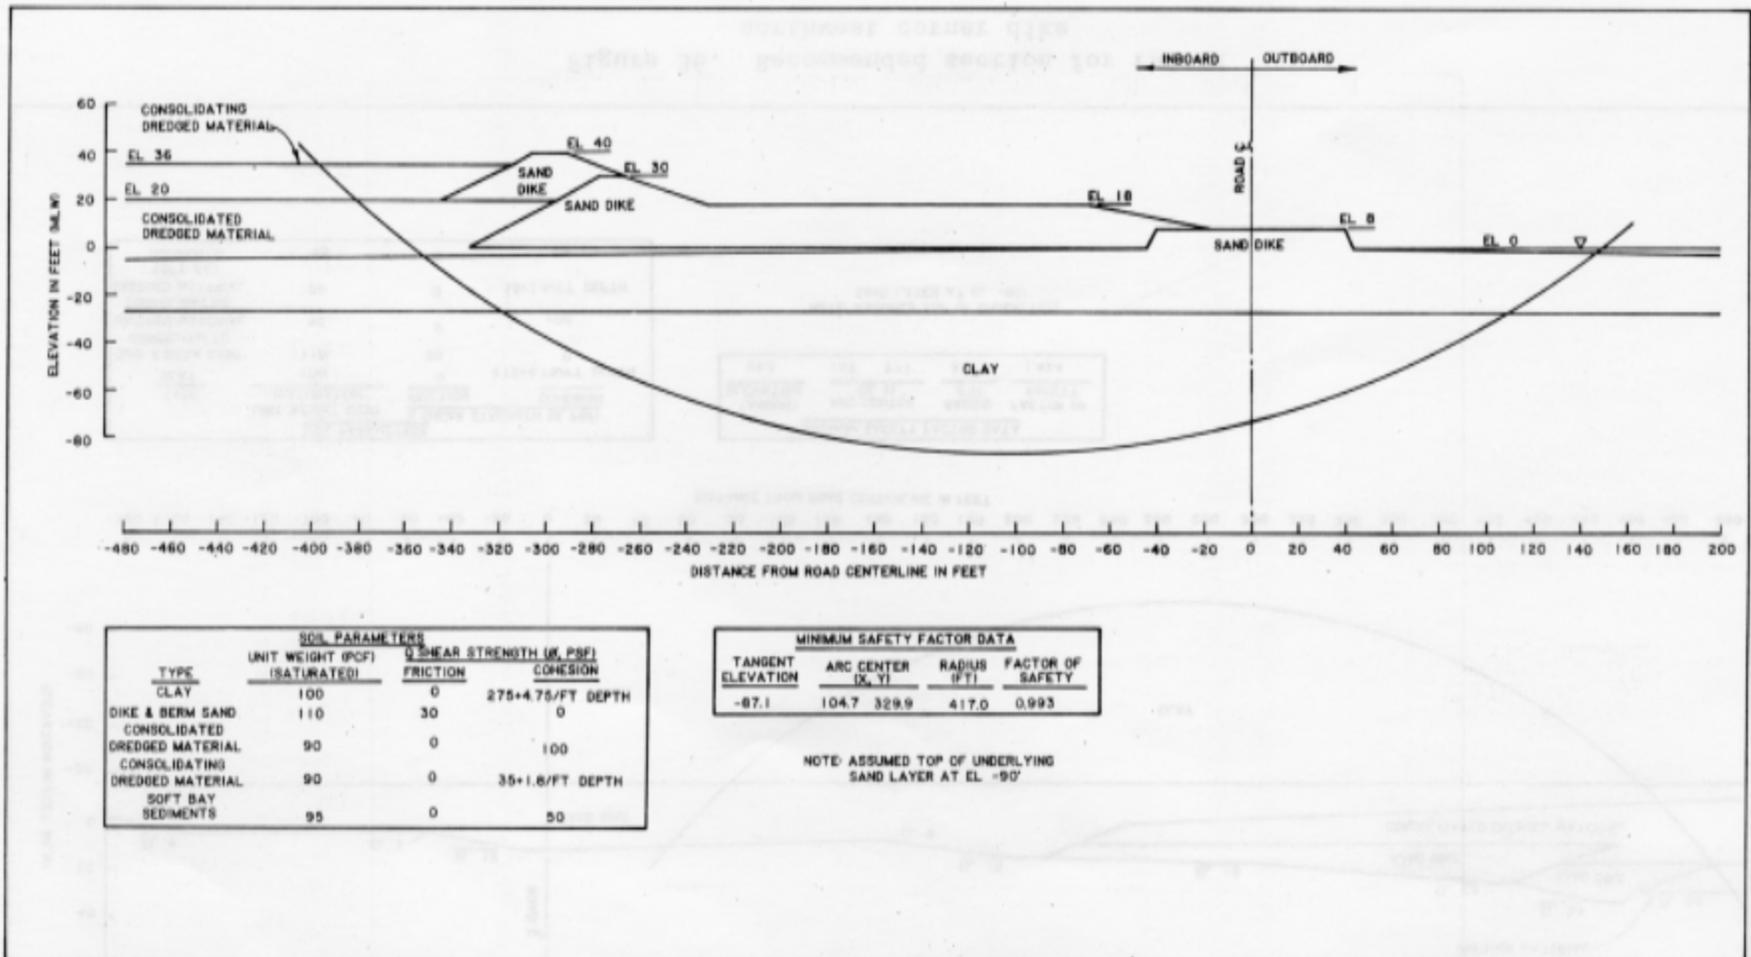
Figure 35. Critical circle for partial setback of raised north dike

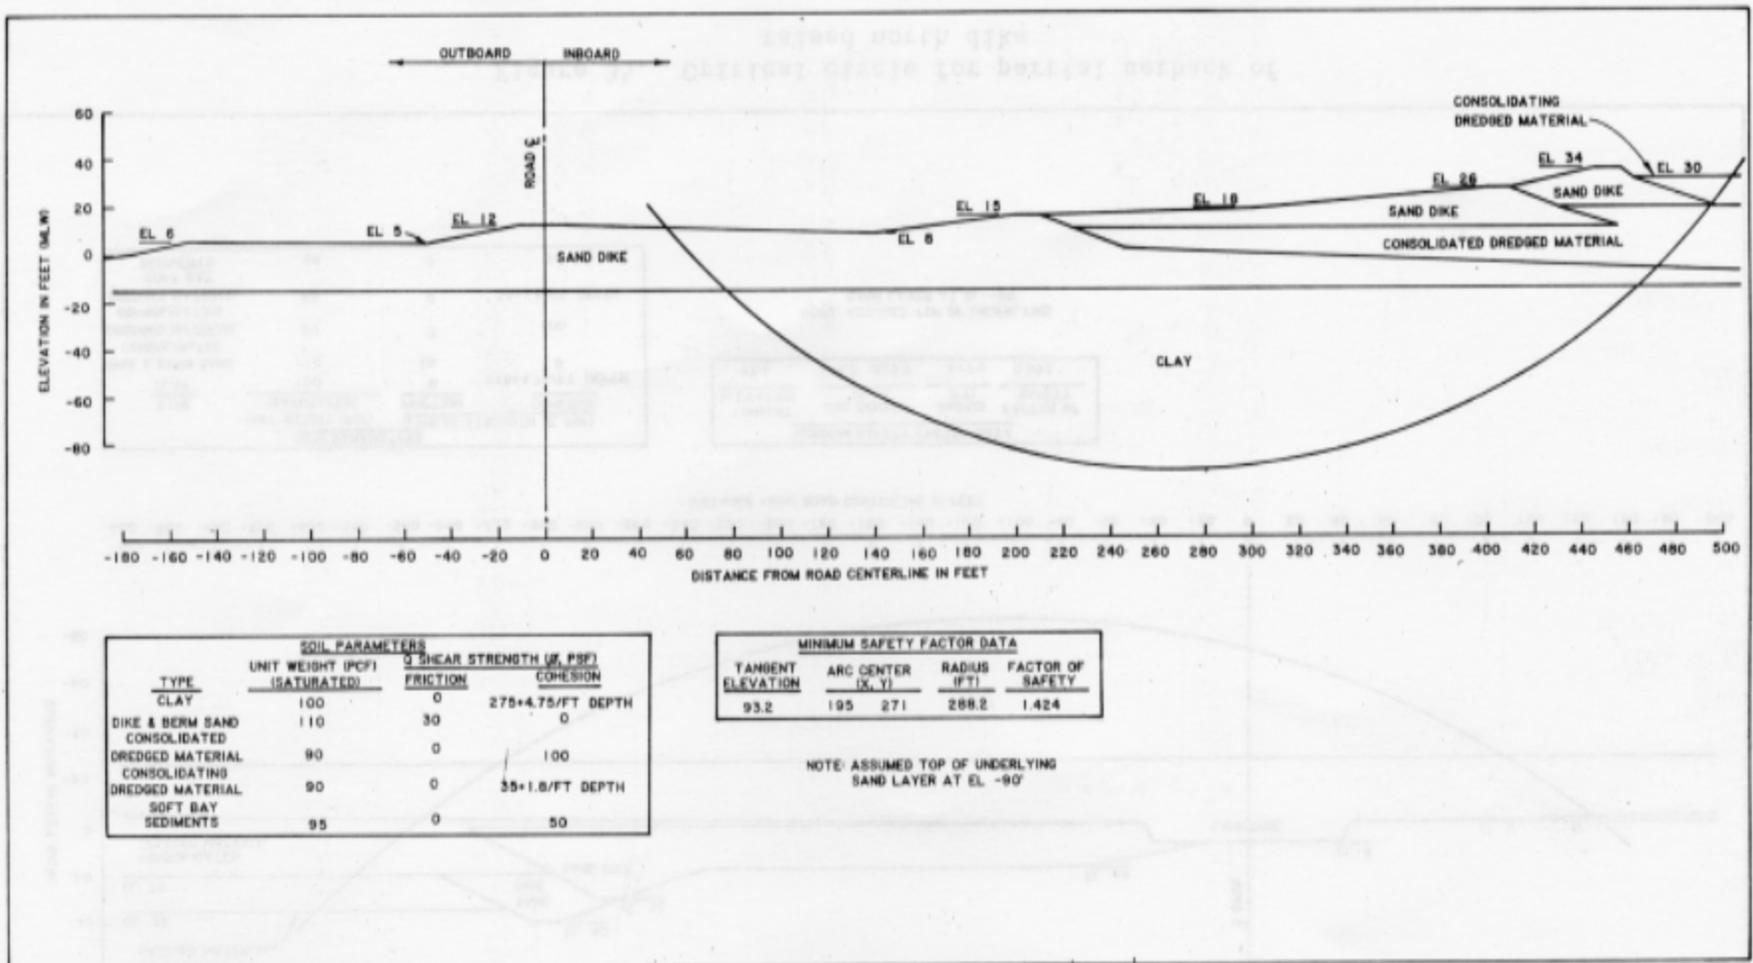
Figure 36. Recommended section for raised northwest corner dike
