**Maury River at Echols Farms
Stream Restoration II
Plan view concept**

PROPOSED
STREAM BANK
STABILIZATION
MAURY RIVER
ECHOLS FARMS
2016 (UDGIF)

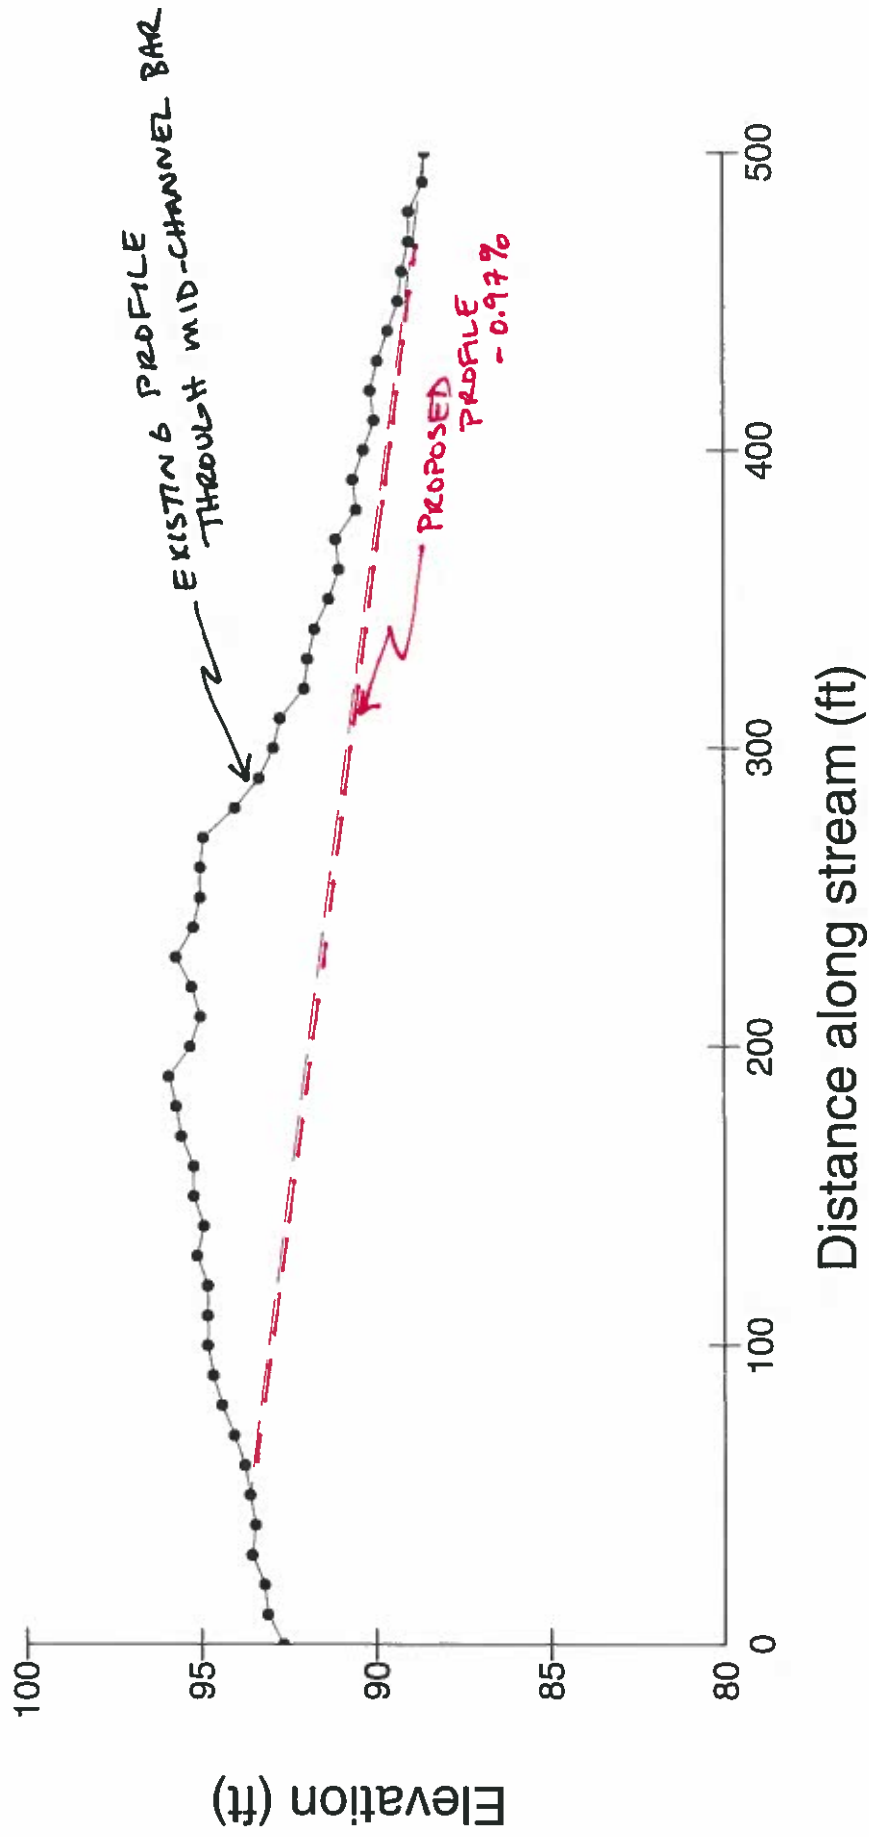
Maury longitudinal profile through existing mid-channel bar and proposed thalweg

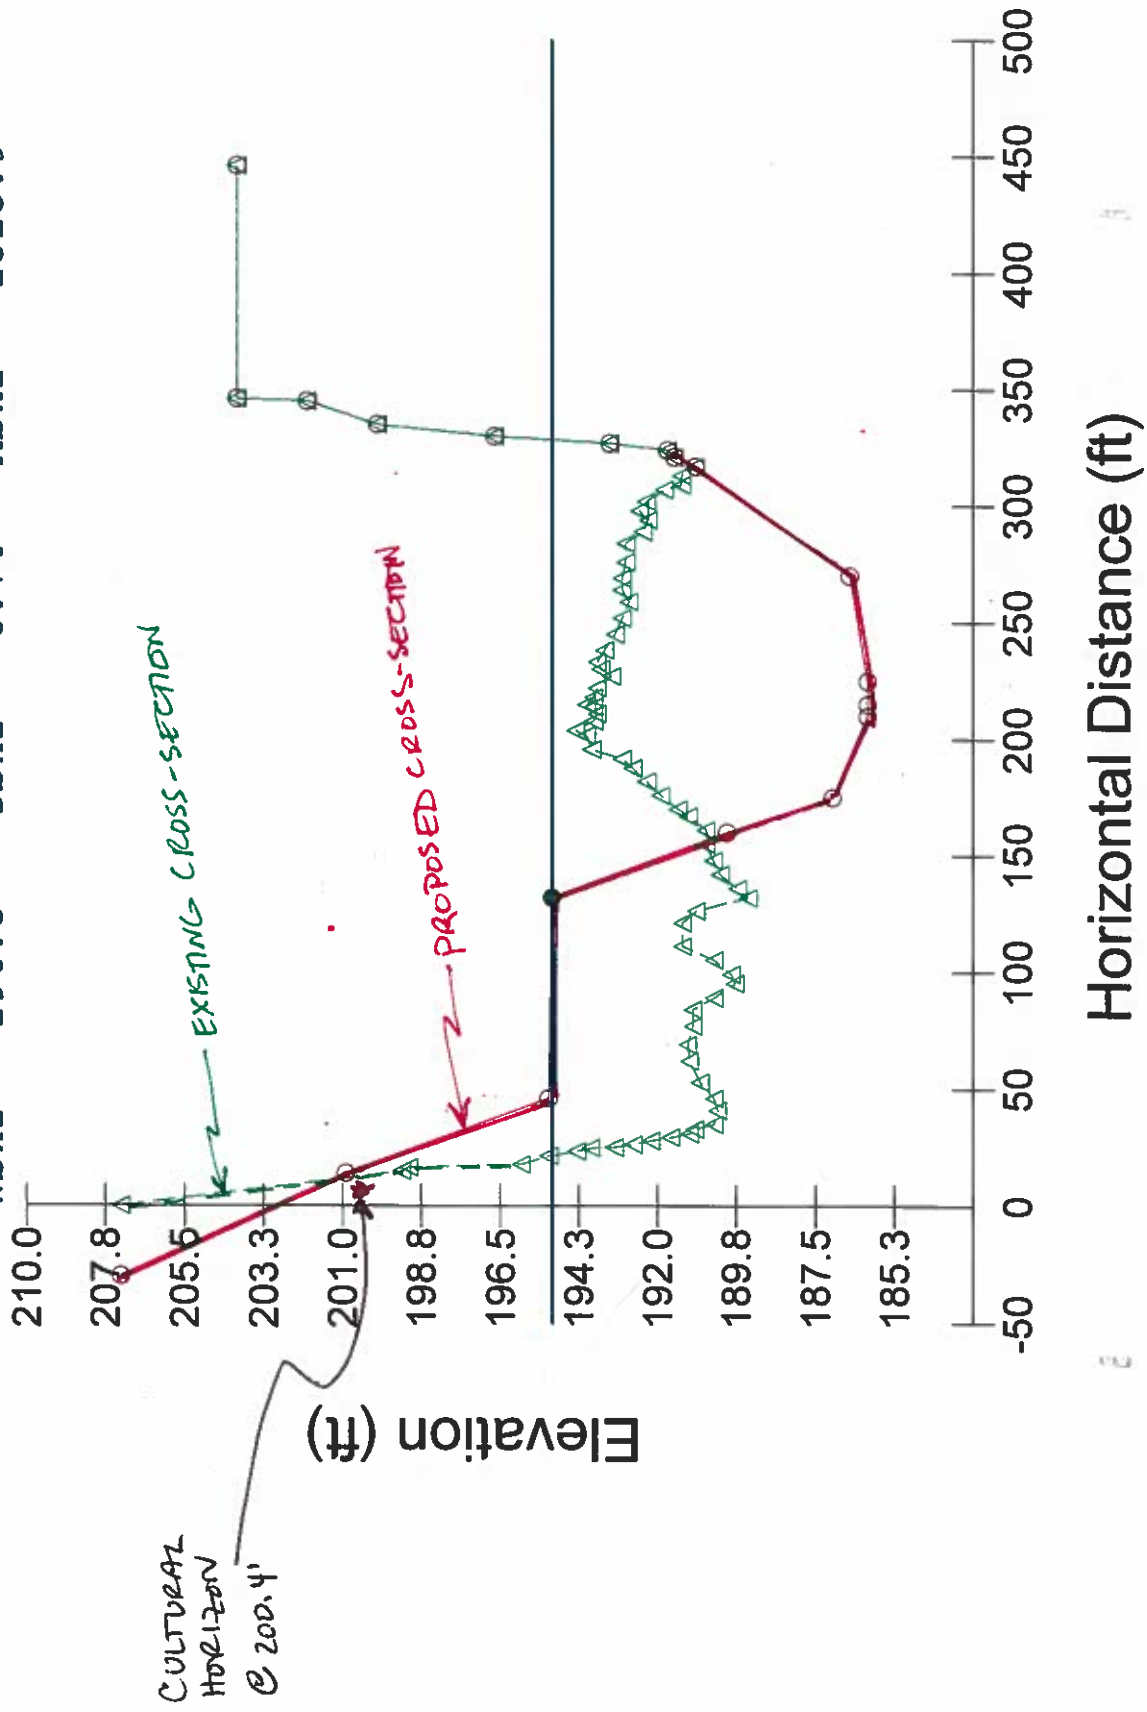
Maury Proposed Rifle Cross-section

○ Proposed Cross-section Bankfull Indicators Water Surface Points Impaired section

Wbkf = 196.5 Dbkf = 6.74 Abkf = 1323.9

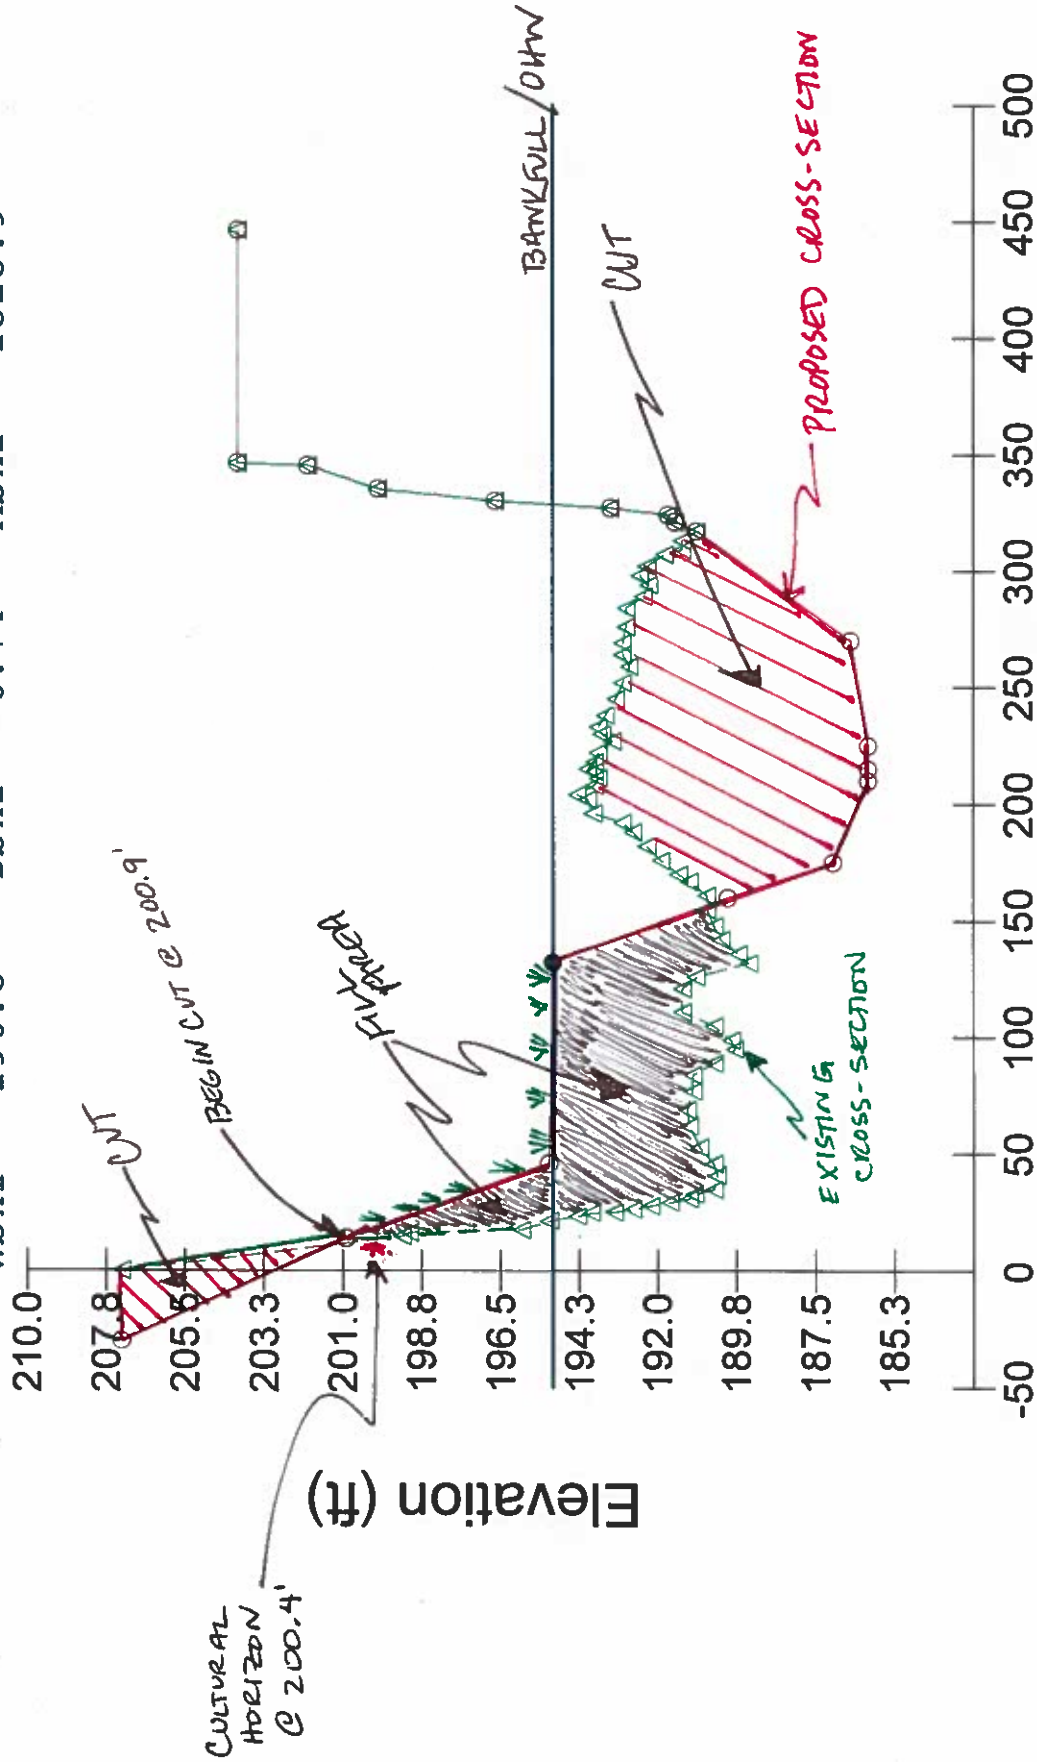
Maury Proposed Riffle Cross-section

○ Proposed Cross-section Bankfull Indicators Water Surface Points Impaired section
 Wbkf = 196.5 Dbkf = 6.74 Abkf = 1323.9

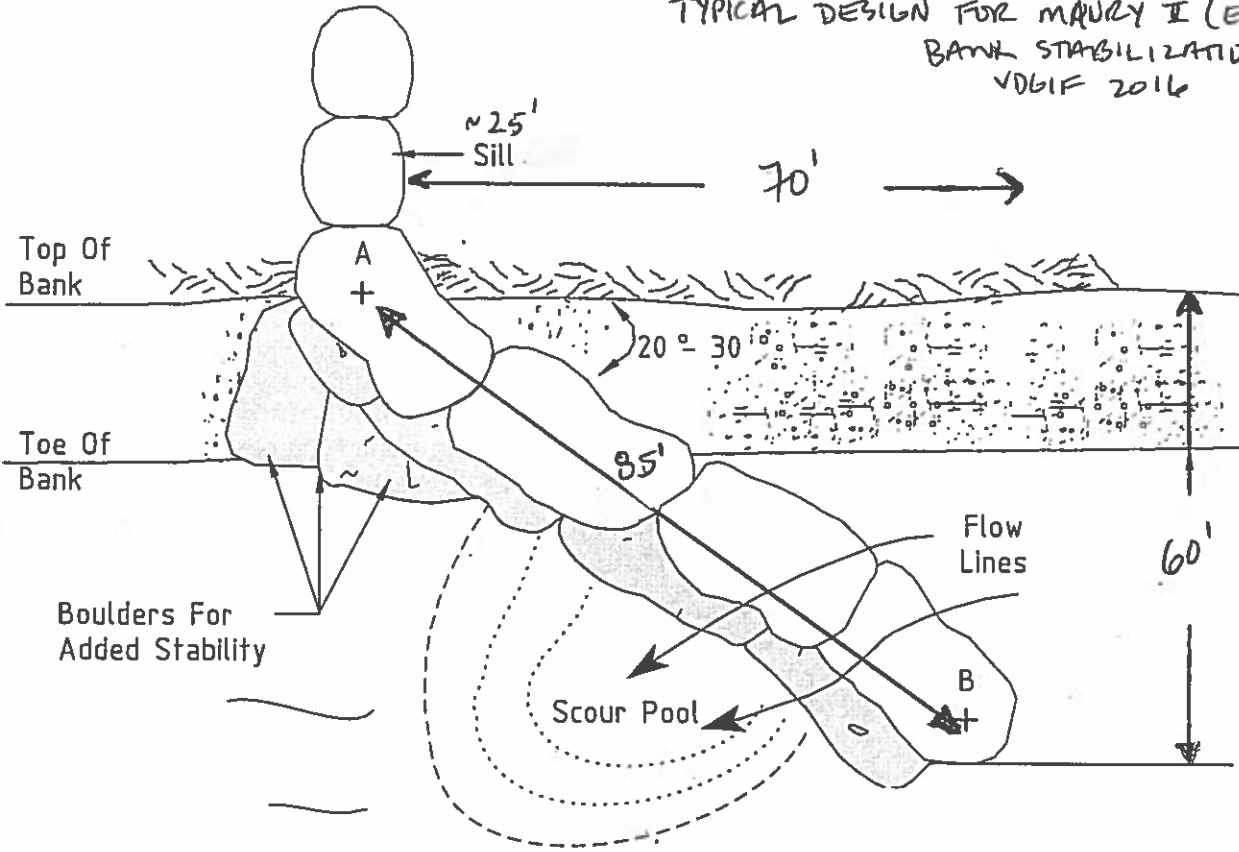
PLAN

DETAIL 4.1: ROCK VANES

TYPICAL DESIGN FOR MAURY II (ECHOLS)
BANK STABILIZATION
VDGIF 2016
