**Parcel ID Map
Verizon Elizabeth River HDD
WSSI #P.WSI0000035**

ER No:
 PCTS No:
 FILE NAME: C_VERIZONHDD_PLAN
 DATE: SEPT 2023 SCALE: AS SHOWN
 SHEET C-300

Verizon Elizabeth River HDD Permitting

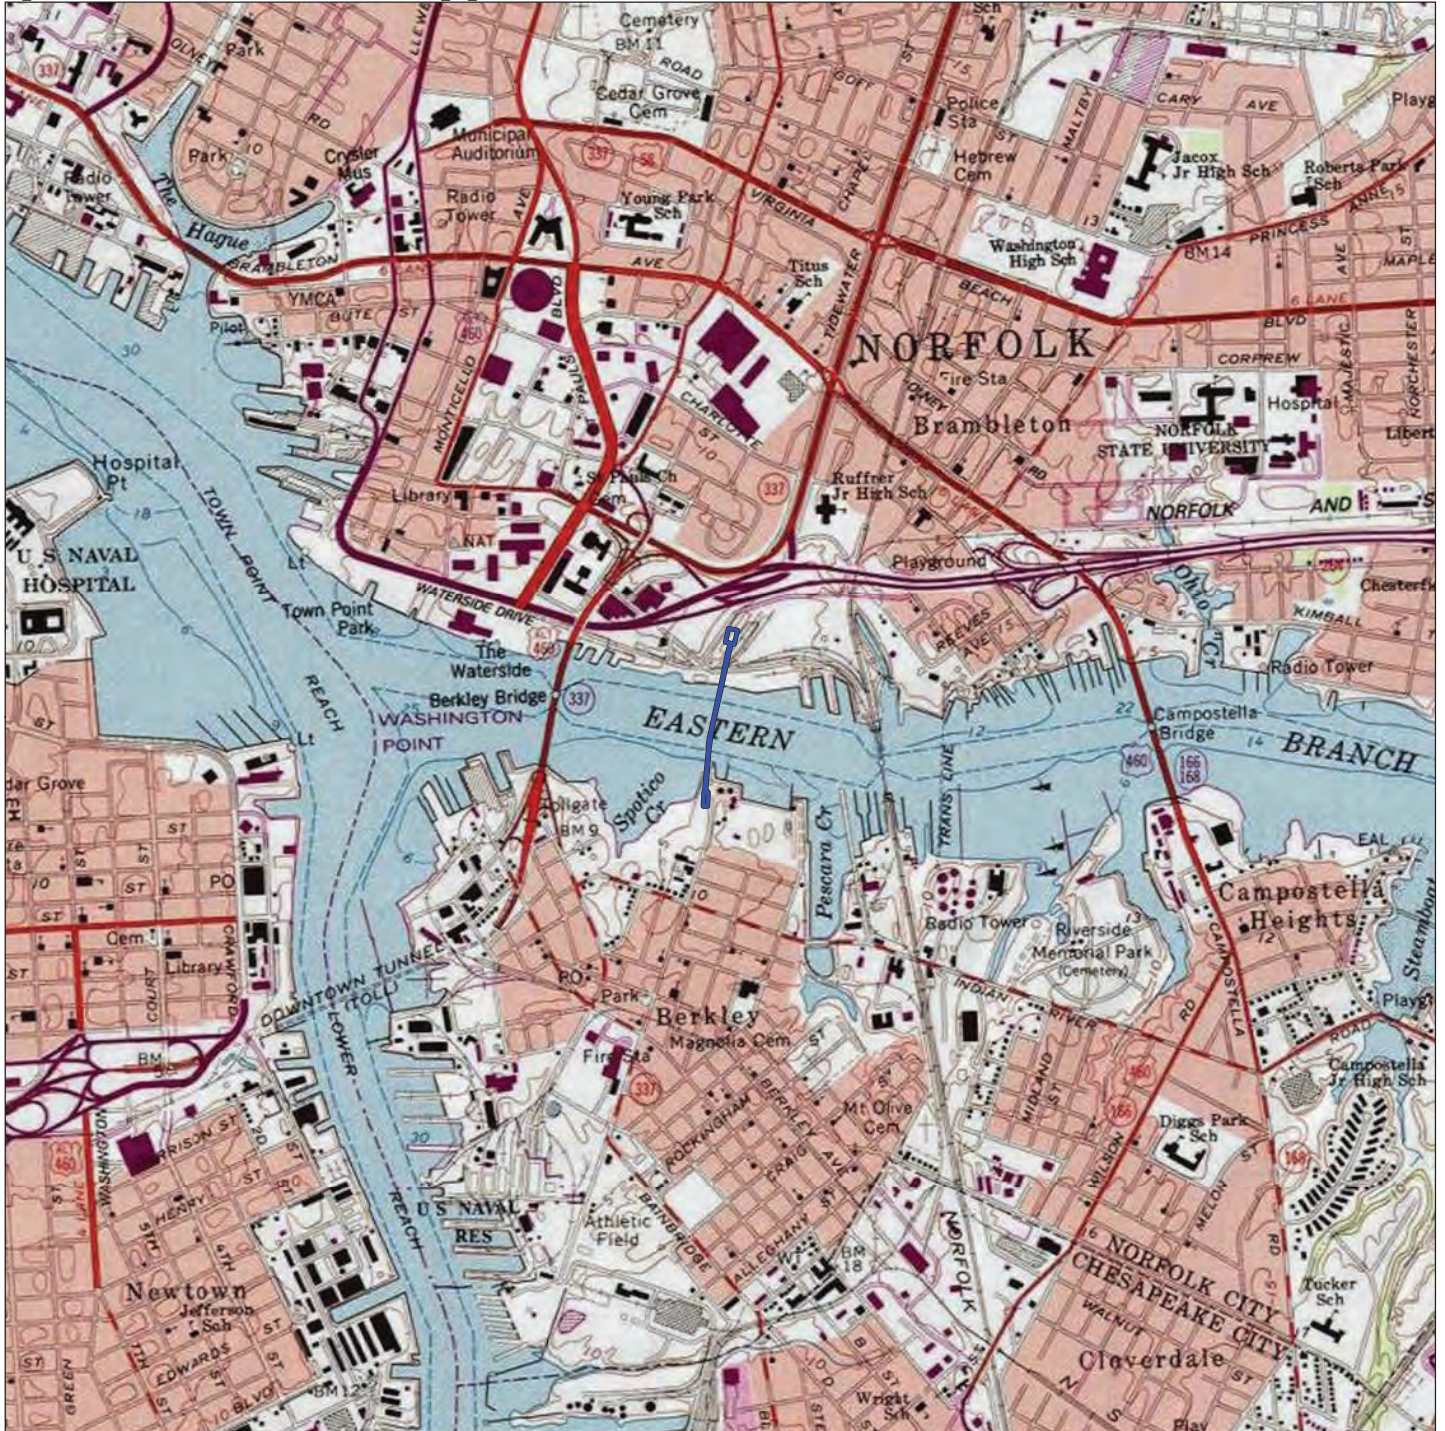
Exhibit 5

LOD: ±0.9 acres

USGS 7.5' Quadrangle Map
Verizon - Elizabeth River HDD
WSSI #P.WSI0000035
