**Bioretention Areas (Alexandria, VA)  
Beatley Central Library  
Completed in 2000**

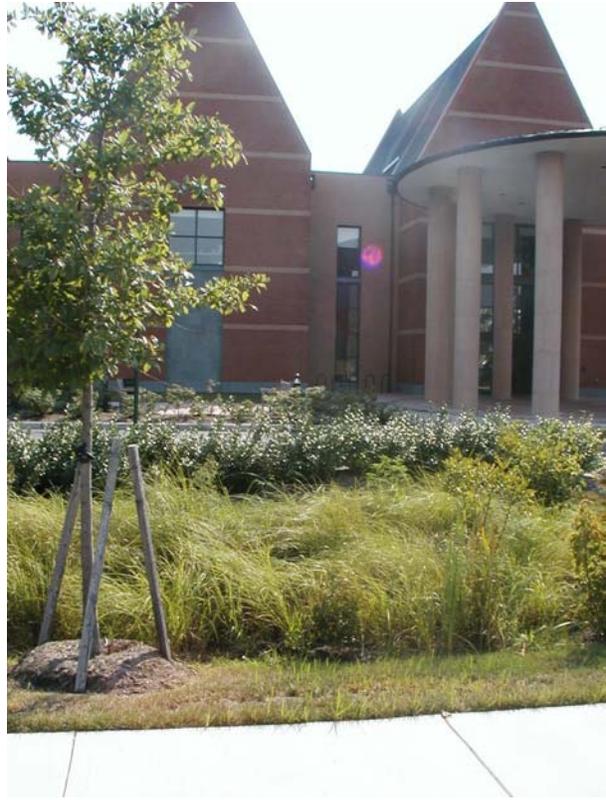
There is an additional bioretention area along the West side of the building, behind the reading garden. This area treats runoff from the remainder of the roof and from the cement garden patio. The West Side bioretention area is set back against the stream buffer and blends well with its surroundings. One thing to note is that the roof is made of copper and the bioretention areas help to remove a fair amount of copper oxidation from their receiving waters before it enters the stormwater system.

*Above photo taken in fall 2001.*

**Construction** - Many of the bioretention areas here had to be reconstructed. They were not percolating properly because the original soil media used contained excessive clay content. They were corrected with sand plugs and they are now functioning well. (Gavan 2001)
